**ROAD ACCIDENT REPORT**  
**CHICAGO, BURLINGTON, AND**  
**QUINCY RAILROAD COMPANY**  
**TRAIN 64 AND TRAIN 824**  
**DERAILMENT AND COLLISION**  
**WITH TANK CAR EXPLOSION**  
**CRETE, NEBRASKA**  
**FEBRUARY 18, 1969**

REPORT NUMBER: NTSB-RAR-71-2

CHICAGO, BURLINGTON, AND  
QUINCY RAILROAD COMPANY  
TRAIN 64 AND TRAIN 824  
DERAILMENT AND COLLISION  
WITH TANK CAR EXPLOSION  
CRETE, NEBRASKA  
FEBRUARY 18, 1969

ADOPTED: FEBRUARY 24, 1971

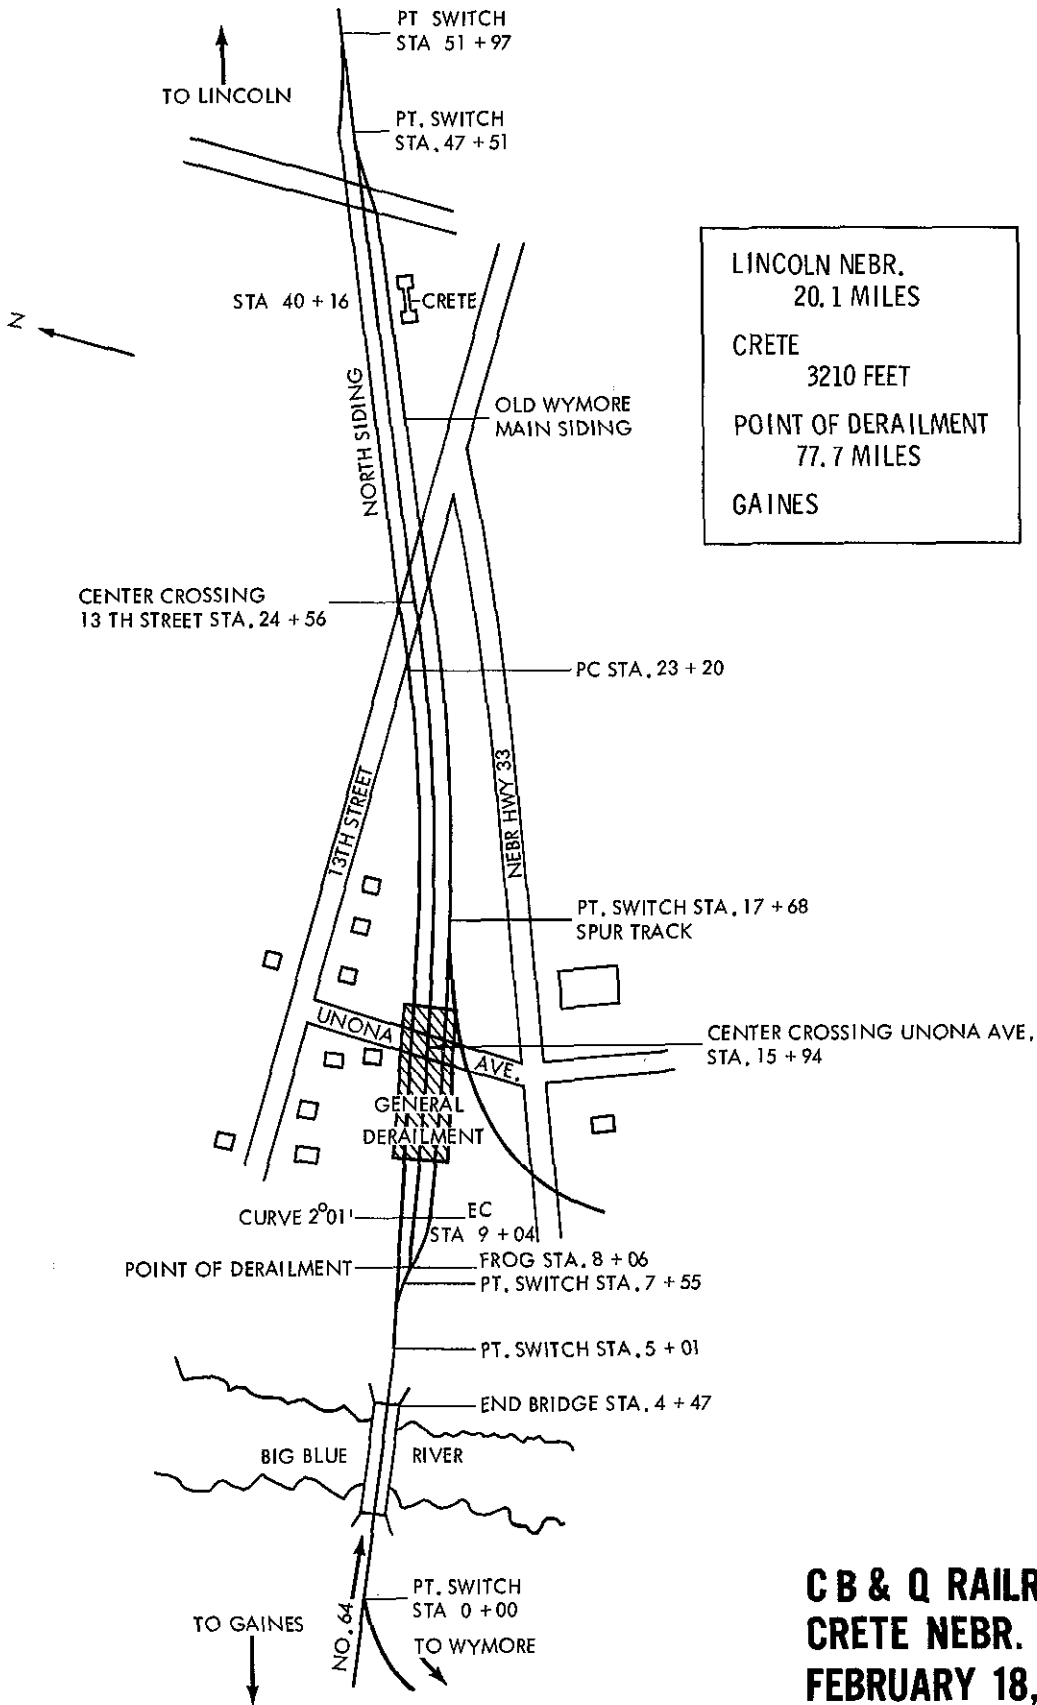
# FIGURE 1

A single-track branch line, known as the Wymore Branch connects with the main track at a point 4,016 feet west of the station at Crete. (See Figure 1 page 3. )

A residential and light business area is located along each side of the railroad east of the Blue River, as shown in the sketch, Figure 1. In the area of the accident, there are no buildings between the highway and the railroad. Residences are located along each side of Unona Avenue north of the railroad and along both sides of 13th Street.

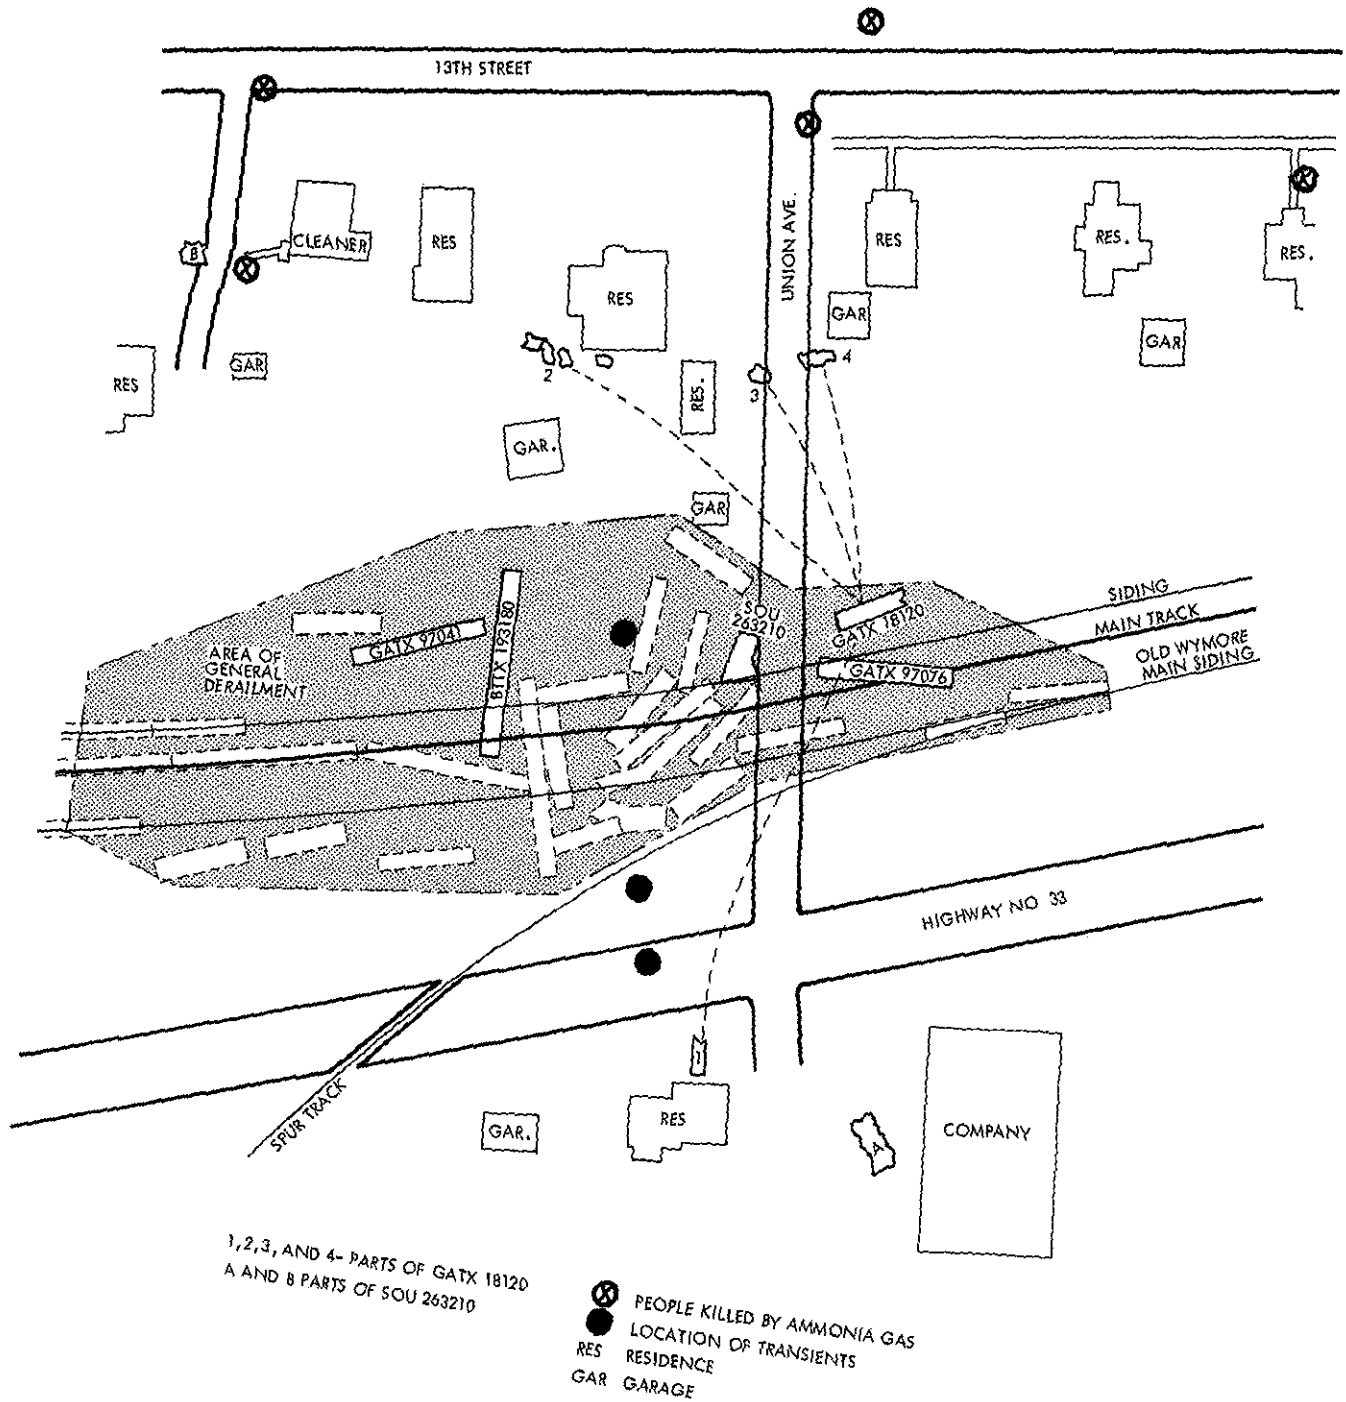
FIGURE 5

Three transients who were riding on one of the derailed cars of train No. 64 were killed in the derailment of No. 64. The bodies of two of the transients were found south of the track near or on Highway No. 33, and the third was found north of the railroad near the derailed cars. (See Figure 5). It could not be determined on which car they were riding when the accident occurred.

Any person who ventured outside of his house into the vapor cloud without adequate protection was either killed or seriously injured as a result of exposure to the ammonia. Five people were killed immediately by the ammonia, one person died subsequently, and 28 people were injured seriously. Figure 5 shows the locations where the fatalities occurred.
