REPORT NO. 3310
CHICAGO, MILWAUKEE, ST. PAUL AND PACIFIC
RAILROAD COMPANY
IN RE ACCIDENT
NEAR FREDONIA, WIS., ON
FEBRUARY 2, 1950

Kind of accident: Derailment

Cause: Broken rail

Accident near Fredonia, Wis., on February 2, 1950, caused
by a broken rail.

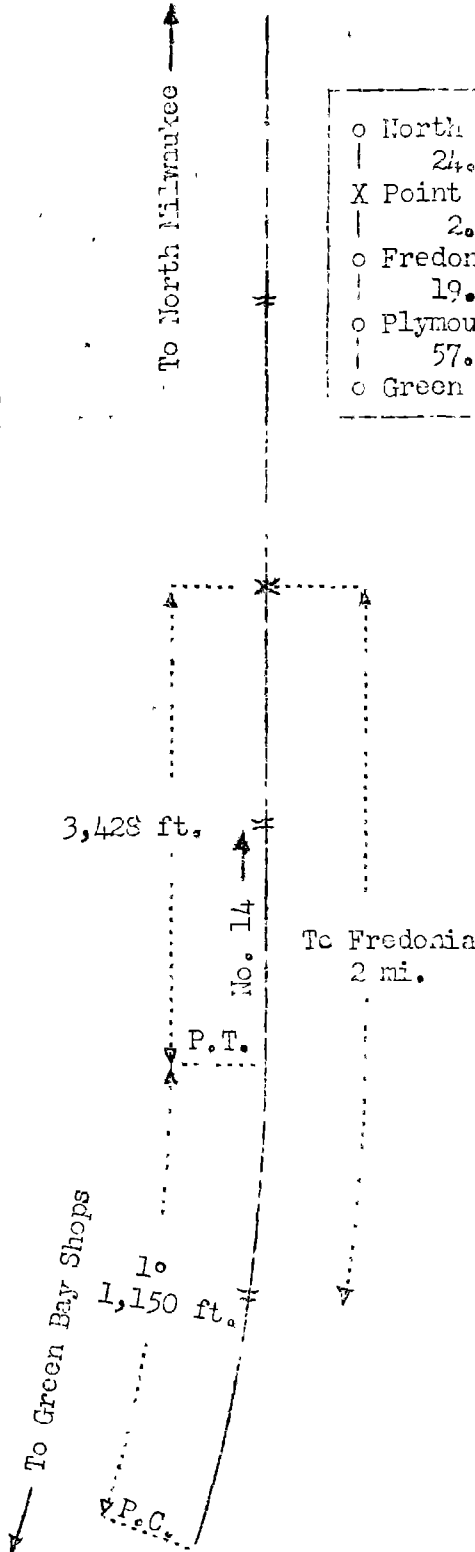
- o North Milwaukee, Wis. 24.4 mi.
- X Point of accident 2.0 mi.
- o Fredonia 19.7 mi.
- o Plymouth 57.9 mi.
- o Green Bay Shops, Wis.
