**RAILROAD ACCIDENT INVESTIGATION**

**Report No 3830**

CHICAGO, ROCK ISLAND AND PACIFIC RAILROAD COMPANY

JANUARY 16, 1959

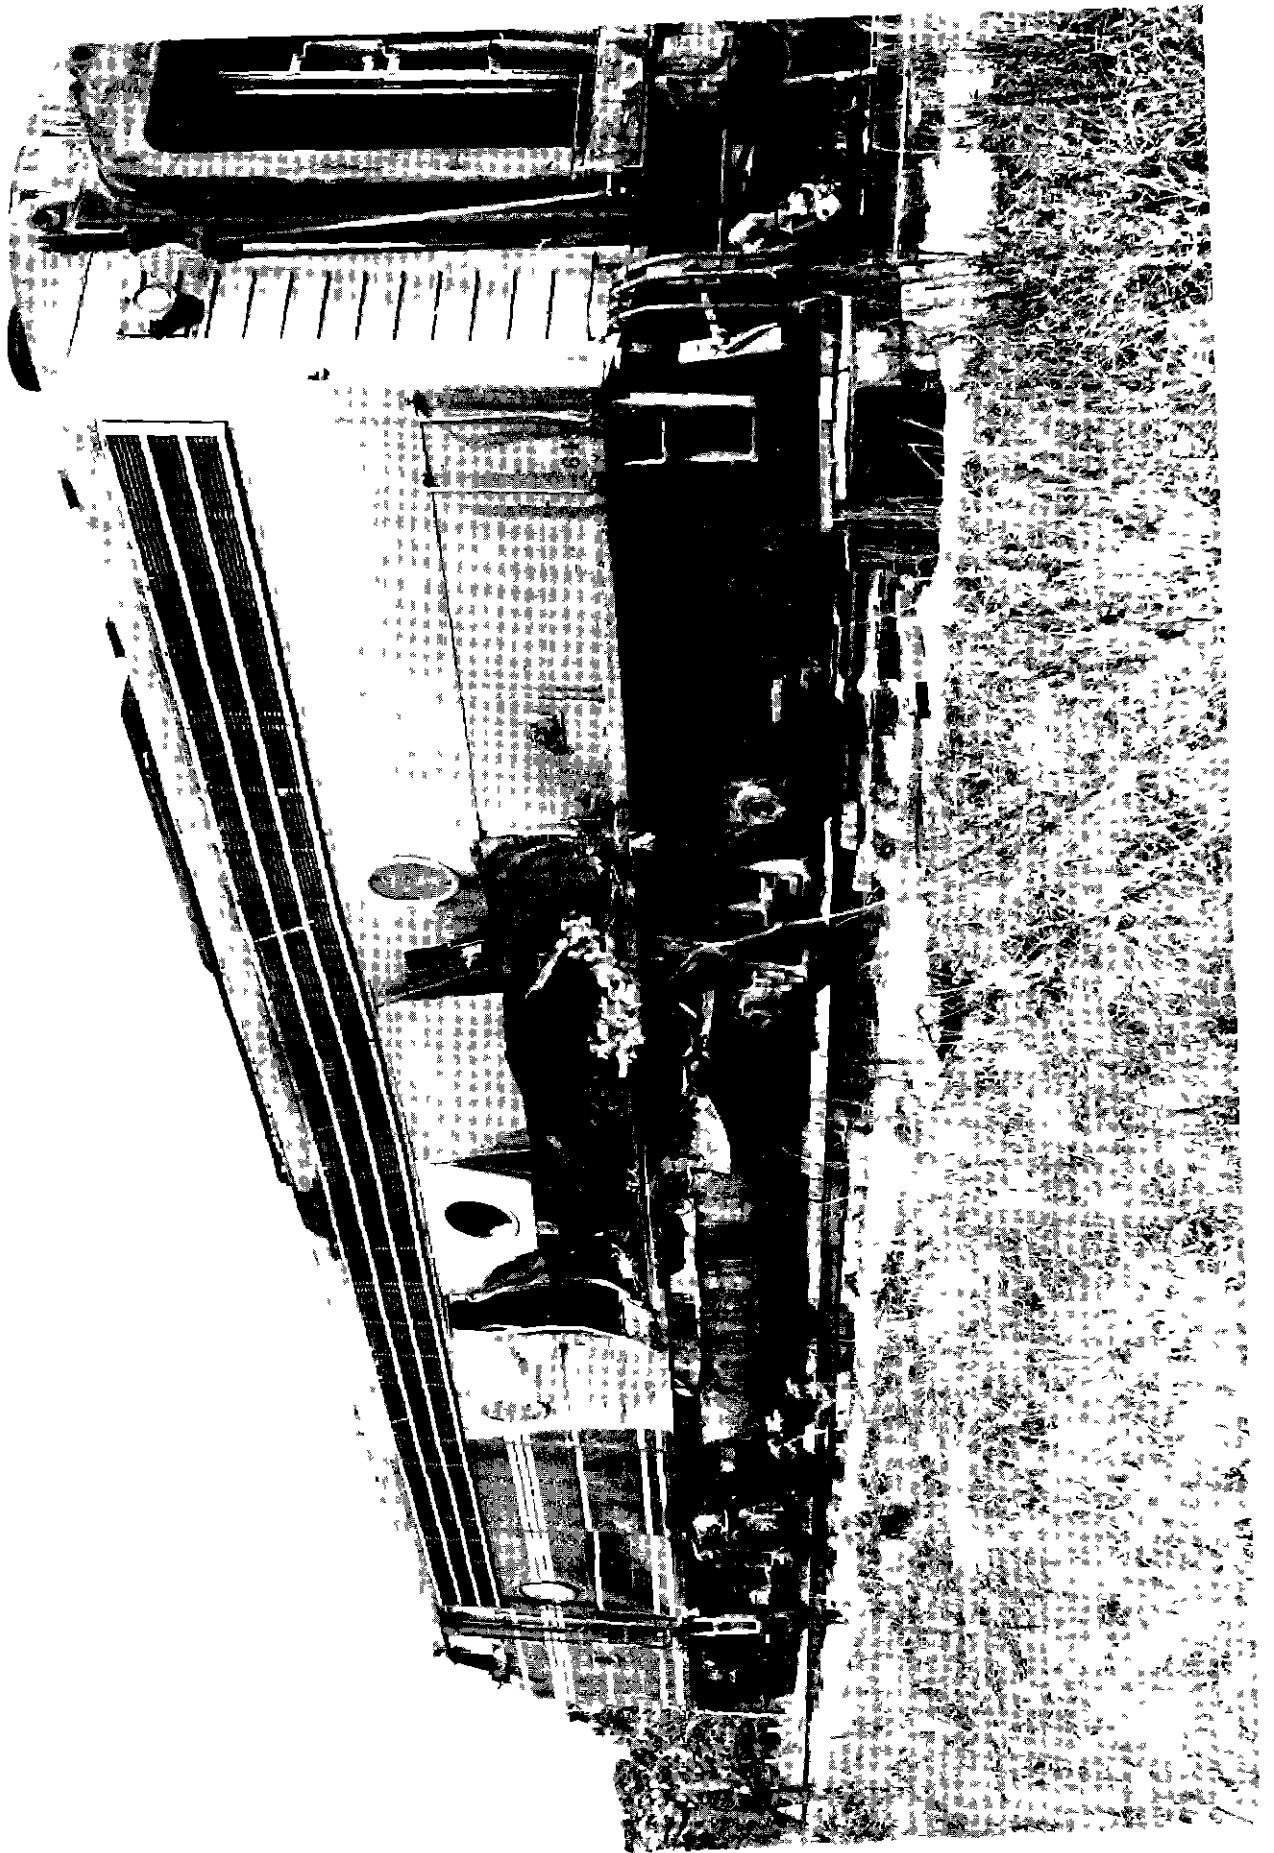
equipment of No 508 stopped in various positions on or near the track structure as shown in the sketch of this report. Four freight cars standing on the siding north of the crossing were struck by equipment of No 508 and were derailed. The diesel-electric units, the 4th to 9th cars, inclusive, of No 508, and 3 of the freight cars were heavily damaged. The 1st to 3rd cars, inclusive, of No 508, and a freight car, were slightly damaged.

The tractor and the semi-trailer stopped in the northwest angle of the intersection. The tractor was separated from the semi-trailer and was destroyed. The semi-trailer was heavily damaged.

An examination of the track structure after the accident occurred disclosed that it was damaged throughout a distance of 780 feet northward from the point of accident. It is apparent that the motortruck struck the leading diesel-electric unit with sufficient force to cause the rear truck to become derailed, and the general derailment occurred at the facing point switch.
