RAILROAD ACCIDENT INVESTIGATION.

REPORT NO. 4168 LIBRARY

CHICAGO, ROCK ISLAND AND PACIFIC RAILROAD COMPANY

MARCH 25, 1970

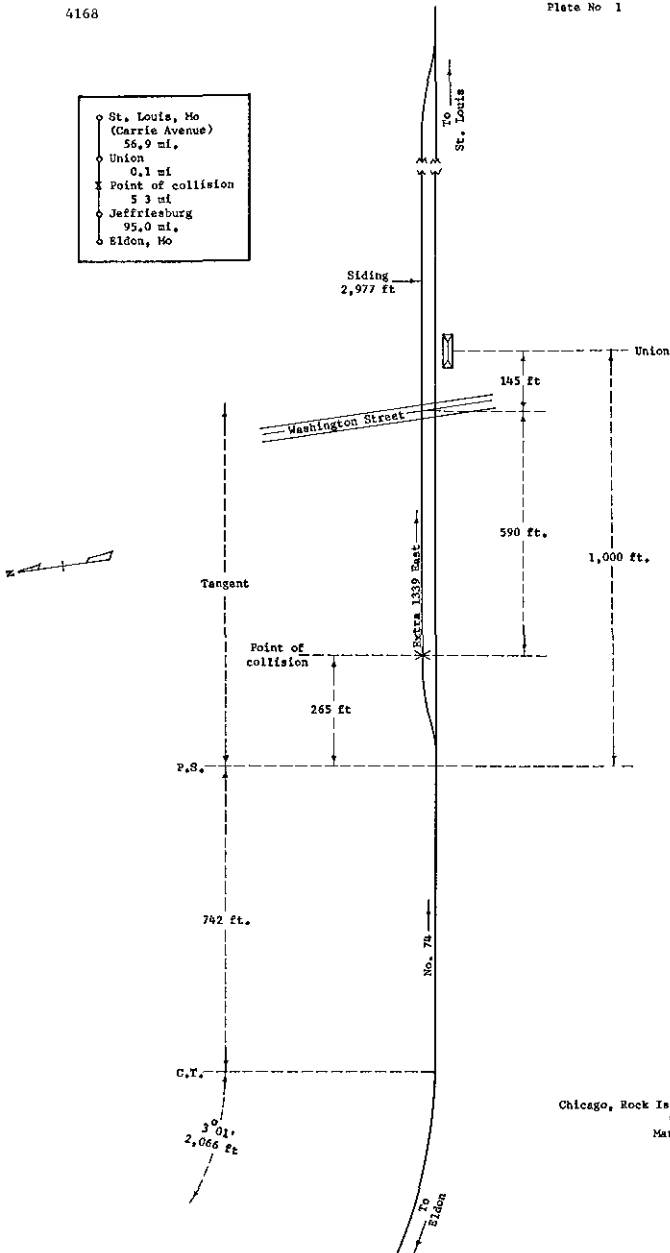
West siding-switch at Union, from distance of 310 feet.

At the time of the collision, the switch stand for the west switch of the siding at Union had neither a switch lamp nor a reflectorized target. This condition was brought to the attention of the Missouri Public Service Commission. Two days after the accident, the State agency initiated action to ensure the CRI&P's compliance with the order of September 10, 1968.

2 Failure of the conductor of Extra 1339 East to restore the west siding-switch at Union to normal position after his train entered the siding and cleared the main track was the primary cause of the accident. The reason for this failure appears to be that due to fatigue resulting from having been up and about for 23 or 24 hours, the conductor forgot to restore the switch to proper position, lined for movements on the main track.

5. Apparently because of it being somewhat dark at the time, the engineer of No. 74 did not notice the west switch of the Union siding was improperly lined before reaching a point a relatively short distance from the switch.
