INTERSTATE COMMERCE COMMISSION

Ex Parte No. 183

ACCIDENT NEAR UTICA, ILL.

Accident near Utica, Ill., on July 7, 1951, caused by a defective spring-rail-frog assembly.

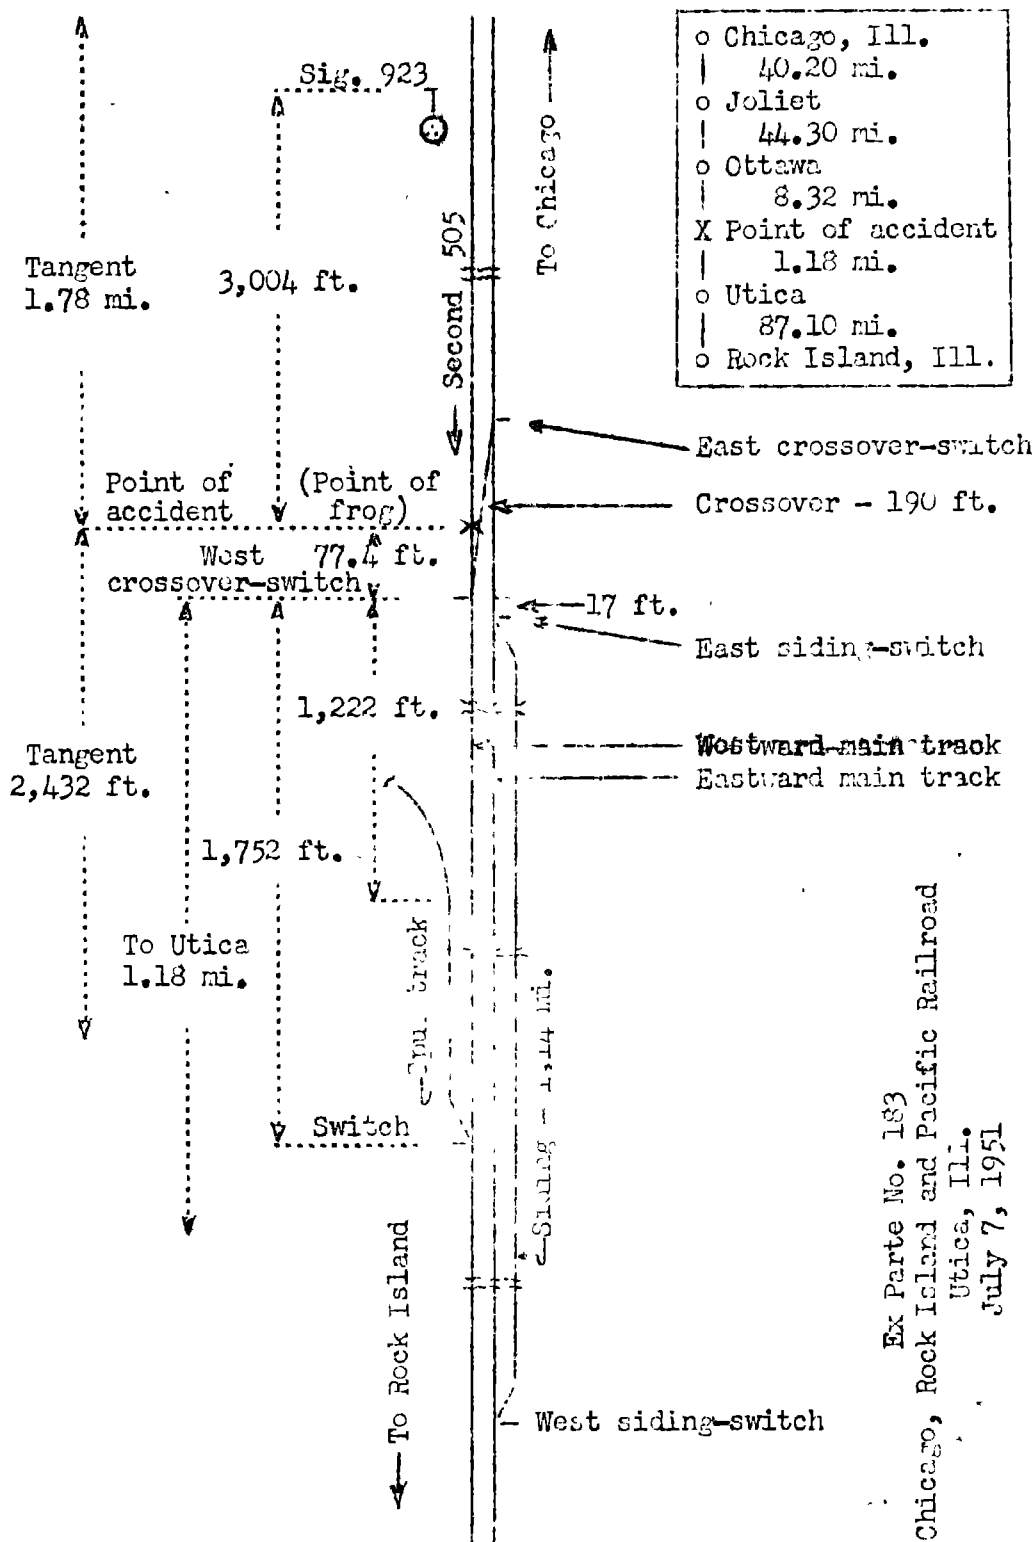
Ex Parte No. 183
Chicago, Rock Island and Pacific Railroad
Utica, Ill.
July 7, 1951

When the accident occurred the structure of the turnout of the west crossover-switch consisted of a No. 10 spring-rail frog, the angle of which was 5°43'29", 112-pound rails and switch rails, and two manganese 1-piece guard rails 8 feet 4-1/2 inches in length. The frog was 17 feet 10-1/2 inches in length. It was laid new during April, 1947, on 11 treated hardwood switch ties and was provided with bearing plates and a 1-piece base plate. For through movements on the main track, the carrier's specifications require that a 2-inch flangeway be provided between the rigid wing-rail and the frog point. For movements through the turnout, they require that the spring wing-rail be adjusted for a 2-inch flangeway when fully open.

hold-down horn was broken. As a result, the horn was secured to the rail by only the one bolt through the west leg. It was an old fracture. When the housings were placed in normal position after the accident occurred it was found that the vertical clearance between the horns and the tops of the housings of the east and the west hold-downs were, respectively, 11/16 inch and 1/8 inch. The left side of the channel toe block was bent outward and the metal reinforcing strip on the left side of the channel was crushed downward. The four joint bolts which secured the left side of the channel toe block to the rail had been broken in tension. Fractures existed in three of the bolts before they were broken which covered, respectively, 55, 75 and 95 percent of the cross-sectional area. The head of each joint bolt was worn smooth, and each bolt was bent and worn which indicated that the joint had been loose a considerable time before the accident occurred. The switch tie under the east end of the toe joint of the frog was sound and provided a good bearing for the tie plate, but the switch tie under the west end of the toe joint and the next tie westward were decayed and plate cut and there had been a vertical movement of the toe joint of at least 1/2 inch. The top of the receiving end of the next rail was battered by wheel treads and at least one flange had struck the end of the rail. The north main-track rail opposite the frog was canted outward, and the bottom of the guard rail was marked by the base of the main-track rail.

It is found that this accident was caused by a defective spring-rail frog assembly.
