NATIONAL TRANSPORTATION SAFETY BOARD

RAILROAD ACCIDENT REPORT

COLLISION AND DERAILMENT
OF AMTRAK TRAIN 6
ON THE BURLINGTON NORTHERN RAILROAD
RUSSELL, IOWA
OCTOBER 12, 1987

NTSB/RAR-88/04

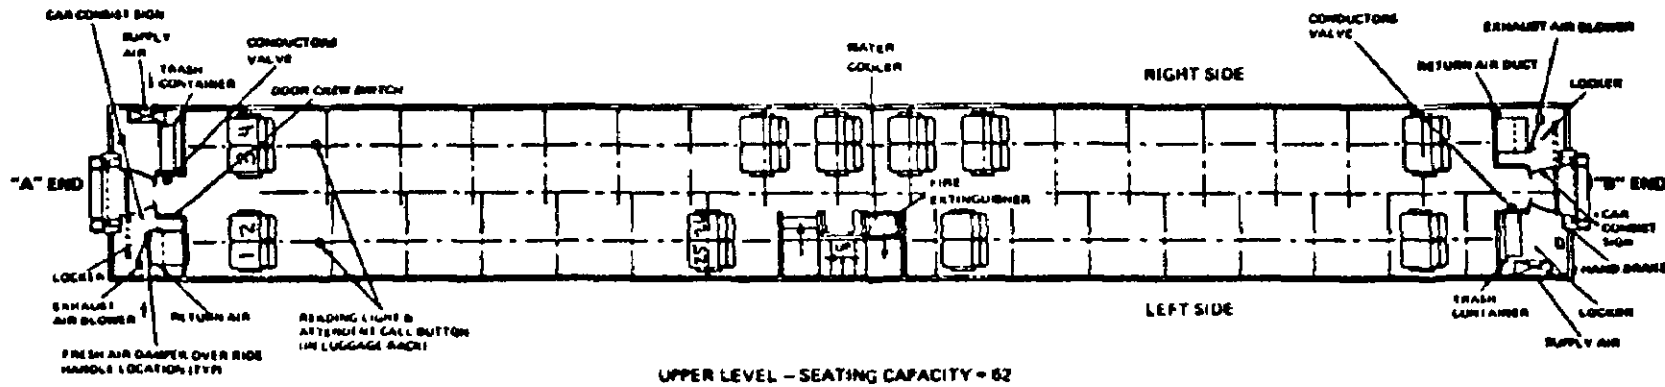
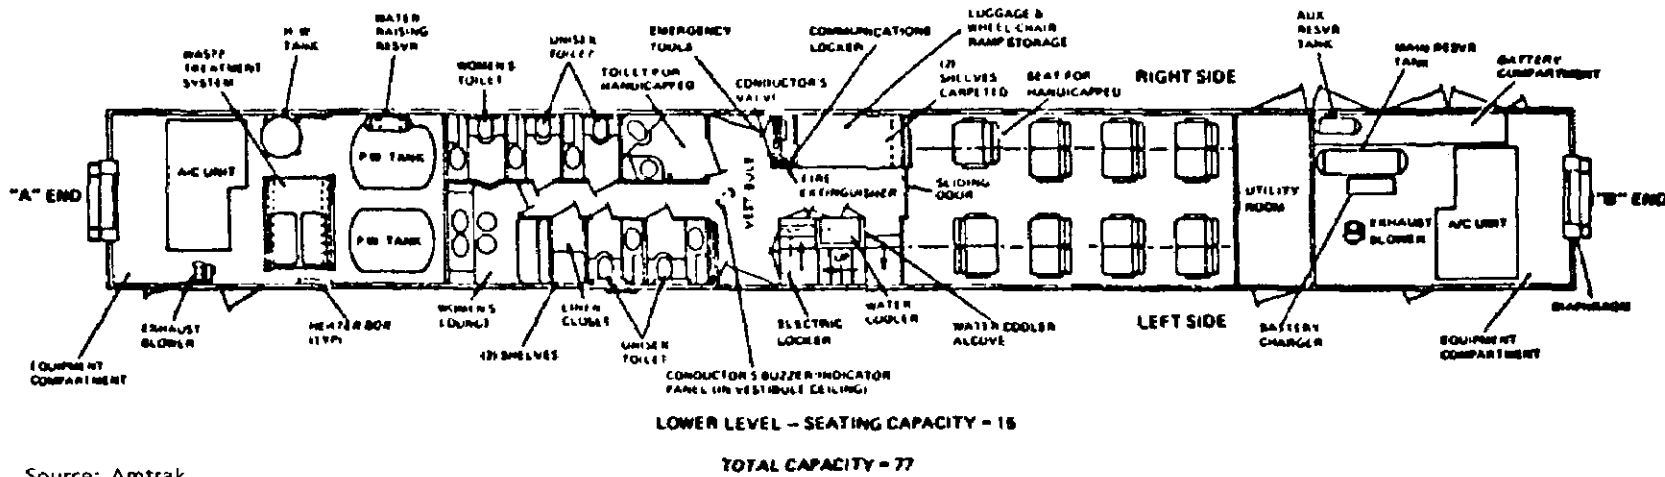
Figure 9 --Coach car, interior arrangement and floor plan.

The five coach cars were of the superliner type. Each car was about 85 feet long and constructed of stainless steel. The upper level had 62 coach seats with leg rests, the lower level had 15 coach seats. A stairway connecting the two levels was located near the center of the car. On each side of the car on the lower level was a center entrance door, on the upper level were end doors that permitted access to the other cars. (See figure 9.)

All seats in the five coach cars were double-width seats with one armrest on each end of the pair of seats. Each of these double-width seat units was mounted on a central pedestal. The units locked into position when facing either forward or rearward. They could be unlocked and allowed to rotate to the alternate position by depressing a pedal at the base of the pedestal. The seats then snapped into the locked position. Seatback cushions were designed to be removed by first pulling the bottom of the cushion away from the frame, separating the hook-and-loop type fastener, then lifting the headrest part of the cushion off the sheet metal strip at the top of the frame, which served as the headrest support. Overhead luggage racks, approximately 2 feet wide, were located along the sidewalls over the seating areas and contained no type of baggage securing devices.

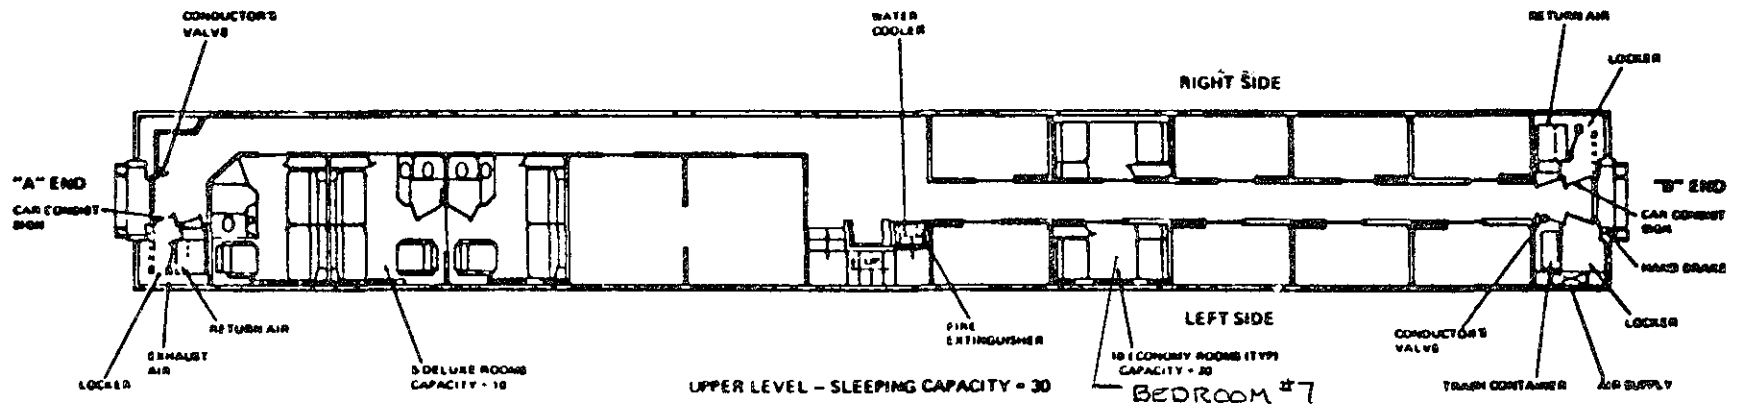
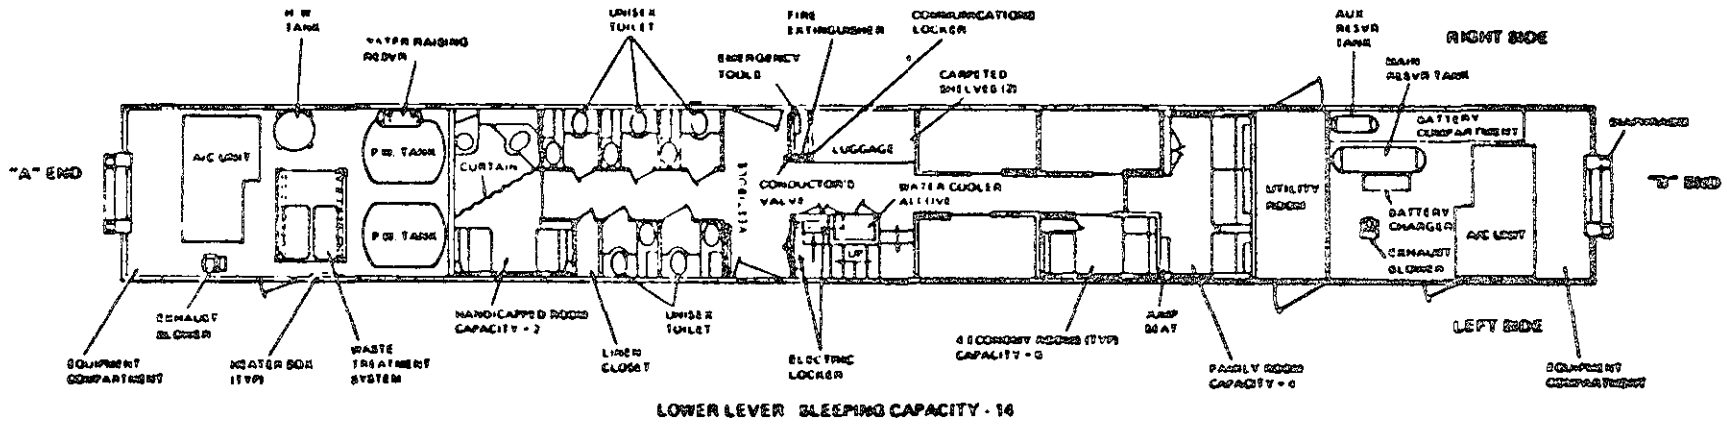
Figure 10.--Sleeping car, interior arrangement and floor plan.

The three sleeping cars were of the same construction and design as the superliner coach. Each had five deluxe rooms and 10 economy rooms on the upper level, for a sleeping capacity of 30. A stairway led to the lower level, where there were four economy rooms, one family room, and a handicapped room, for a sleeping capacity of 14. The lower level had five unisex restrooms and storage at the car ends. (See figure 10.)
