# NATIONAL TRANSPORTATION SAFETY BOARD

## RAILROAD ACCIDENT REPORT

REAR-END COLLISION OF  
CONRAIL COMMUTER TRAINS  
PHILADELPHIA, PENNSYLVANIA

NTSB-RAR-80-5

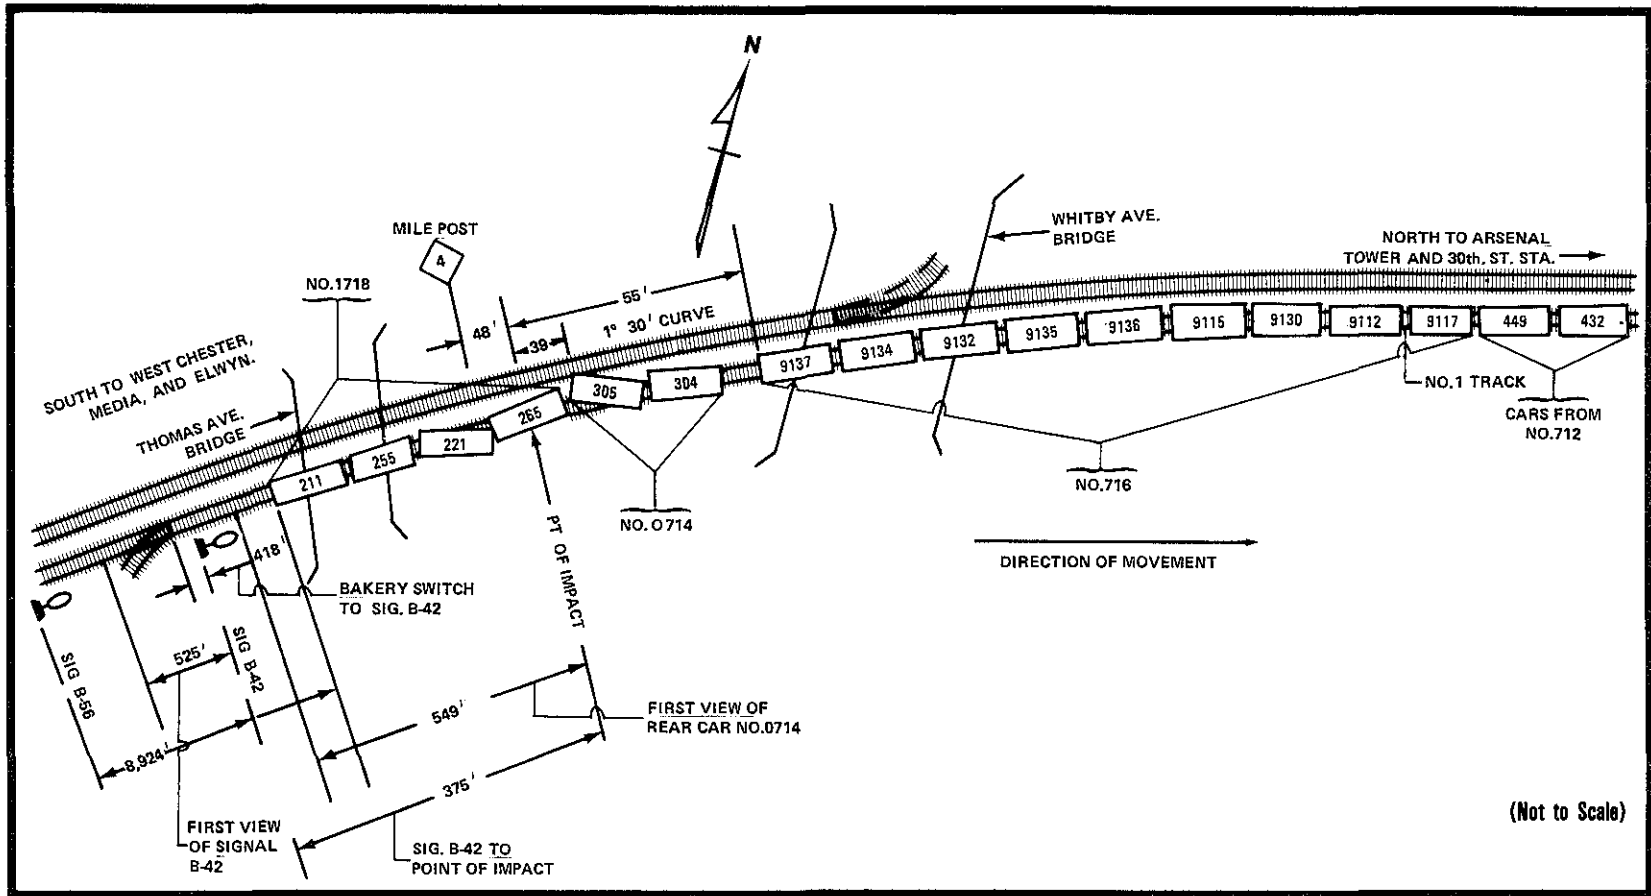
Figure 2.—Plan view of accident site.

The approach signal, B-56, for signal B-42 is 8,924 ft south of signal B-42. Signal B-42 is 385 ft south of the point of impact. (See figure 2.) The position light signals can display the following aspects:

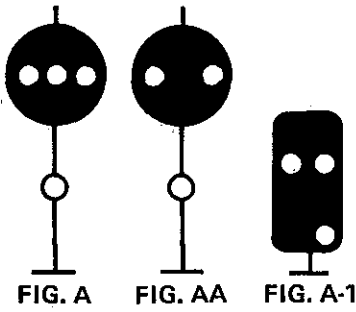
Aspect Displayed by Signal B-42

**INDICATION**—Stop; then proceed at Restricted speed.

**NAME:** Stop and proceed.

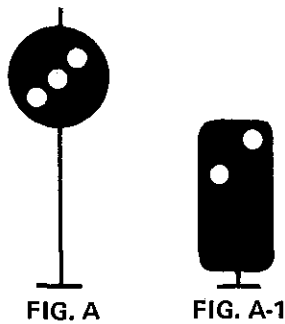
Aspect Displayed by Signal B-56

**INDICATION**— Proceed prepared to stop at next signal. Train exceeding Medium speed must at once reduce to that speed.
