**REAR-END COLLISION OF
SEPTA-CONRAIL TRAINS
NOS. 406 AND 472
ON CONRAIL TRACK
NORTH WALES, PENNSYLVANIA
JULY 17, 1980**

NTSB-RAR-80-11

**REAR-END COLLISION OF
SOUTHEASTERN PENNSYLVANIA TRANSPORTATION AUTHORITY
AND CONSOLIDATED RAIL CORPORATION TRAINS
NOS. 406 AND 472
ON CONRAIL TRACK
NORTH WALES, PENNSYLVANIA
JULY 17, 1980**

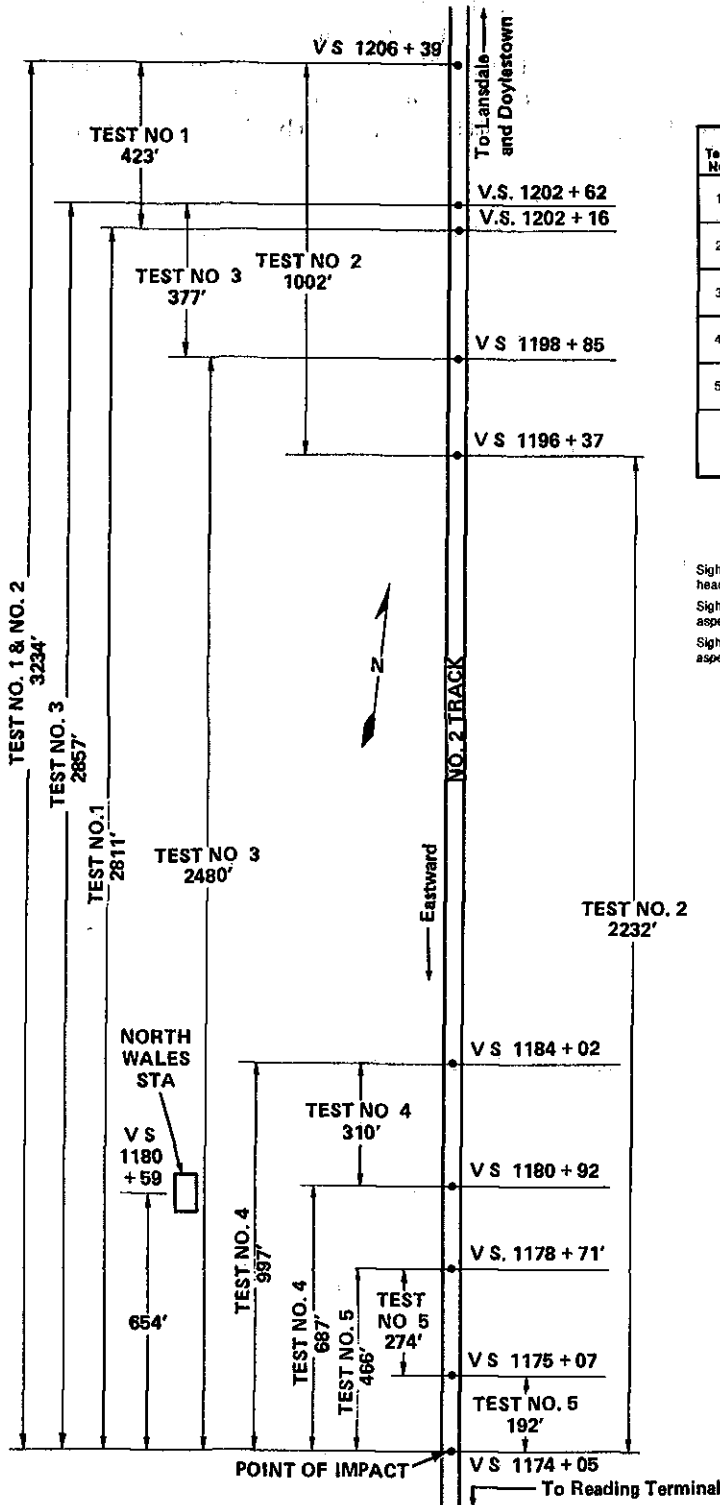
APPENDIX C STOPPING TESTS DATA

Test No.	Speed (MPH)	Stopping Distance (ft.)	Stopping Time (sec.)	Remarks
1	40	423	13 09	Emergency stop No wheel slide
2	55	1002	A) 20 50 B) 17 99	Emergency 2-car propulsion
3	30	377	A) 13 60 B) 11 15	Repeat of Test No. 2
4	38	310	A) 11 80 B) 11 70	Simulated run Emergency stop (Beaver St.)
5	35	274	A) 20 20 B) 10 57	Simulated emergency A) Single car complete stop B) Engineman's application
