RAILROAD ACCIDENT REPORT

HEAD-END COLLISION
OF CONSOLIDATED RAIL CORPORATION
FREIGHT TRAINS UBT-506 AND TV-61
NEAR THOMPSONTOWN, PENNSYLVANIA
JANUARY 14, 1988

NTSB/RAR-89/02

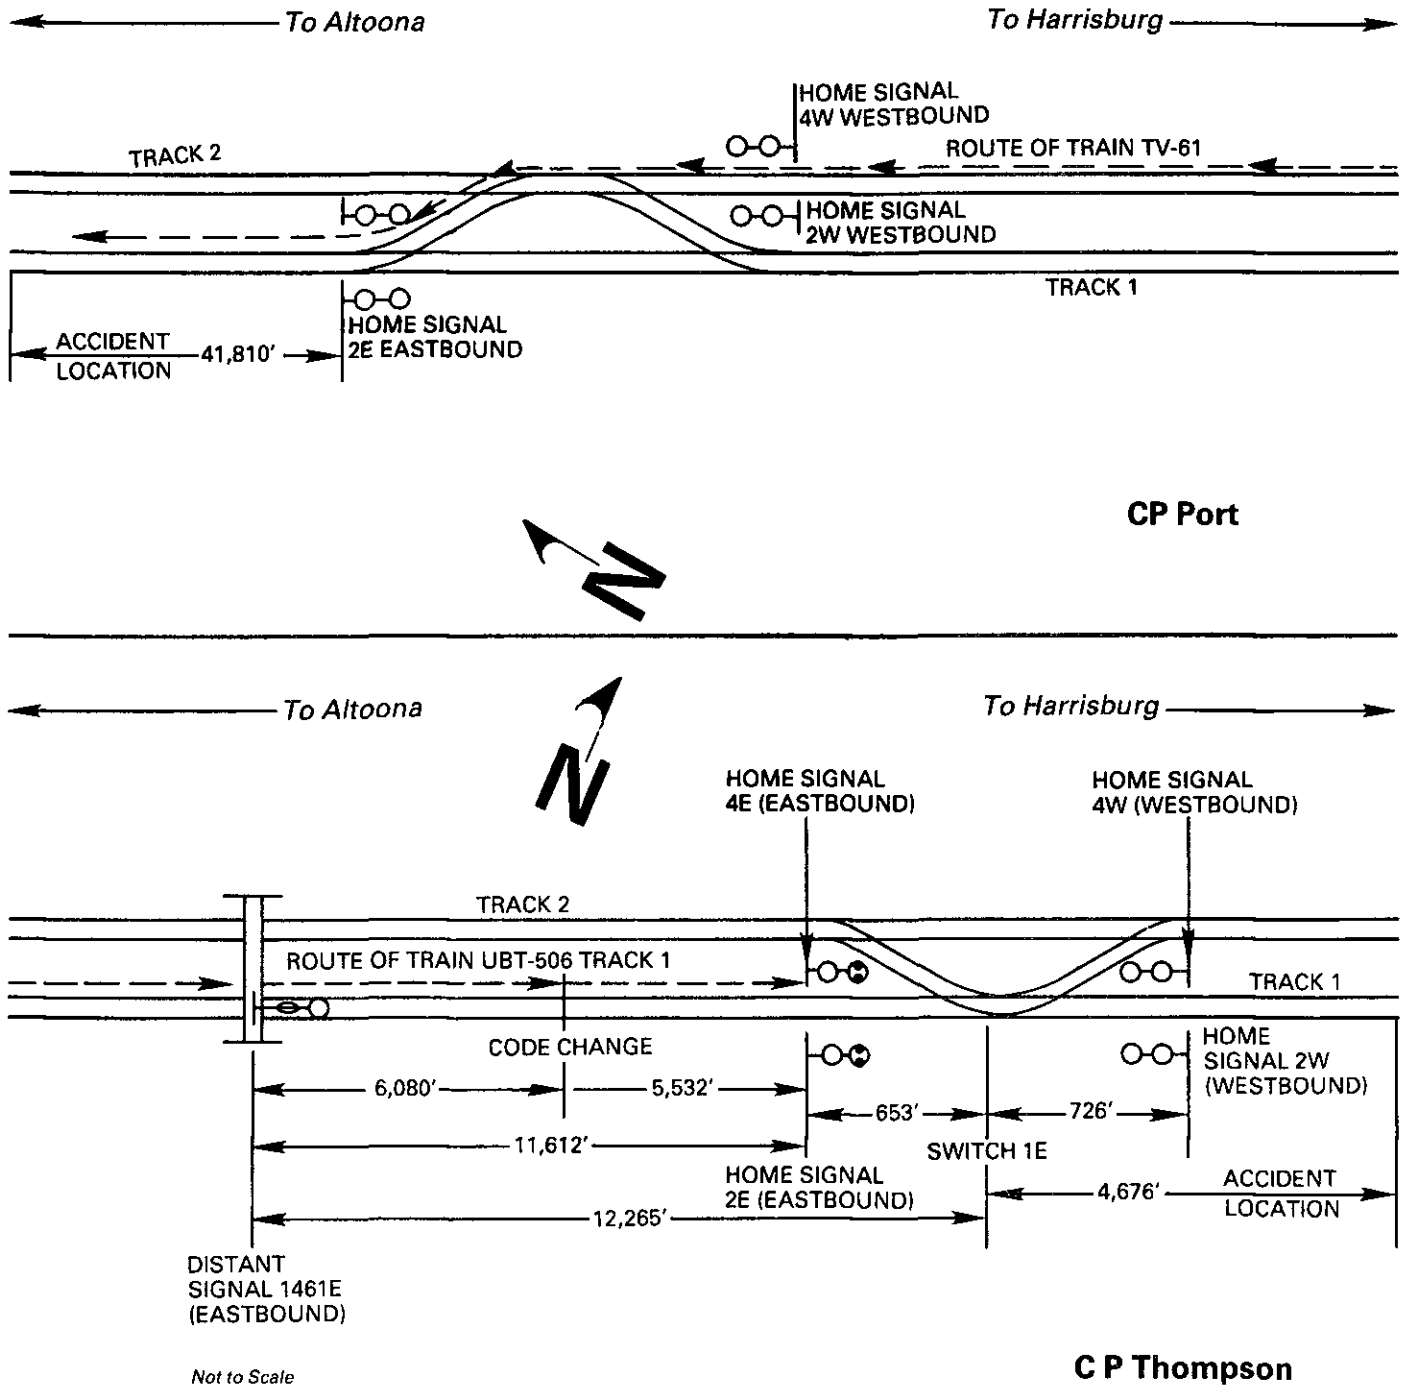
Figure 2 --Configuration of signals, switches, and tracks at CP Port and CP Thompson Interlockings

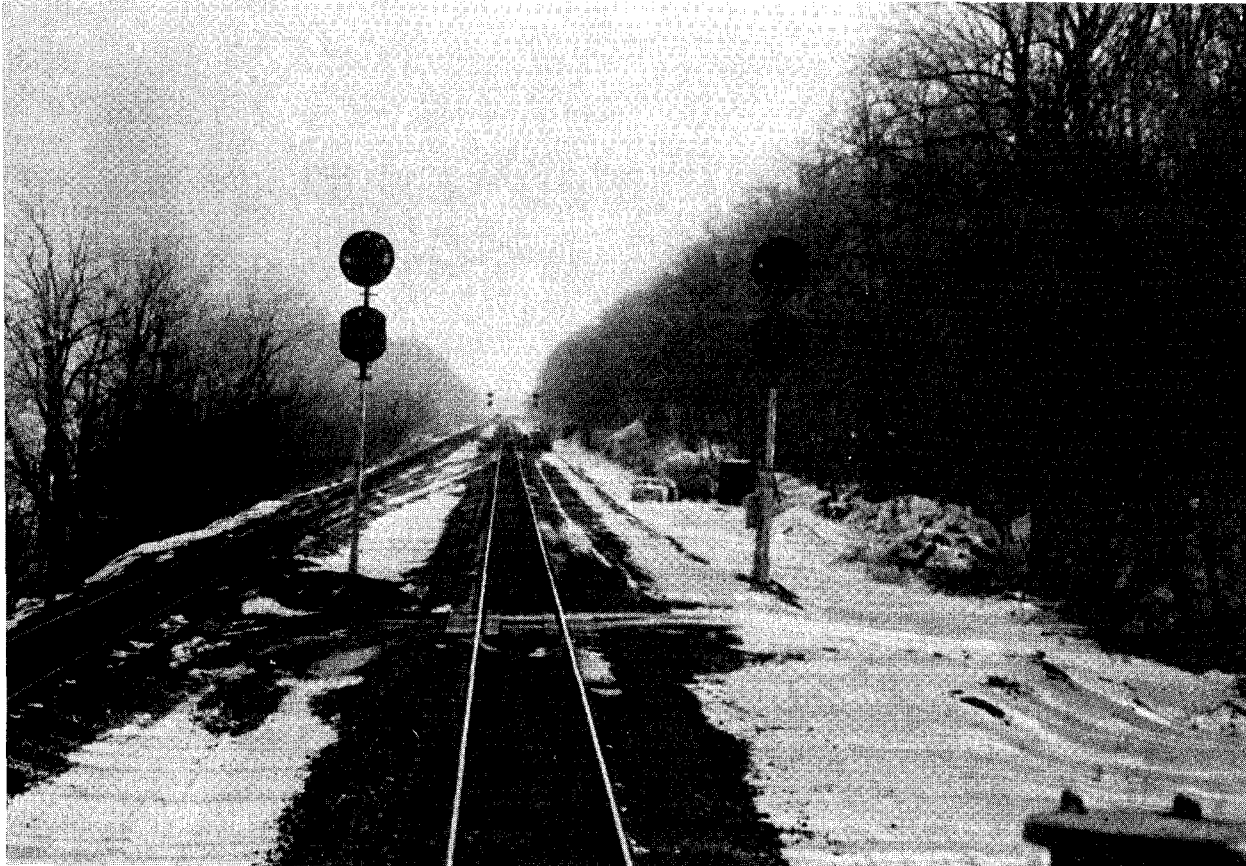
With the route for the westbound trains aligned for crossover movement from track 2 to track 1 at CP Port and from track 1 to track 2 at CP Thompson, eastbound home signal 2E for track 1 at CP Thompson should have displayed a "stop" aspect. Distant signal 1461E,⁵ located 11,612 feet west of signal 2E, should have displayed an "approach" aspect. These wayside signals governed the movement of train UBT-506 as it approached CP Thompson on track 1. The "approach" aspect of signal 1461E required a reduction to medium speed (not exceeding 30 mph), and the "stop" aspect of home signal 2E required the train to stop short of the signal which was located 653 feet west of west crossover switch 1E at CP Thompson. (See figure 3.)

Figure 3.--CP Thompson interlocking with signal 2E in foreground and switch 1E beyond, as viewed from an eastbound train on track 1

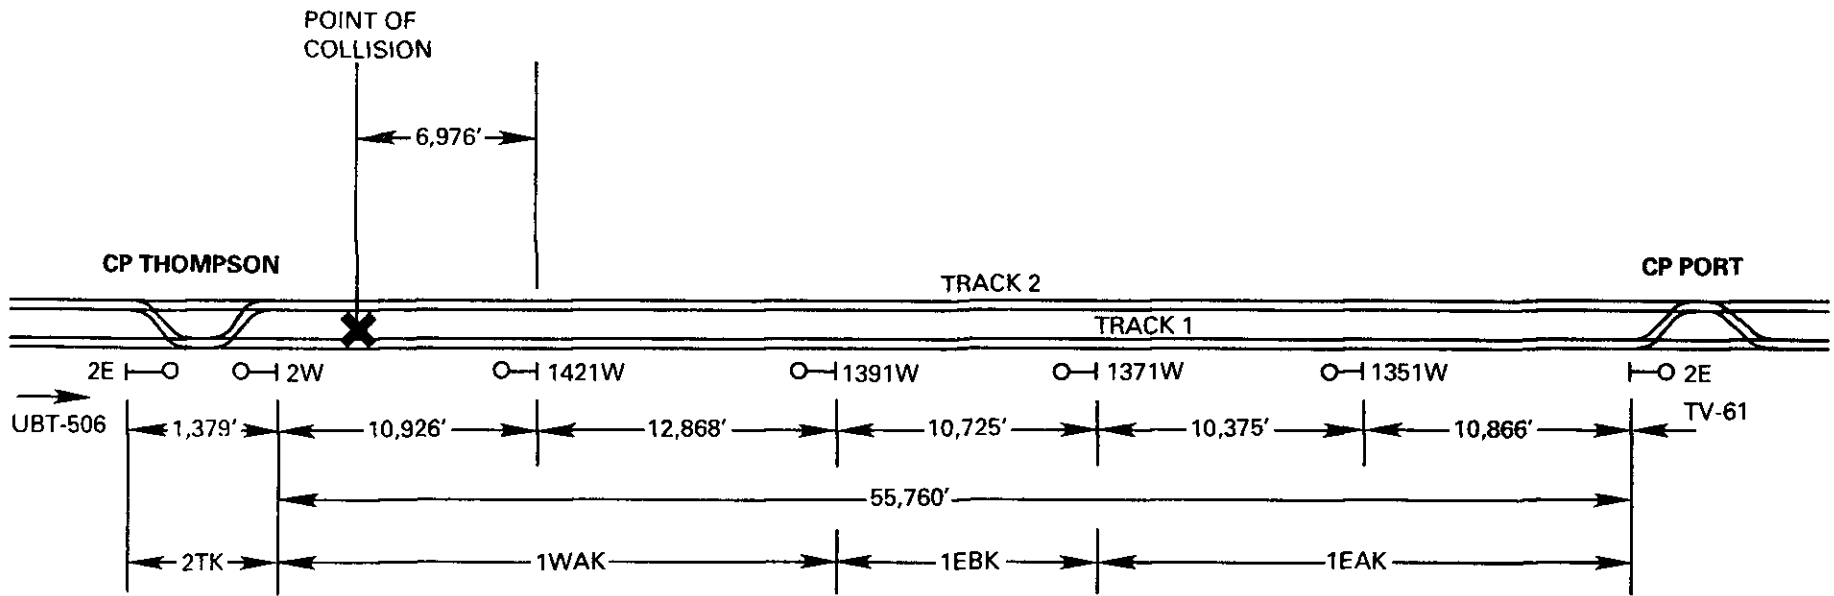
At the time of the accident, the CP Port and CP Thompson interlockings were displayed on adjacent CRT screens with CP Thompson on the left. The five signal blocks on each track between these interlockings are represented by three rectangles identified from west to east (left to right as displayed on the screens) as 1WAK, 1EBK, and 1EAK in the case of track 1. These display circuit indications represent track sections that are 23,794, 10,719, and 21,241 feet long, respectively. Only circuit 1EBK represents a single block. Circuit 1WAK represents the westbound approach block to CP Thompson and the adjacent block to the east. Circuit 1EAK represents the eastbound approach block to CP Port and the block adjoining it on the west.⁹ The track 1 side of the interlocking at CP Thompson is represented by display circuit 2TK. (See figure 6.)

Figure 6.--Diagram of tracks between CP Thompson and CP Port interlockings showing locations of wayside signals and the distances between them

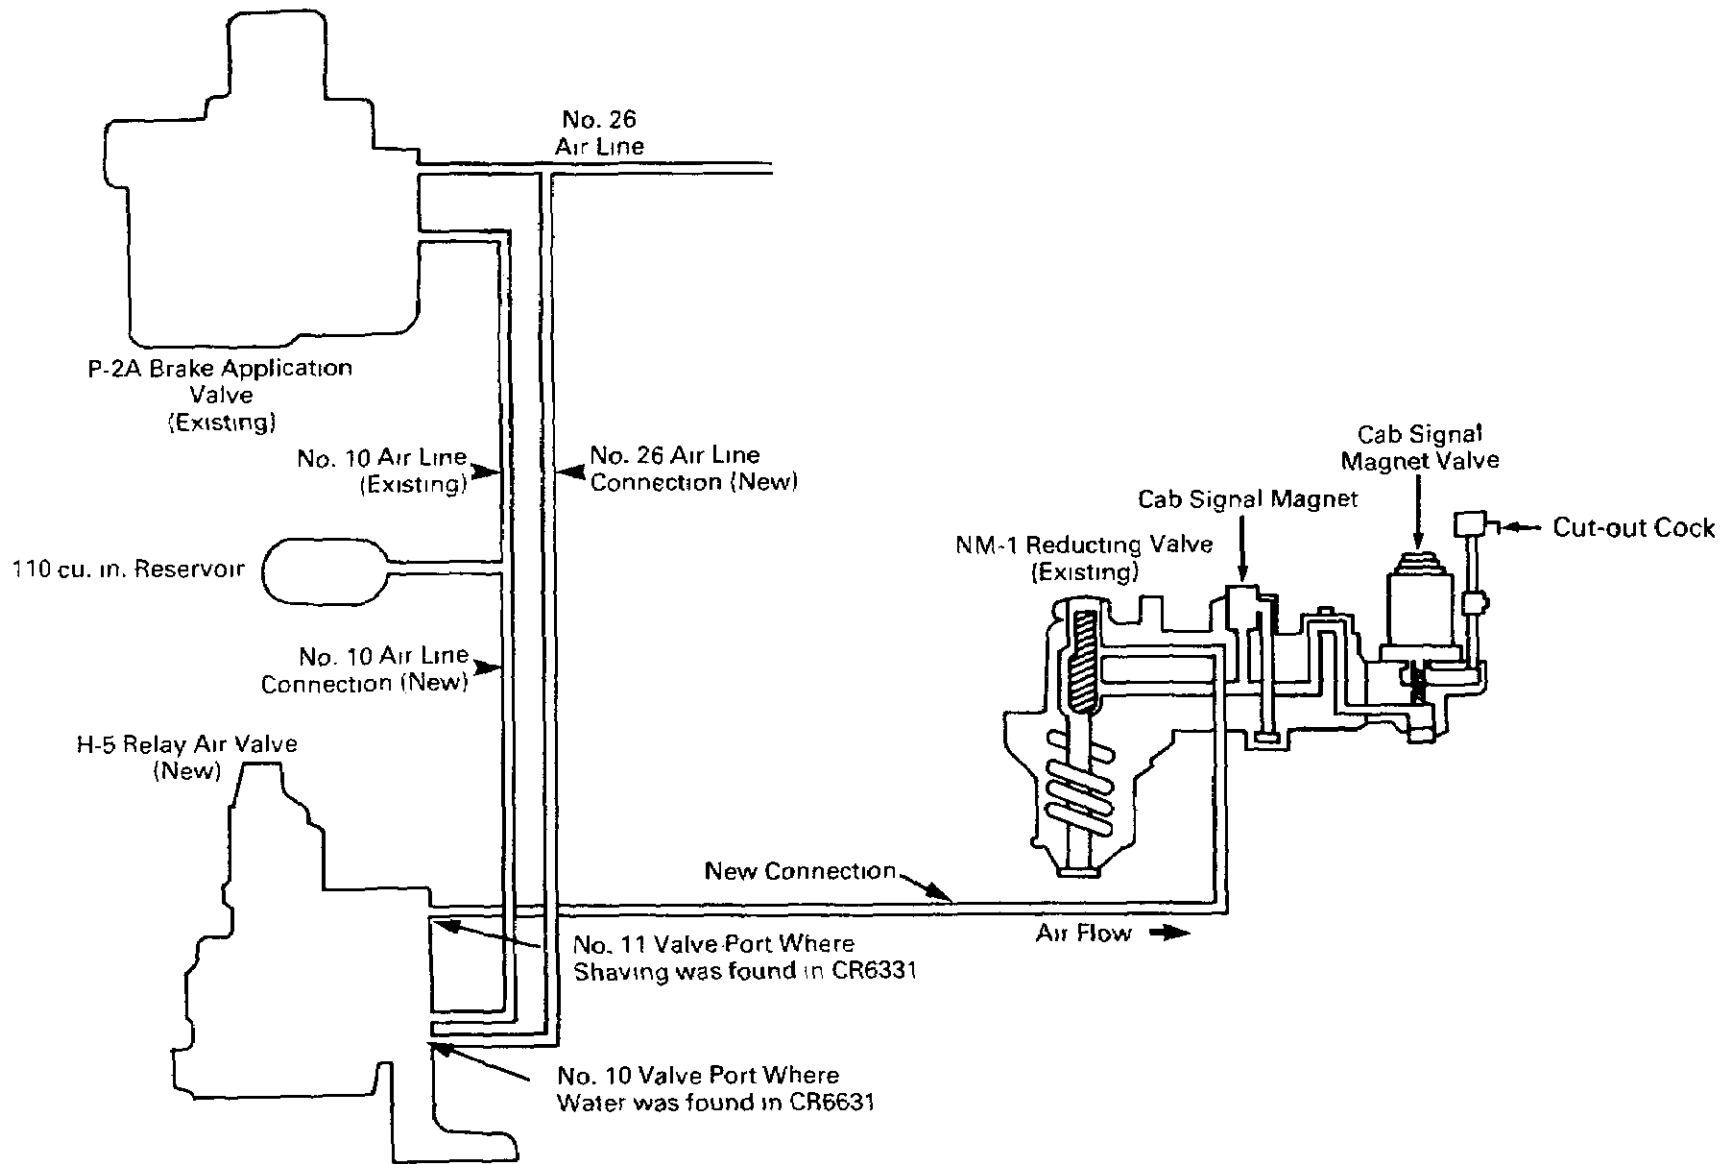
The modification adding the ATS backup feature to the ACS system of Conrail locomotive units involved the installation of a H-5 relay air valve and 3/8-inch outside diameter (o d) copper tube air lines connecting the H-5 valve to the existing NM-1 reducing valve of the ACS system, as well as to the existing No. 10 air line (connecting the 110-cubic inch reservoir to the P-2-A brake application valve of the automatic air brake system) and the No. 26 air line (connecting the automatic brake valve with the P-2-A valve). (See figure 10.) The newly installed H-5 valve and the copper tubing connections were located in a noninsulated compartment under the floor of the operating compartment.

Figure 10.--Schematic diagram showing additions and modifications to the ACS system of Conrail locomotives in adding the ATS feature
