PB93-916303
NTSB/RAR-93/02

RAILROAD ACCIDENT REPORT

DERAILMENT AND SUBSEQUENT COLLISION
OF AMTRAK TRAIN 82 WITH RAIL CARS
ON DUPONT SIDING OF CSX TRANSPORTATION INC.
AT LUGOFF, SOUTH CAROLINA, ON JULY 31, 1991

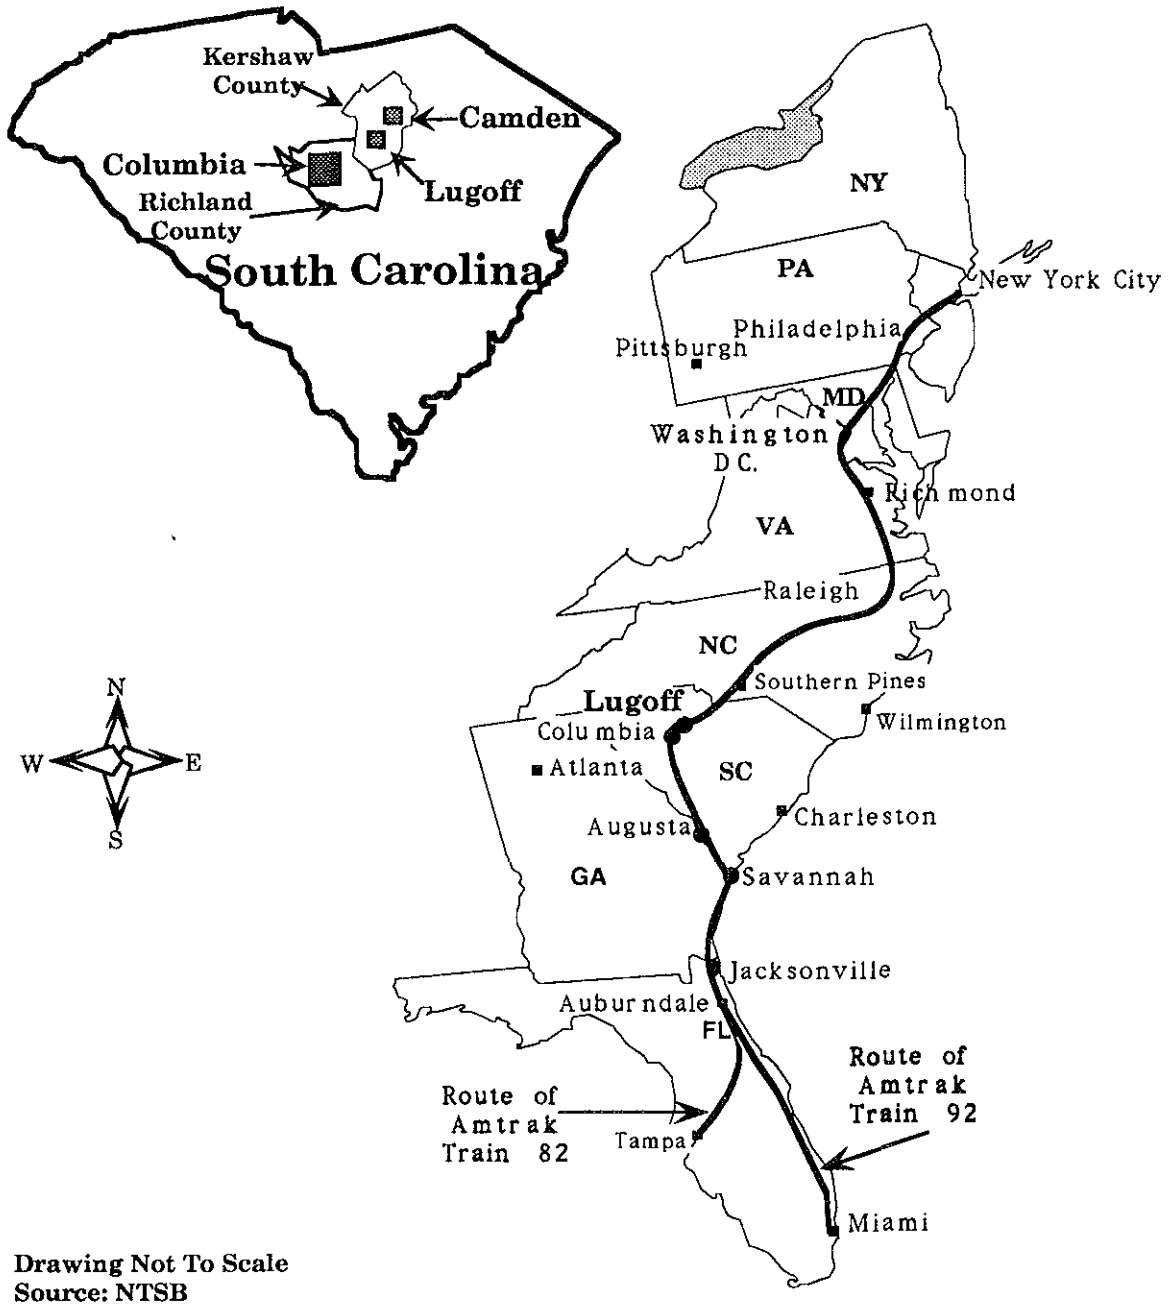
Figure 3 --Maps of South Carolina and of train route

The dispatcher and the assistant chief dispatcher monitored the conversation between the locomotive crew and Cayce Yard and heard the engineer give his location as "the Lugoff crossover." At 5:12 a.m., the assistant chief dispatcher called the Kershaw County emergency medical services (KCEMS), advised them of the accident, and stated that the train was between Lugoff and Camden, South Carolina. (Both Lugoff and Camden are in Kershaw County.) (See figure 3)
