NATIONAL TRANSPORTATION SAFETY BOARD

RAILROAD ACCIDENT REPORT

DERAILMENT OF AMTRAK PASSENGER TRAIN 8
OPERATING ON THE SOO LINE RAILROAD,
FALL RIVER, WISCONSIN
OCTOBER 9, 1986

NTSB/RAR-87/06

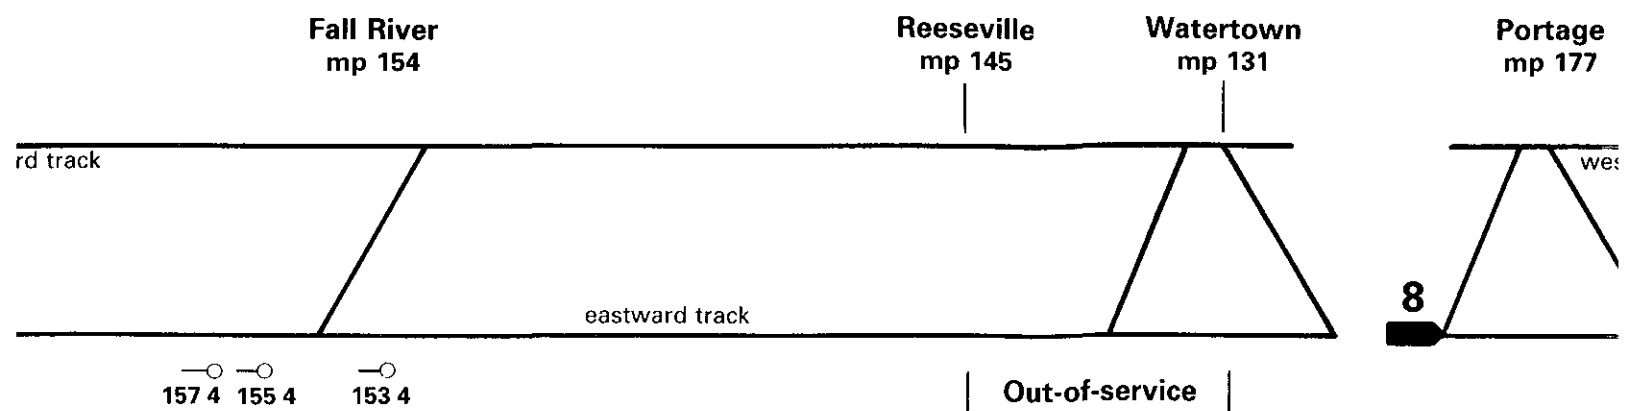
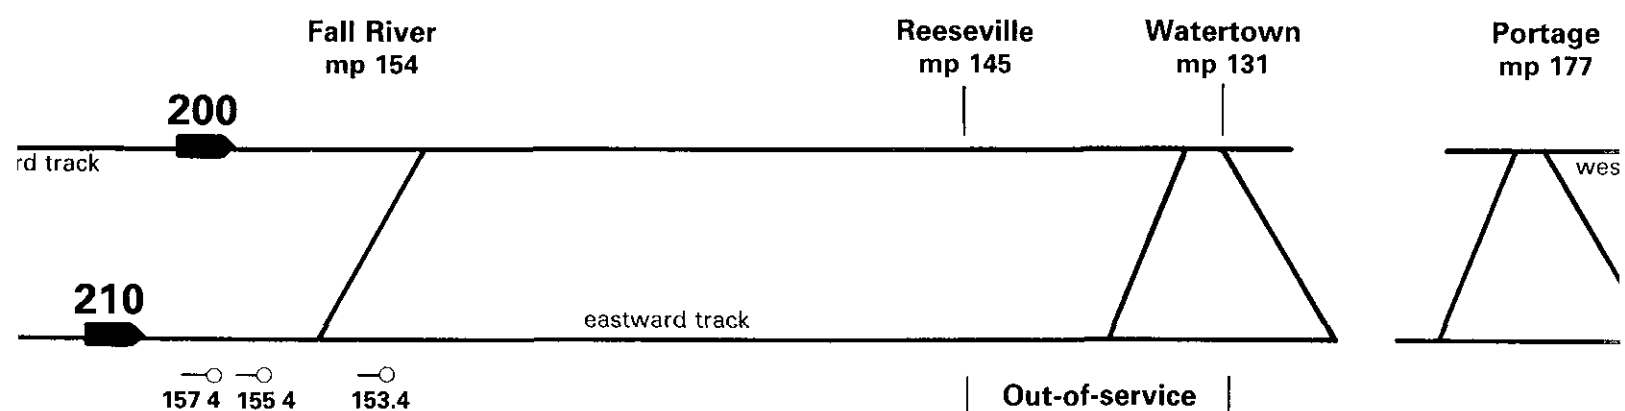
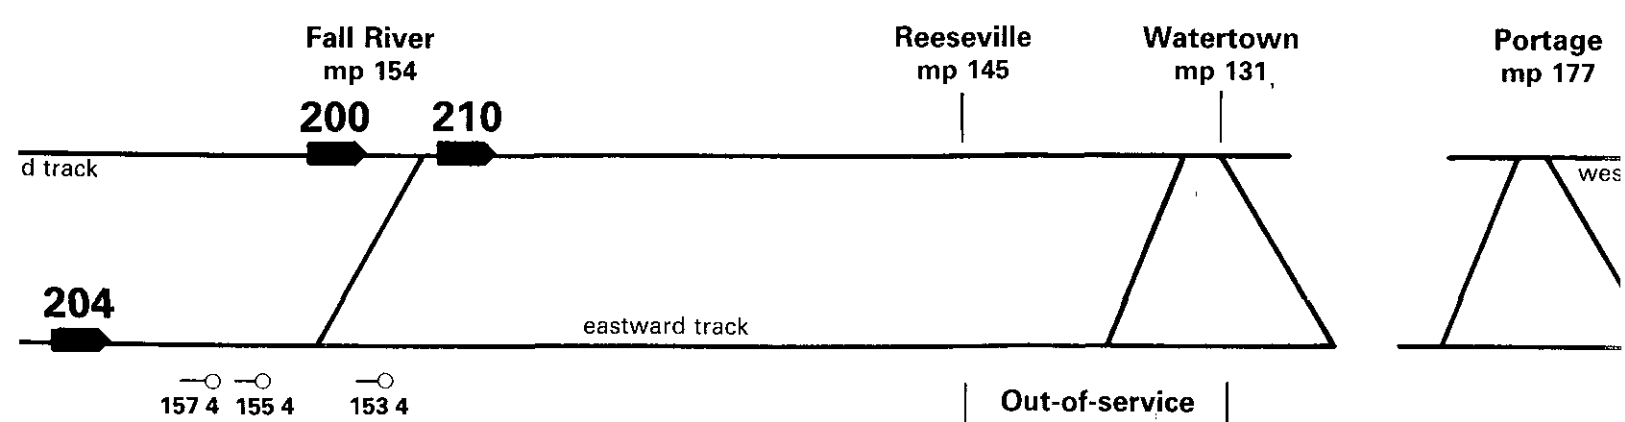
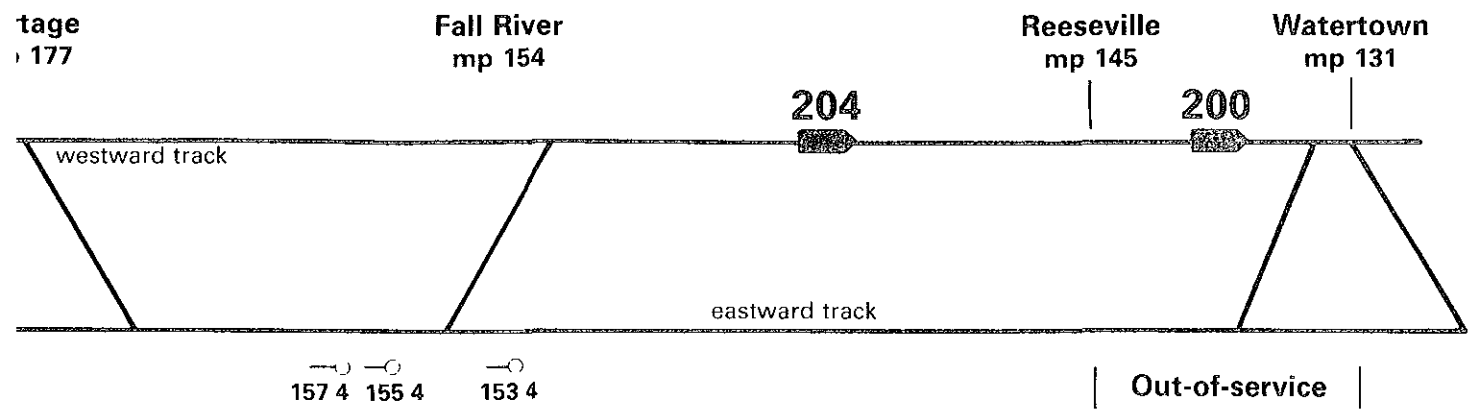
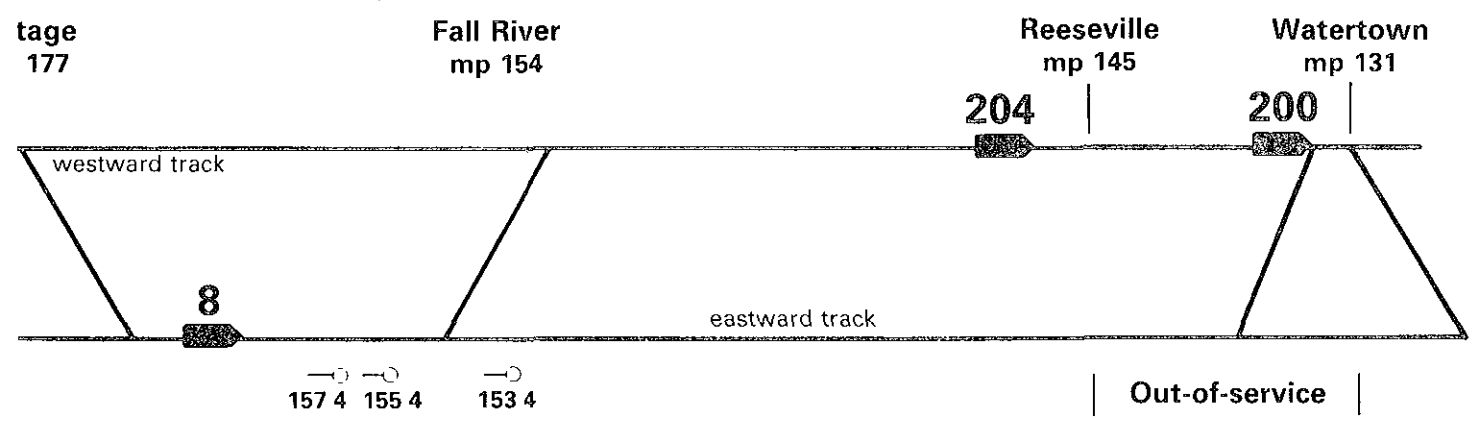
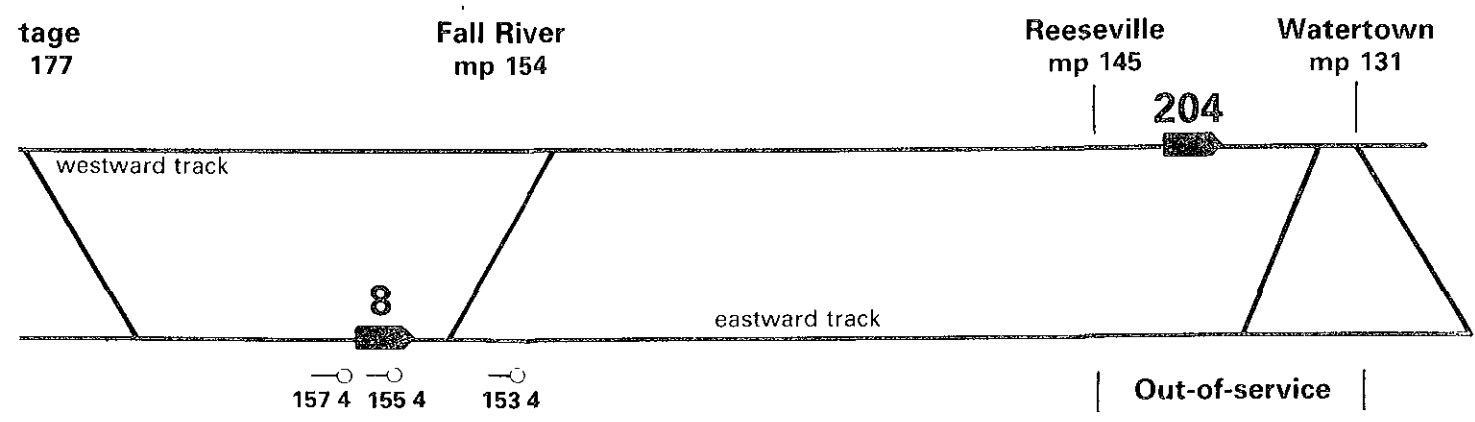
Figure 1. - - Track conditions for train movement o

A copy of train order number 11, an order to take the track out-of-service, was to be issued by the operator at Portage, Wisconsin, to the conductor and engineer of each eastbound train arriving at Portage (appendix C). The order established the limit for eastbound trains operating on the eastward track to milepost 145.0 (figure 1); any eastbound train arriving at this point could not proceed further eastward.

At 9 a.m., eastbound freight train 200 arrived at Portage. (See figure 1a.) The engineer and conductor received train order no. 11 and another order that allowed them to operate on the westward track. Eastbound freight train 204 arrived at Portage at 9:10 a.m., and the engineer and conductor of that train also received a copy of train order no. 11. However, train 204 was held at Portage by the dispatcher to await the arrival of eastbound train 210. The train dispatcher stated that he wanted train 200 to depart Portage on the westward track and train 210 to depart Portage before train 204 on the eastward track. He further explained that train 210 would pass train 200 en route to Fall River, 24 miles east of Portage, and would cross over to the westward track before train 200 was allowed to proceed east of Fall River. Train 200 was a caboosless train.

Train 204 departed Portage at 10:40 a.m. on the eastward track and its engineer and conductor were instructed to stop at Fall River to receive a train order. Train 204 arrived at Fall River about 11:30 a.m. and stopped; the switchtender overheard on his portable radio that the engineer and conductor of train 204 had received an order that would allow the train to cross over to the westward track at Fall River. The switchtender then reversed the switches to allow train 204 to proceed. Train 204 completed the crossover to the westward track at 11:34 a.m. (figure 1d), and the switchtender then lined the switches to the normal position.

At 12:19 p.m. (figure 1f) the dispatcher completed train order no. 52 to the operator at Portage that would give train 8 permission to cross over at Fall River (appendix D). The operator stated that he immediately began trying to contact the engineer of train 8 by radio, but that he received no response. However, the engineer on train 8 stated that he and the fireman received the radio transmission from the operator and acknowledged it. The fireman continued to acknowledge the radio transmissions from the operator but received no indication that the operator was receiving his calls. The fireman also called to a crewmember on the train and requested a radio check to determine if the crewmember could receive his transmission. Using a portable radio, the crewmember said, "Yes, but you are scratchy." The operator stated that he did not hear any response from train 8 and so notified the dispatcher. The operator was also switching from the Portage radio base station to the Watertown base station in an attempt to communicate with train 8. The dispatcher instructed the operator to stop train 8 at Fall River and to come to the wayside phone to receive the order. The dispatcher also attempted to communicate with train 8 using the radio at the Watertown base station. A track foreman in a Soo truck at the work site near milepost 145 overheard the operator on the radio in the truck attempting to contact train 8 and heard what he believed was a faint response. The track foreman radioed the operator and informed him that train 8 was responding. As train 8 continued east, the two signals approaching Fall River were green, indicating to the engineer that the signal blocks ahead were clear and that he could continue to operate the train at the authorized speed. The engineer reduced the speed of the train to 65 mph

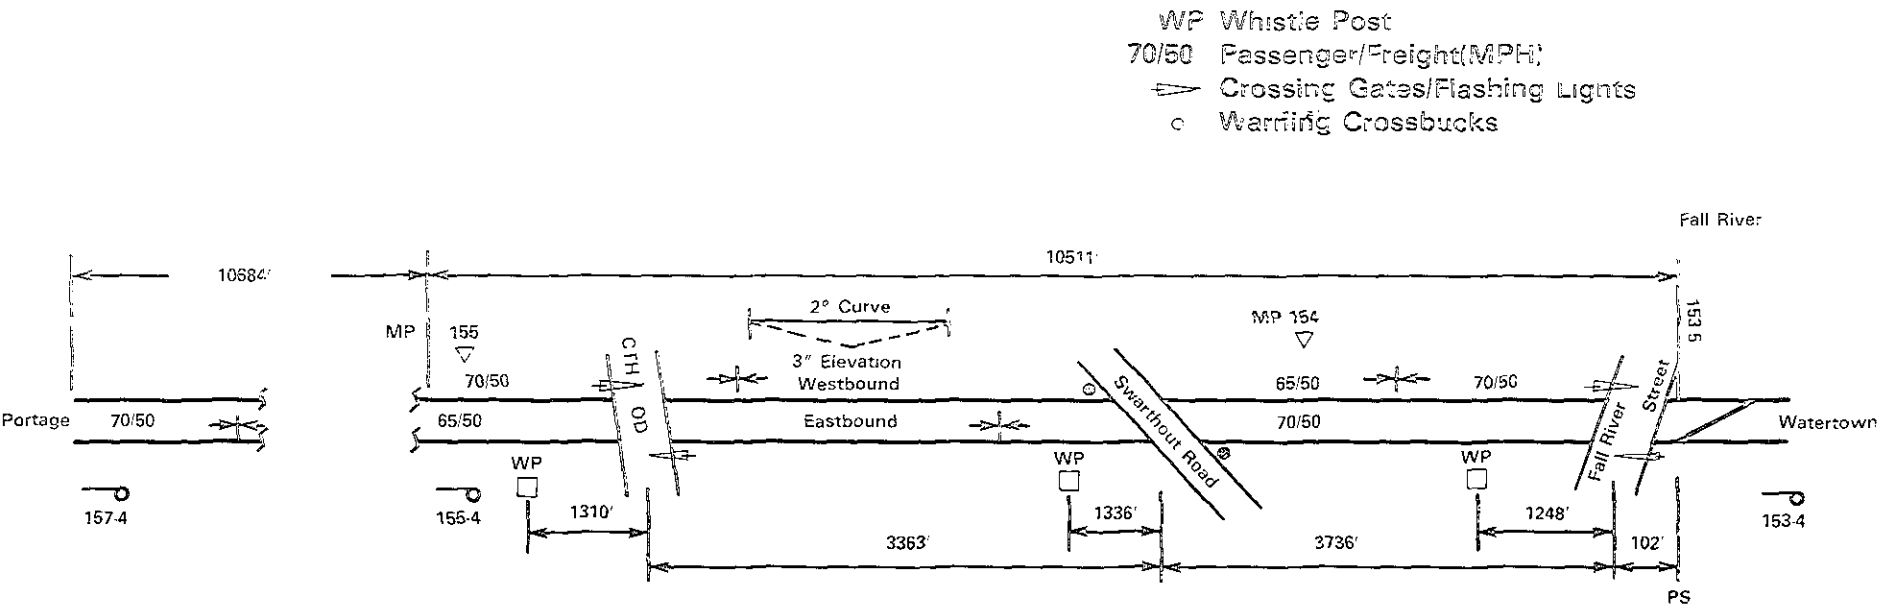
Figure 2. --Grade crossing/signals west of Fall River.

The switchtender stated that he heard the train whistle sound a warning at the road crossing east of the last signal before Fall River and knew by the location of the whistle that train 8 had passed the signal. The operator at Portage had not told the switchtender that he was unable to contact train 8 by radio. The switchtender then called on his portable radio saying, "Number 8, have you got your orders?" He stated that he heard someone respond, "Number 8 . . .," followed by a message lost in static. The switchtender also stated that he believed he had received an affirmative answer and that he had been told by the dispatcher that train 8 would be advised about the crossover move. He then lined and locked the crossover switch of the eastward track. While he was walking to the other switch to line it, train 8 began sounding the whistle for the grade crossing at Main street (figure 2).

The Soo tracks pass through Fall River from northwest to southeast. Fall River Street crosses the tracks at grade approximately 50 feet west of the crossover. Fall River Street is a protected grade crossing with automatic crossing gates combined with flashing light signals. A passive protected grade crossing (railroad warning crossbucks) at Swarthout Road is approximately 3,736 feet west of Fall River Street and a protected grade crossing (automatic gates combined with flashing light signals), CTH "CD" (figure 2), is approximately 7,099 feet west of Fall River Street.
