RAILROAD ACCIDENT INVESTIGATION

REPORT NO 4177

DULUTH, MISSABE AND IRON RANGE RAILWAY COMPANY

JANUARY 30, 1971

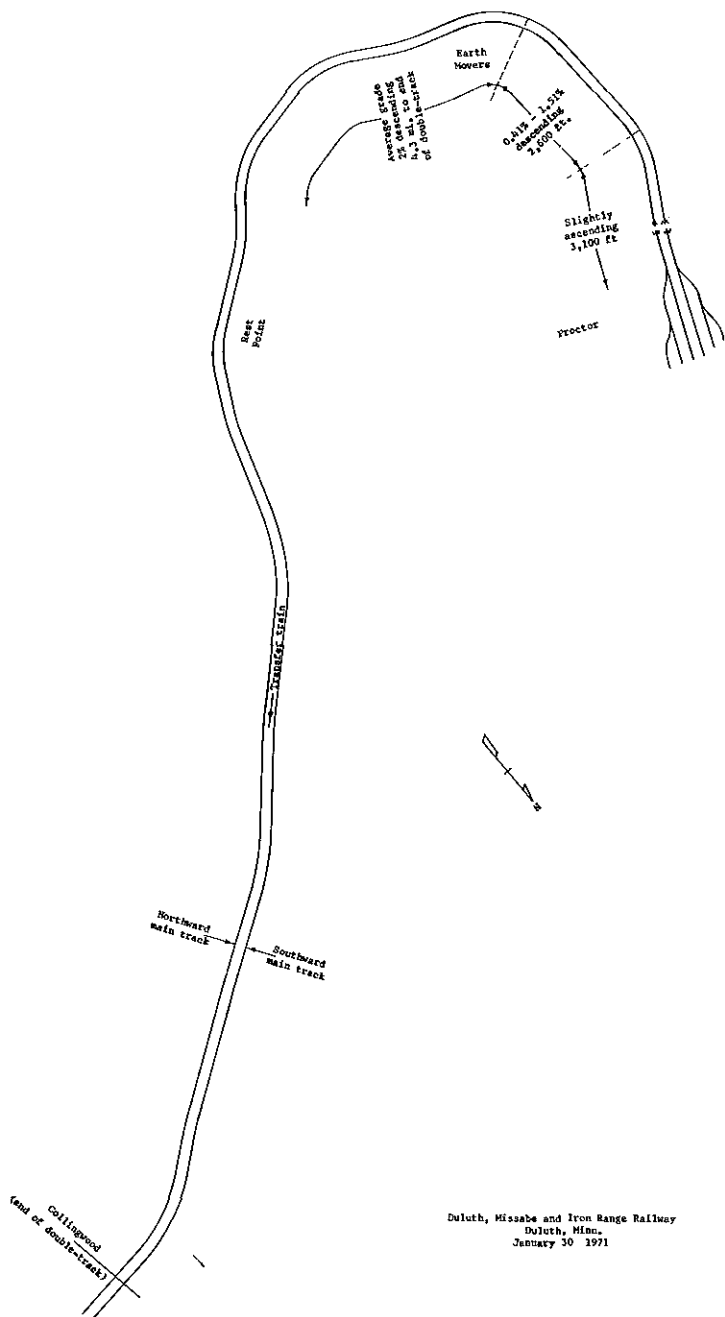
PLATE NO 2

The accident occurred on that part of the railroad extending southward from Minntac to Ore Dock No 5 on the shore of Lake Superior at Duluth, Minn., a distance of 75.1 miles. Ore Dock No 6 (see Plate No 2) is used to transfer rail shipments of iron ore and taconite pellets to lake vessels or winter storage areas. It is 2438 feet long, extending over the shoreline of Lake Superior at a height of approximately 80 feet. Four tracks, each 2419 feet long, are on the dock. From the east, these tracks are identified as Nos 1, 3, 4 and 6.

Two auxiliary tracks, known as the east and west lead tracks, connect the tracks of Ore Dock No. 6 to the south end of the double-track line at Collingwood. The east lead track constitutes a continuation of the southward main track. It leads to tracks No. 1 and 3 of Ore Dock No. 6, as shown in Plate No. 2.
