# NATIONAL TRANSPORTATION SAFETY BOARD

## RAILROAD/HIGHWAY ACCIDENT REPORT,

GRADE CROSSING COLLISION OF A  
FLORIDA EAST COAST RAILWAY COMPANY  
FREIGHT TRAIN AND AN  
INDIAN RIVER ACADEMY SCHOOLBUS  
PORT ST. LUCIE, FLORIDA  
SEPTEMBER 27, 1984

NTSB/RHR-85/01,

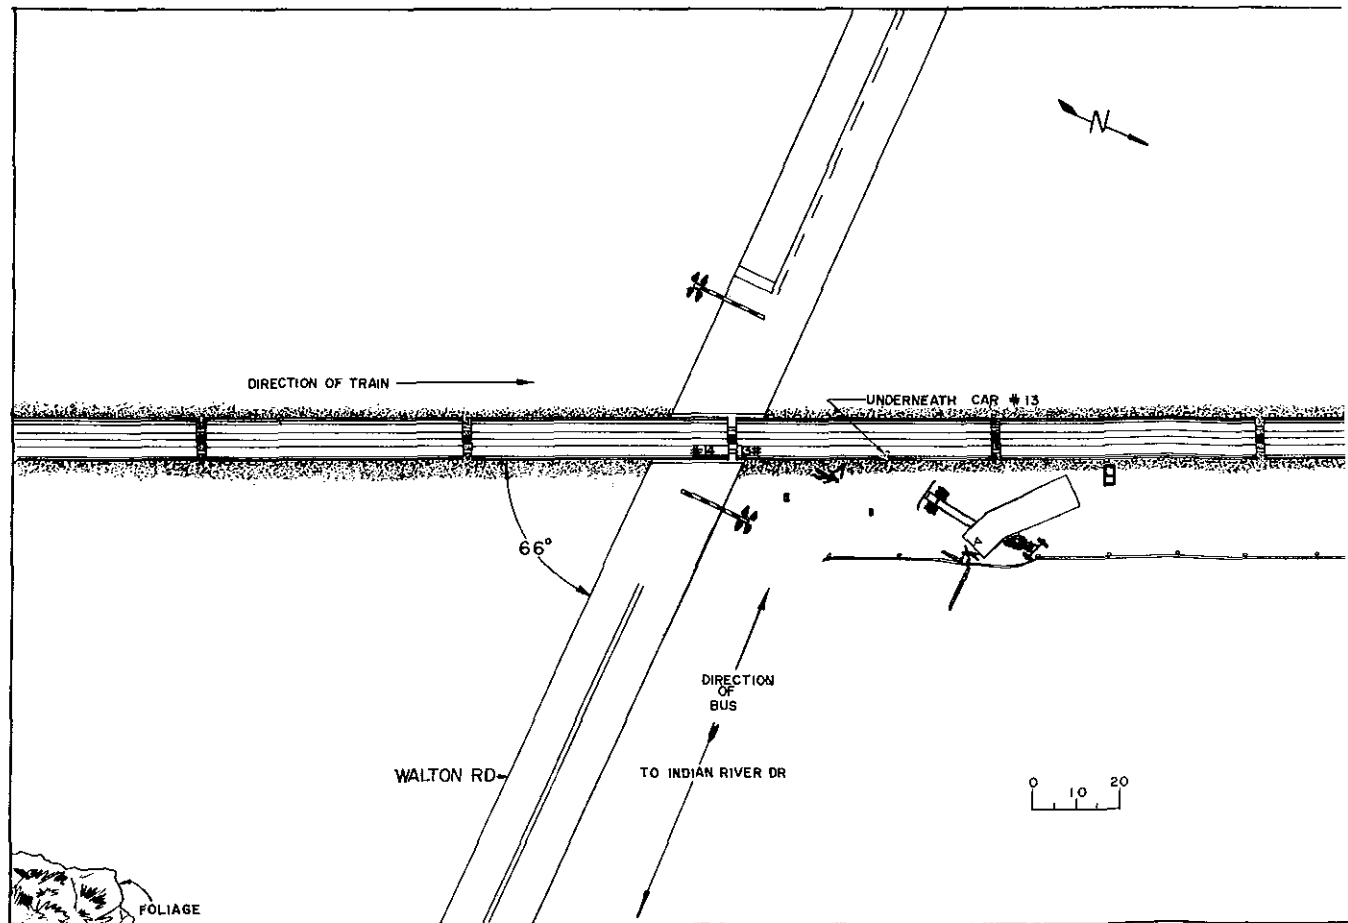
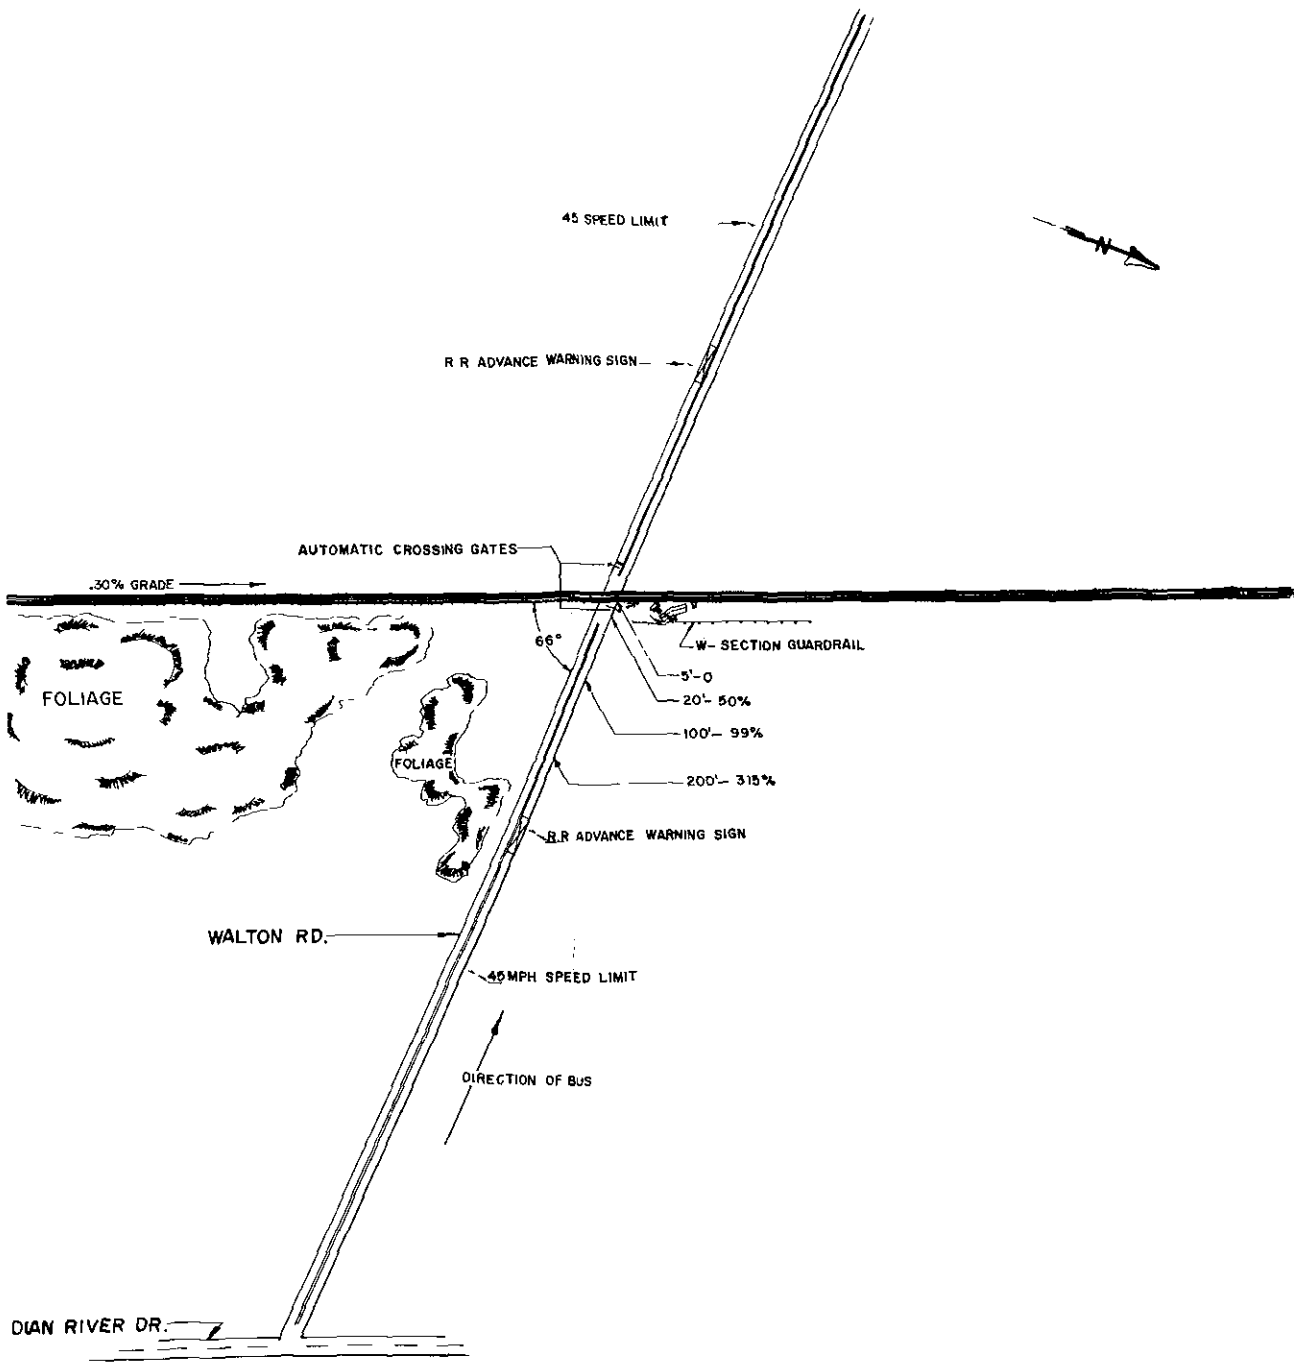
FIGURE 1. -- PLAN VIEW OF ACCIDENT SITE.

The front of the train came to rest 798 feet north of the center of the crossing. The cars of the train remained coupled and in line on the track. The traincrew was not injured. (See figures 1 and 2.)
