REPORT NO. 3506
FLORIDA EAST COAST RAILWAY COMPANY
IN RE ACCIDENT
NEAR OAK HILL, FLA., ON
FEBRUARY 11, 1953

Accident near Oak Hill, Fla., on February 11, 1953, caused
by a broken rail.

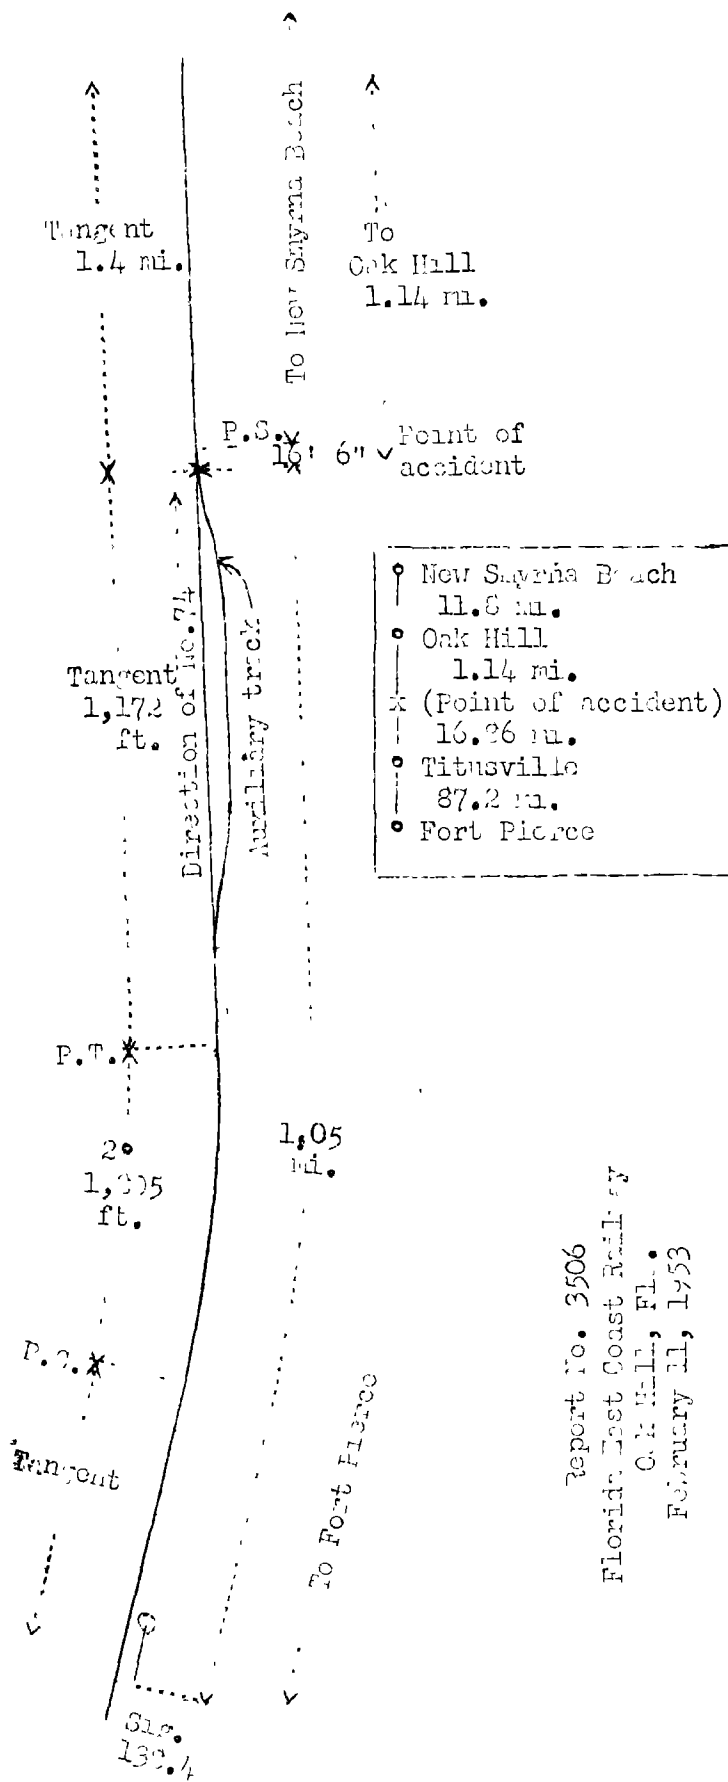
Sketch showing broken rail- east side of track

Examination of the turnout disclosed that the closure rail connected to the east switch rail was broken. This rail was manufactured by the Tennessee Coal, Iron & Railroad Company in June, 1942. It bore heat No. 856540B. The leaving end of this rail between the second bolt hole and the end of the rail was broken into a number of pieces, four of which were recovered. Fractures extended from the second bolt hole downward through the base at points 6-1/2 inches and 12 inches south of the end of the rail and upward through the head at points 6 inches, 7-1/2 inches, and 12 inches south of the end of the rail. The head of the rail south of two of the breaks was battered. This indicated that several wheels of a south-bound train had passed over the rail after a portion of the head became dislodged. A portion of the head of the switch rail 1 inch in length was broken out of the heel. This piece was not recovered. A fracture in the switch rail extended downward from the point where the portion of the head was broken out, through the second bolt hole, and through the base at a point 15 inches north of the end of the rail. All of the breaks in both rails appeared to be new. Both bolts at the leaving end of the closure rail and the bolt through the first bolt hole of the switch rail were broken.
