# RAILROAD ACCIDENT REPORT

Collision of the State-of-the-Art  
Transit Cars with a Standing Car,  
High Speed Ground Test Center  
Pueblo, Colorado  
August 11, 1973

NATIONAL TRANSPORTATION SAFETY BOARD  
Washington, D.C. 20591  
REPORT NUMBER: NTSB-RAR-74-2

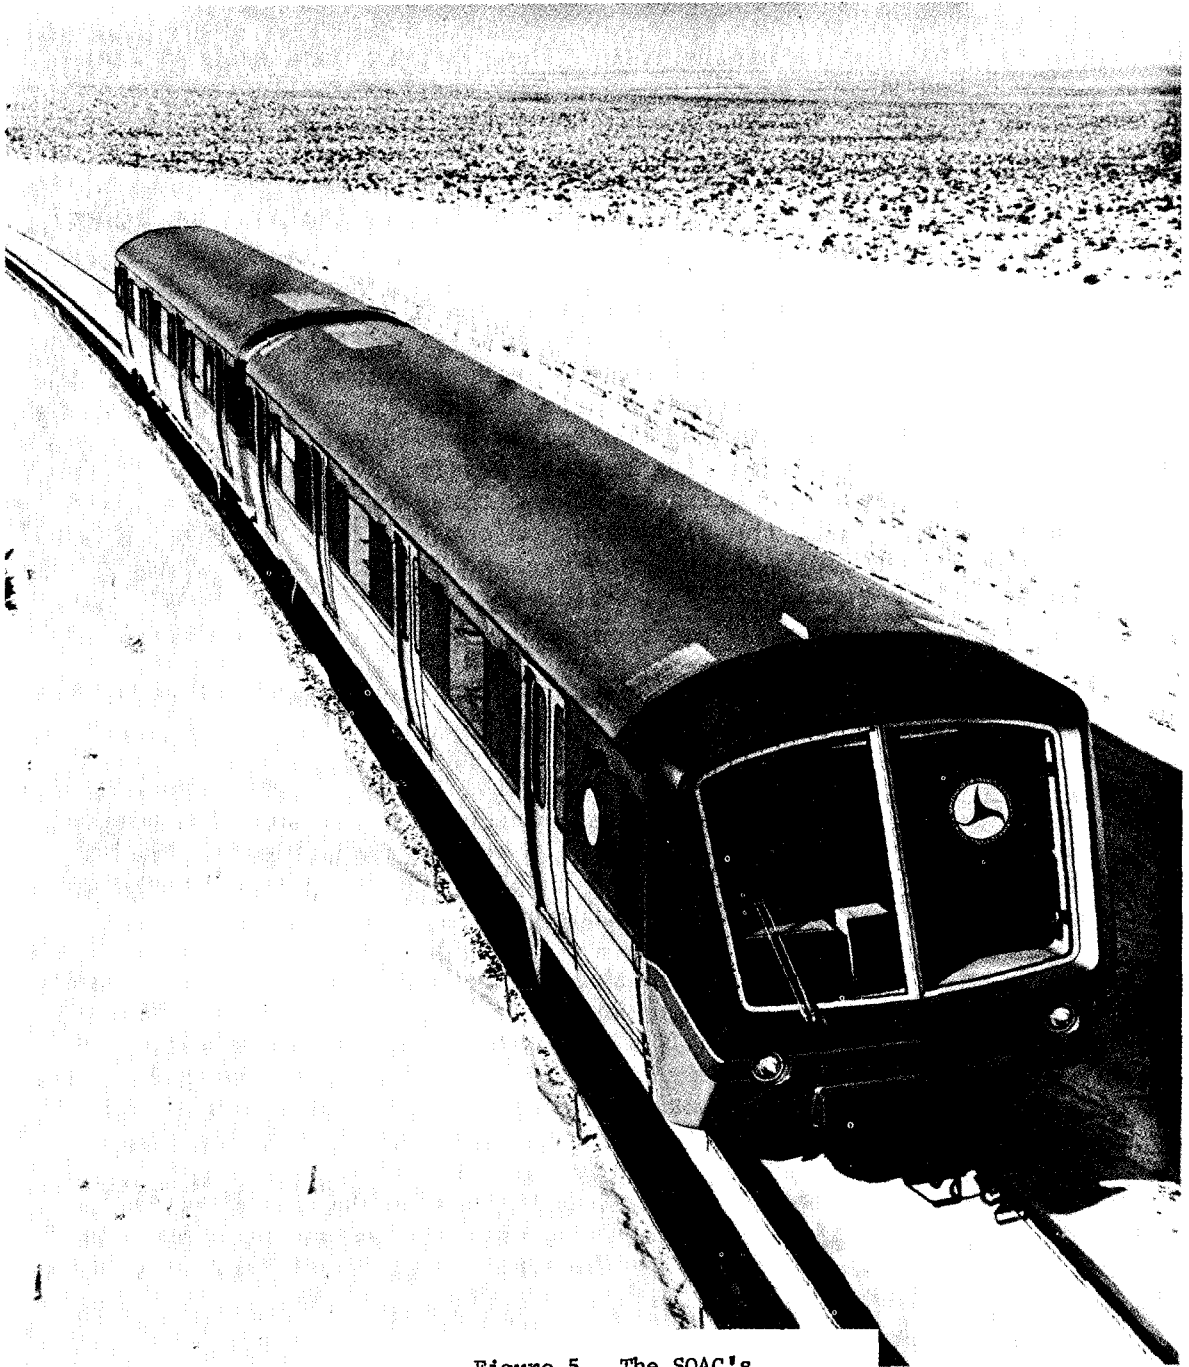
Figure 5. The SOAC's.

General description of the SOAC. The two cars were each 75 feet long and weighed 90,000 pounds empty. They had been ballasted for a normal load weight of 105,000 pounds during testing. The basic car structure was of welded steel with stainless steel exteriors, except for car ends of molded fiberglass. The underframe was made of high-strength, low-alloy steel. A detailed description of the SOAC is included as Appendix E. The cars are shown in Figure 5.
