RAILROAD ACCIDENT REPORT

COLLISION OF
ILLINOIS CENTRAL GULF RAILROAD
COMMUTER TRAINS,
CHICAGO, ILLINOIS
OCTOBER 30, 1972

NATIONAL TRANSPORTATION SAFETY BOARD
Washington, D.C. 20591
REPORT NUMBER: NTSB-RAR-73-5

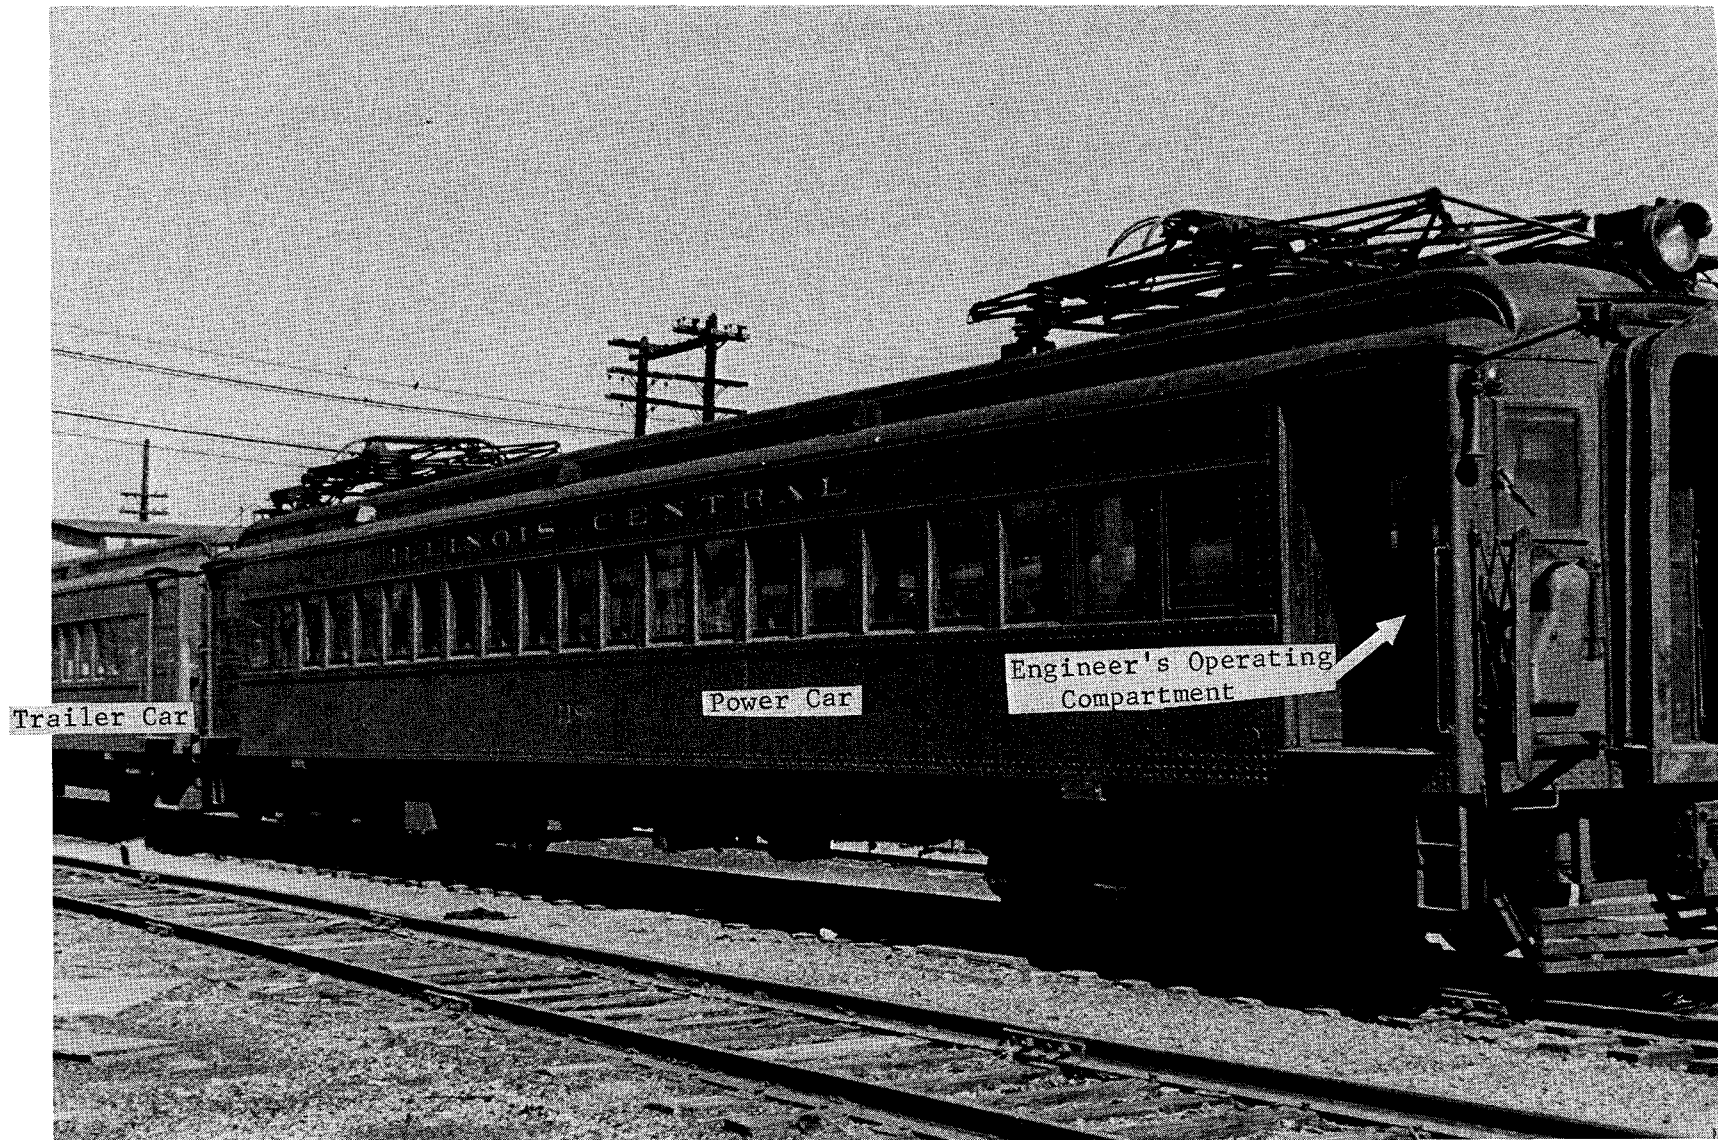
Figure 3. "Old" car, similar to those of train 720.

Train 720. The six multiple-unit (MU) cars of train 720 were of steel construction and had been built between 1924 and 1926. The cars operated in pairs, with a motor car and a trailer car forming a semipermanent unit. The first car of 720 was a trailer car. A vestibule with side doors was located at each end of each car. The operating controls, which did not include a speedometer, were in the end vestibules of each pair of cars. (See Figure 3.)

The cars of train 720 were constructed prior to the establishment of Federal regulations for MU equipment and the couplers, the anti-climbing arrangement, and the collision posts did not comply with the requirements in 49 CFR 230.457.

The first 10 feet of the lead car of train 720 was demolished. The center sills and couplers on several of the other cars of the train were broken, and these cars sustained sufficient damage to prevent prompt return to service.

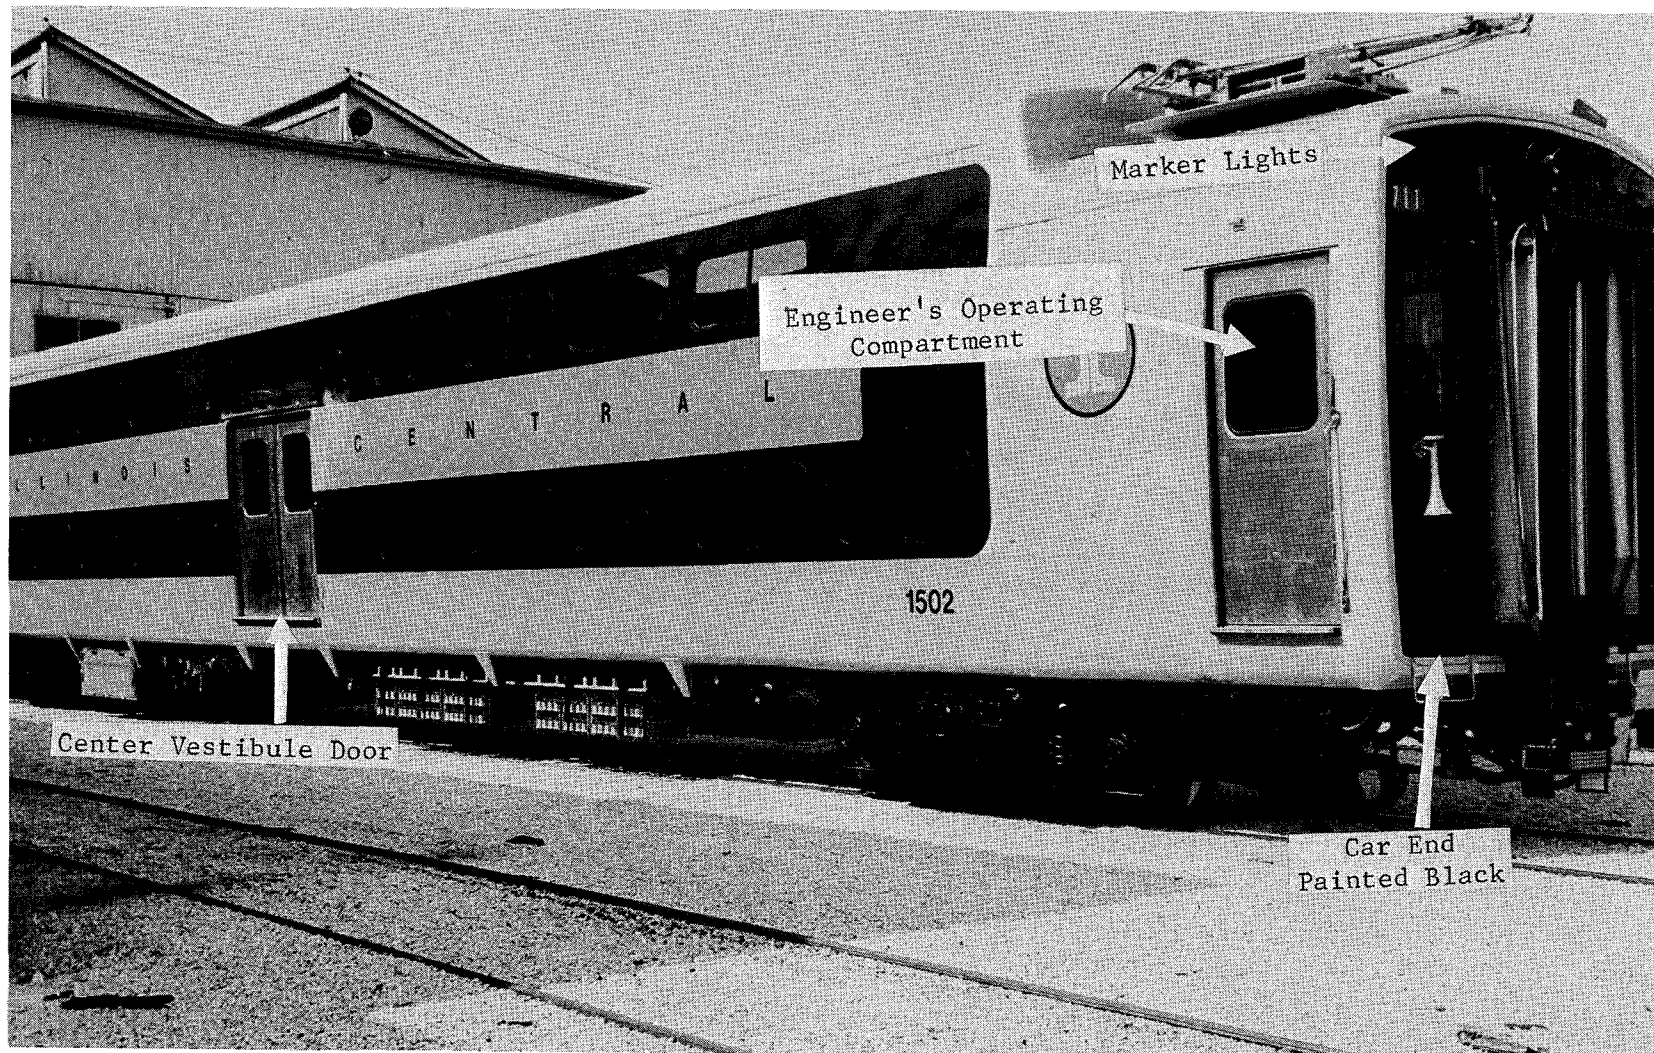
Figure 4. Highliner car, similar to those of train 416.

Train 416. The Highliner cars were self-propelled, electric MU cars in which passengers were seated on two levels. Each car was 85 feet long, 15 feet 10 inches high, and 10 feet 6 inches wide, and weighed about 134,000 pounds. (See Figure 4.)

Train damage. The rear half of the last car of train 416 was demolished. The end of the car and most of the right side were sheared off at floor level. A portion of the left side and several seats on the upper level remained intact. All lower-level seats were destroyed. The underframe of the car was not buckled, and the three other cars of 416 received only minor damage and were returned to service.

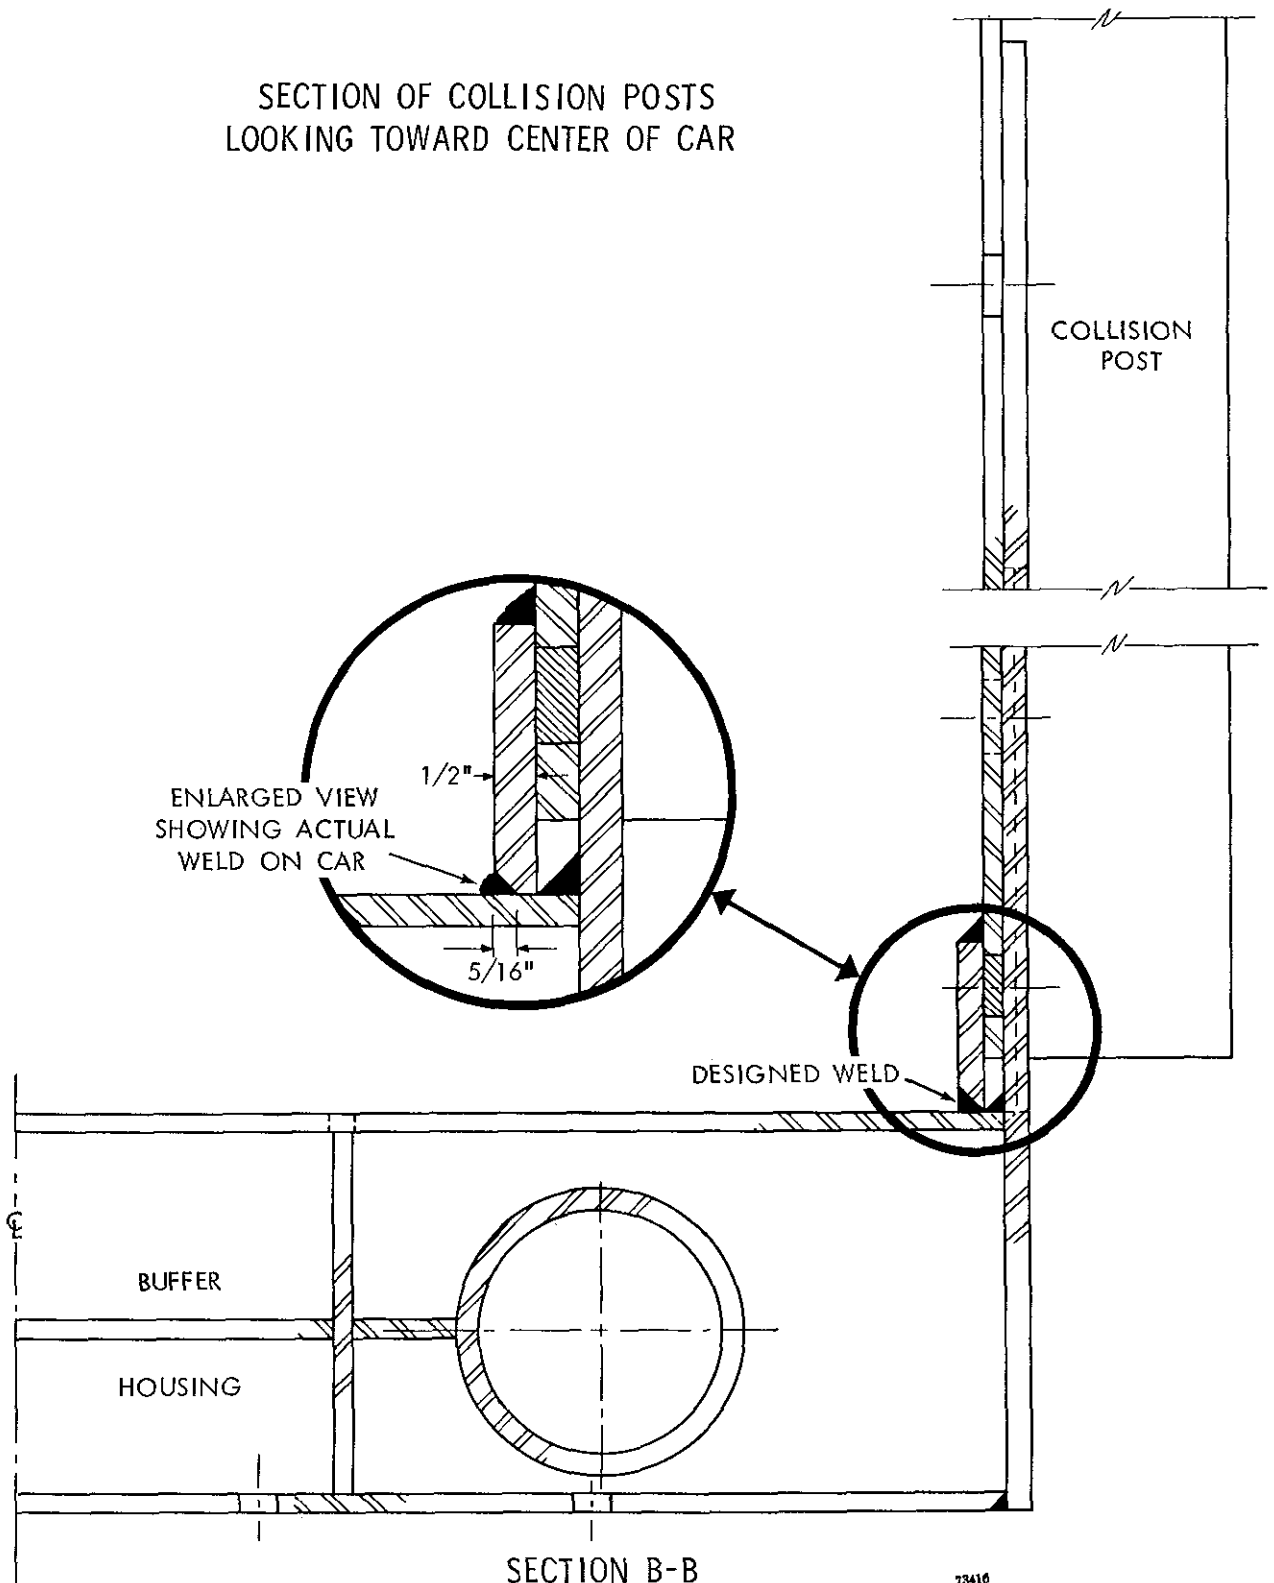
Figure 2

SECTION OF COLLISION POSTS
LOOKING TOWARD CENTER OF CAR
