RAILROAD / HIGHWAY ACCIDENT REPORT

ILLINOIS CENTRAL GULF RAILROAD
FREIGHT TRAIN AND
MOBIL OIL COMPANY
TRACTOR / CARGO-TANK SEMITRAILER
COLLISION AND FIRE
KENNER, LOUISIANA
NOVEMBER 25, 1980

NTSB-RHR-81-1

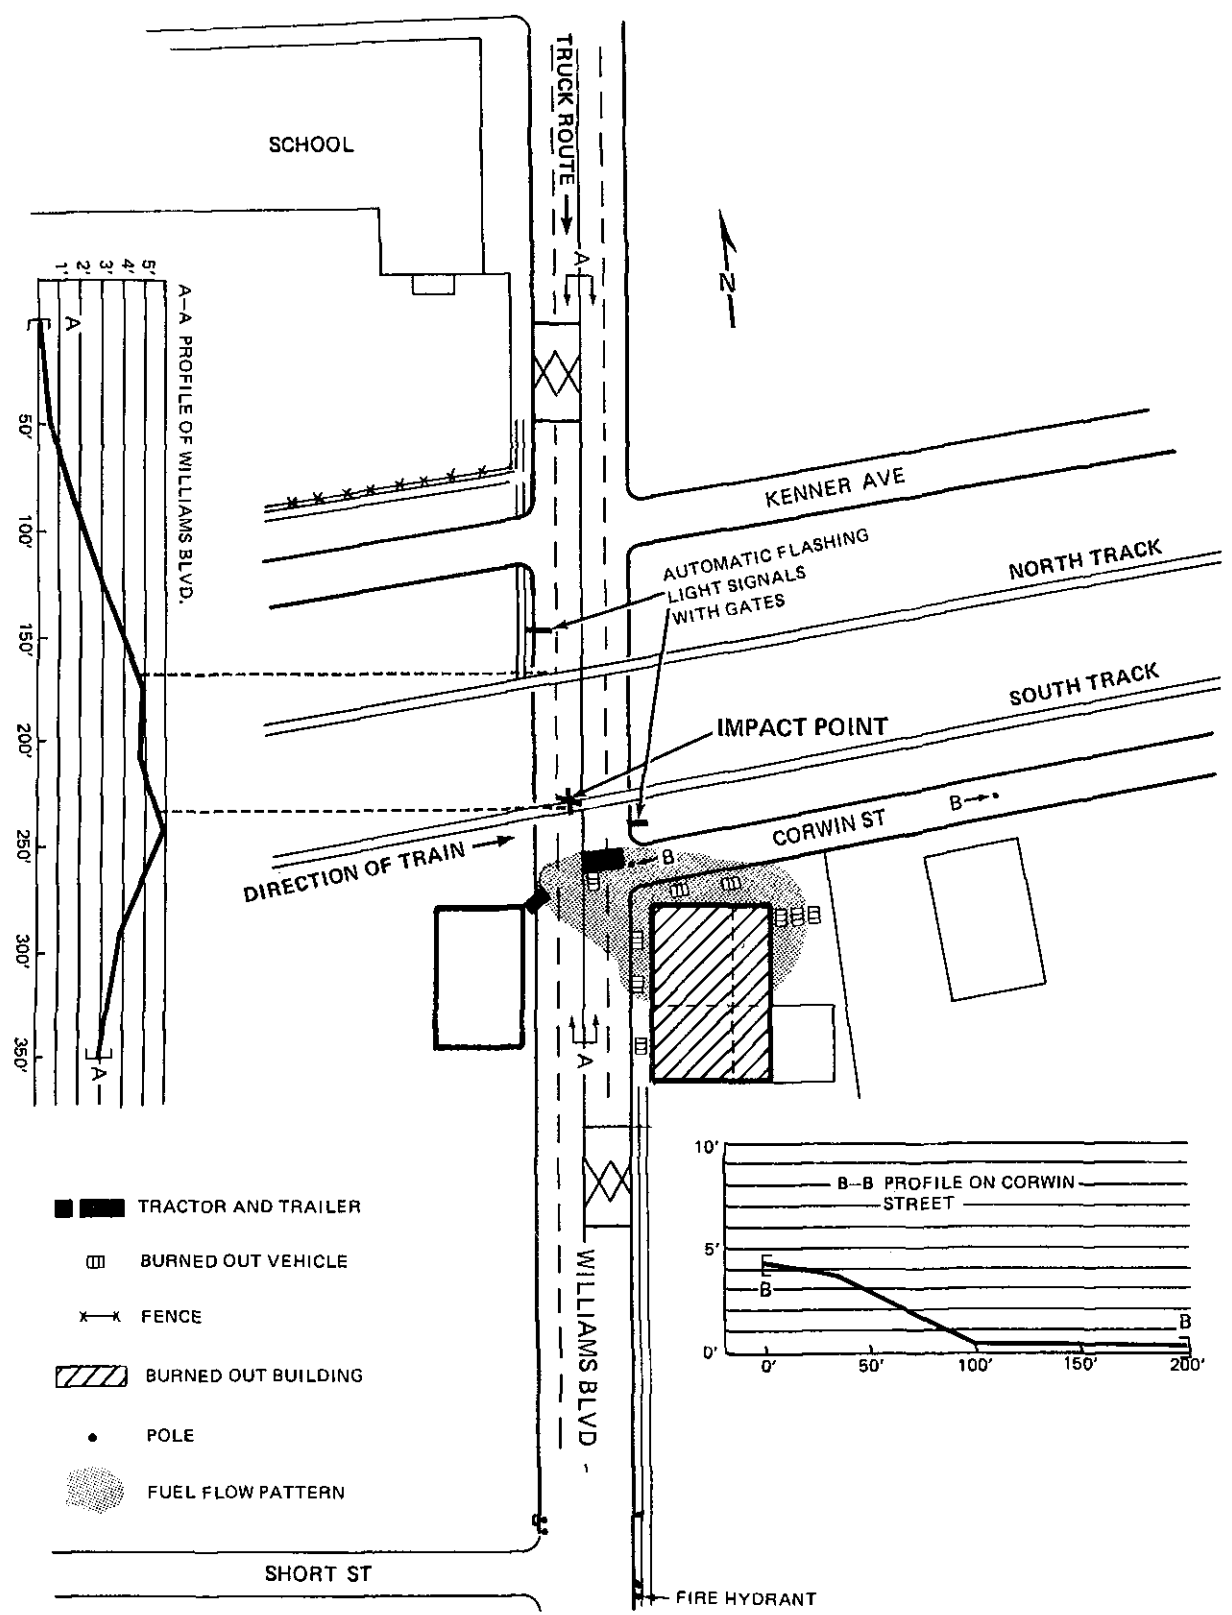
Figure 1.--Plan view of accident site.

As the locomotive struck the semitrailer, the cargo tank ruptured, rolled upside down, and spilled a large amount of cargo fuel which ignited immediately on the roadway just south of the tracks. (See figure 2.) The track level was elevated above the roadway grade and the burning fuel ran 40 feet to the south and 50 feet to the east around a building on the southeast corner of the intersection that housed a bar and an upholstery shop. The burning fuel flowing to the south surrounded the stopped Camaro and the truck tractor and ran past the west (front) door of the bar. The fuel flowing to the east ran into the north foundation and around to the east side of the bar past the north door. (See figure 1.)

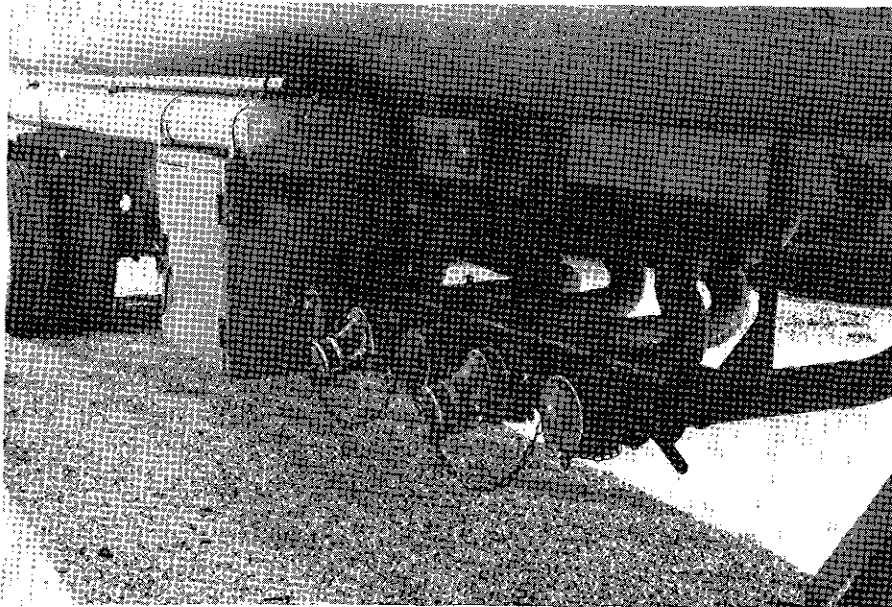
Figure 6.--Undamaged underside of trailer tank similar to tank involved in accident.

The semitrailer wreckage also had been placed on a flatbed trailer. (See figure 4.) Only steel components and approximately one-third of the aluminum cargo tank survived the postcrash fire. The entire underside of the tank had been consumed by fire. (See figures 5 and 6.)

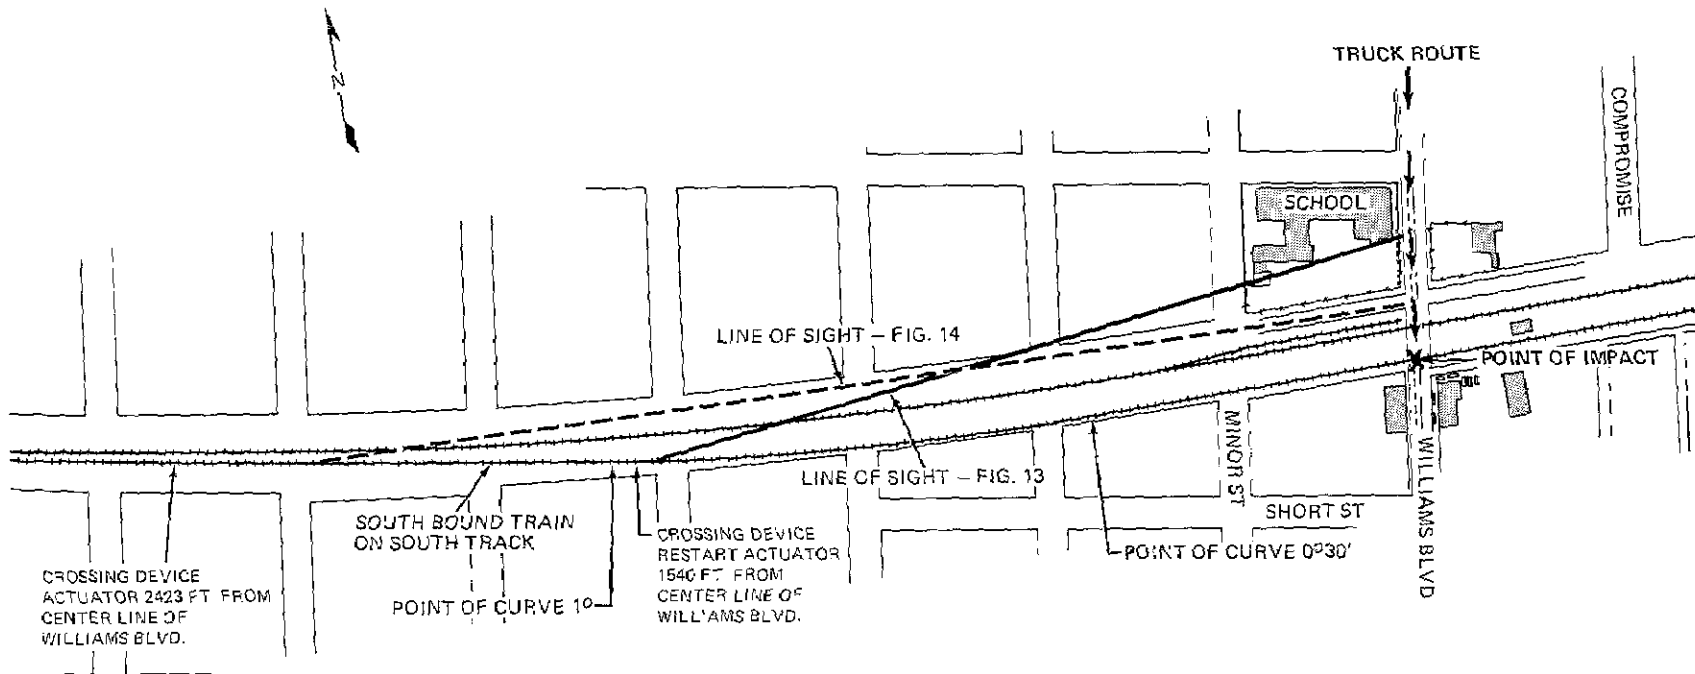
Figure 10.—Track in accident area.

Boulevard and then became a straight section approximately 650 feet west of Williams Boulevard. (See figure 10). In this same area the Williams Boulevard crossing device actuator and a restart actuator were located 2,423 feet and 1,540 feet, respectively, west of Williams Boulevard. The restart device was placed to permit switching activities between the start and restart actuators without the Williams Boulevard crossing devices remaining activated while a train was within these limits.

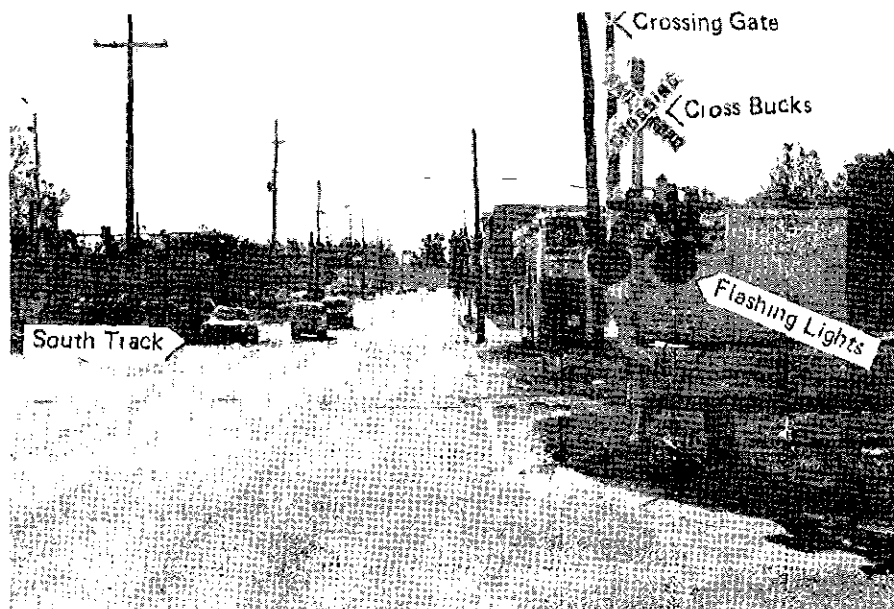
Figure 11.—Warning devices for southbound traffic.

In the vicinity of the crossing, train movements were governed by signal indications of an automatic block signal system, timetable special instructions, and train orders. Pertinent ICG rules and the Kenner city ordinances stated that the maximum allowable speed for an engine or lead car on crossings from Hanson Street to Filmore Street was 25 mph. Trains were operated north and south on the main tracks in the vicinity of the Williams Boulevard intersection. The west track circuit on the southbound main track used to activate the crossing warning equipment was approximately 2,423 feet long. Postaccident tests indicated that the crossing lights and bell began operating about 1 second after activation, and the gates were down in a horizontal position within 15 seconds. (See figure 11.) The southbound 14 1/2-foot crossing gate arm tip extended into the center of the left southbound traffic lane.
