# NATIONAL TRANSPORTATION SAFETY BOARD

## RAILROAD ACCIDENT REPORT

DERAILMENT OF ILLINOIS CENTRAL GULF RAILROAD  
FREIGHT TRAIN EXTRA 9629 EAST (GS-2-28)  
AND RELEASE OF HAZARDOUS MATERIALS  
AT LIVINGSTON, LOUISIANA  
SEPTEMBER 28, 1982

NTSB/RAR-83/05

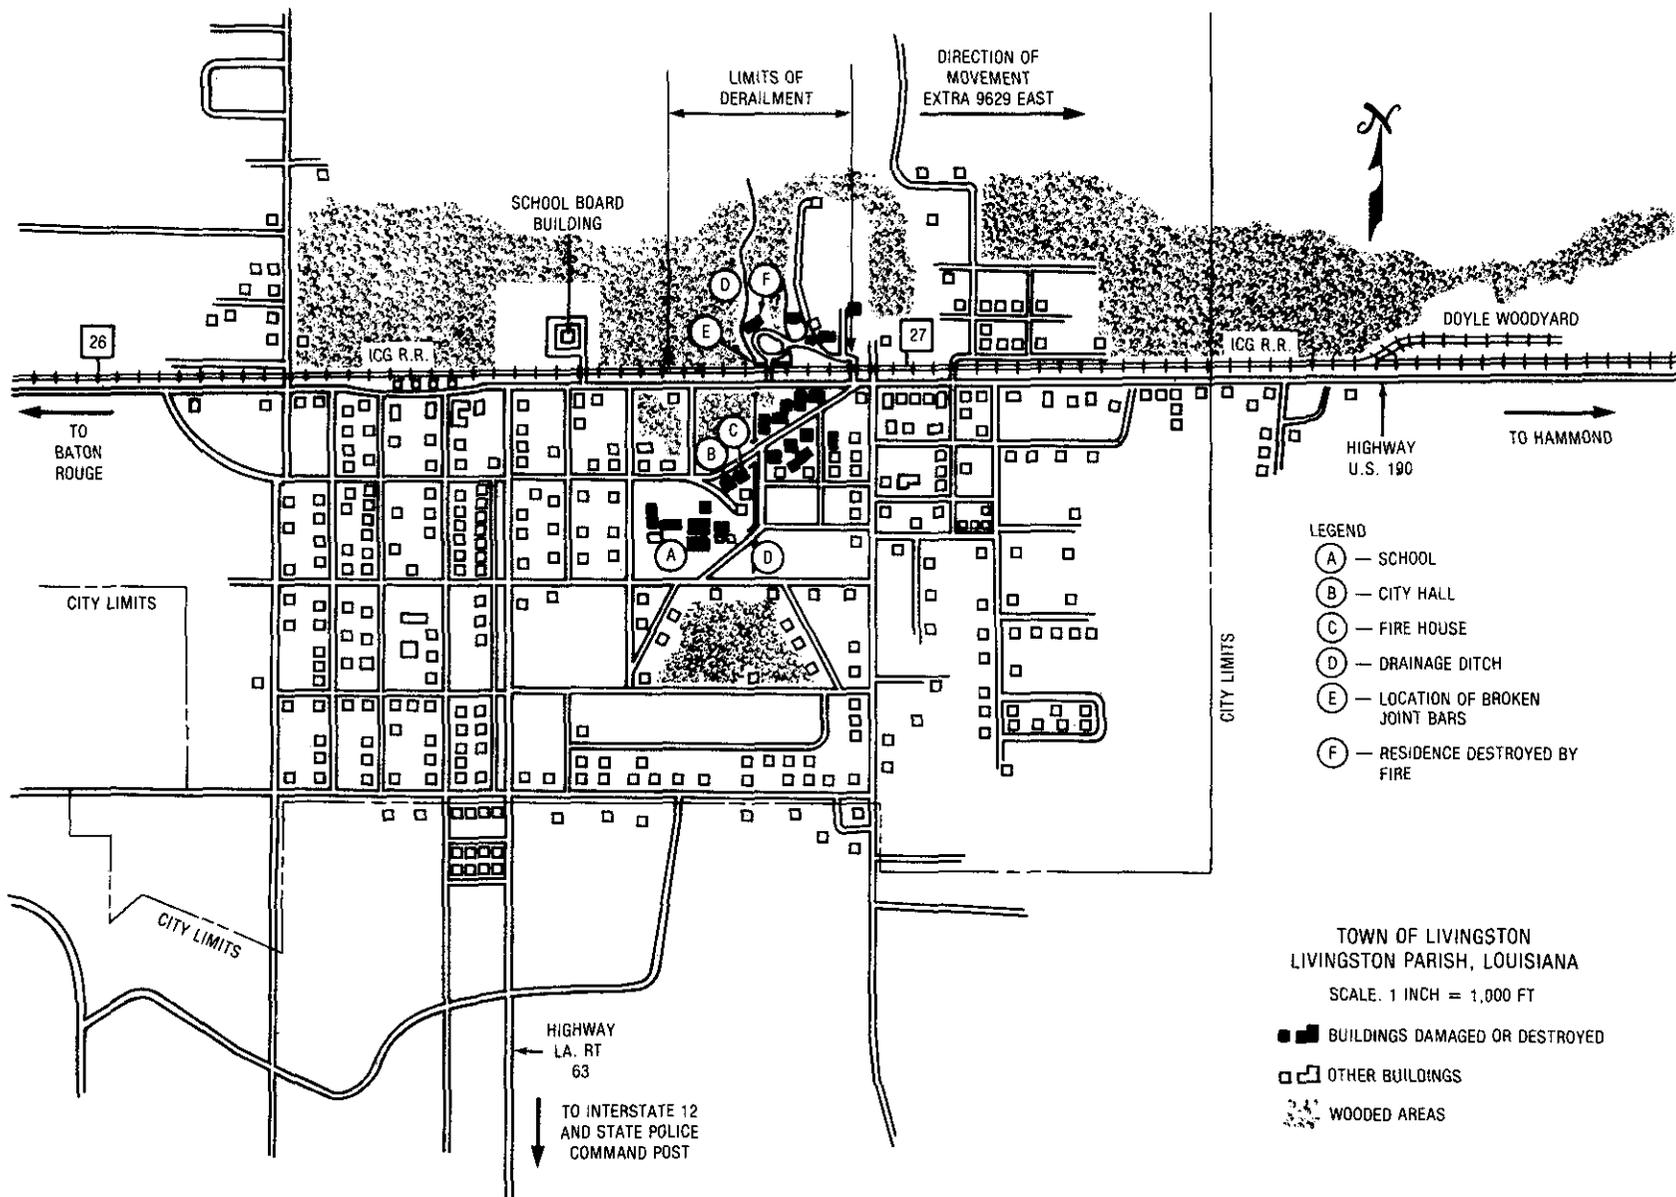
The 16th through the 58th head cars of Extra 9629 East had derailed along the main track for a distance of about 750 feet at milepost 26.8. (See figure 1.) The maximum distance of lateral divergence of derailed cars from the track was 75 feet to the north and 85 feet to the south. Highway 190, which parallels the railroad to the south, was encroached upon by one of the derailed cars and was completely blocked by a tree that had been toppled by the same car. The 26th through 32nd head cars were tank cars loaded with vinyl chloride, a flammable gas. Two of these cars were breached in the derailment, and gas escaping from the cars quickly ignited creating the fireball which the traincrew had reported seeing. The fireball extended about 400 feet from the south margin of Highway 190, across the derailment site, and through a grove of tall pine trees to a residence located about 250 feet north of the track. An explosion blew in the brick front of the dwelling, and the fireball enveloped the entire structure in flames. The lone occupant escaped by jumping through a window and running to safety. A small storage shed about 100 feet south of the highway also was set afire and numerous fires broke out in the derailment wreckage.

Figure 1.--Map of Livingston, Louisiana, and site of the derailment of Illinois Central Gulf train Extra 9629 East on September 28, 1982.

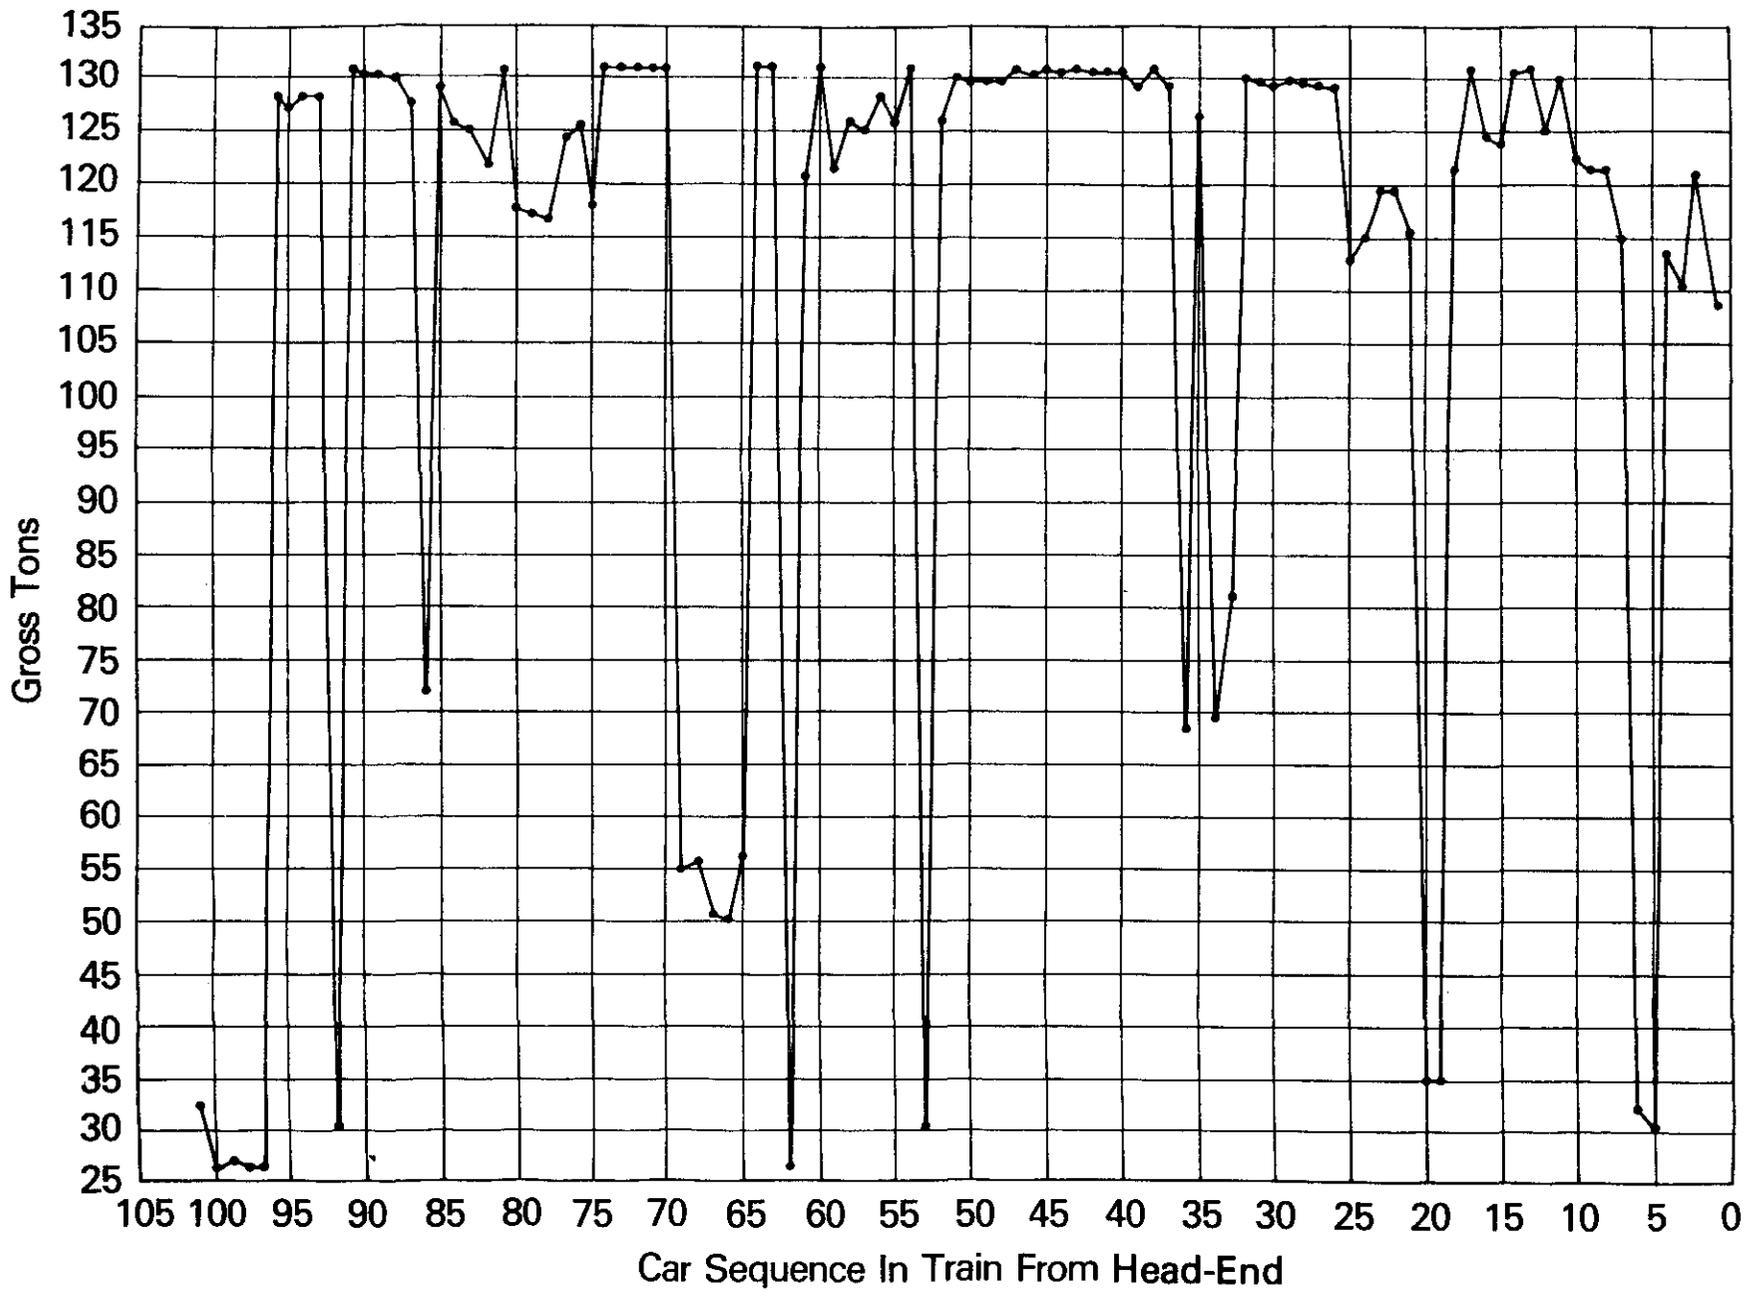
Most of the 16 empty cars in Extra 9629 East were scattered throughout the rear half of the train with 4 of them just ahead of the caboose. (See figure 2.) The 5th, 6th, 19th, and 20th cars were the only empty cars in the forward half of the train. These weighed 30 to 35 tons each whereas the 12 loaded cars between the two pairs of empty cars varied in weight from 115 to 131 tons each. Most of the 33 loaded cars behind the 19th and 20th head cars weighed 130 tons or more.

Figure 2.--Tonnage profile for Extra 9629 East.
