ILLINOIS CENTRAL GULF
RAILROAD COMPANY
FREIGHT TRAIN DERAILMENT
HAZARDOUS MATERIAL RELEASE
AND EVACUATION
MULDRAUGH, KENTUCKY
JULY 26, 1980

NTSB-RAR-81-1

**ILLINOIS CENTRAL GULF RAILROAD COMPANY
FREIGHT TRAIN DERAILMENT
HAZARDOUS MATERIAL RELEASE
AND EVACUATION
MULDRAUGH, KENTUCKY
JULY 26, 1980**

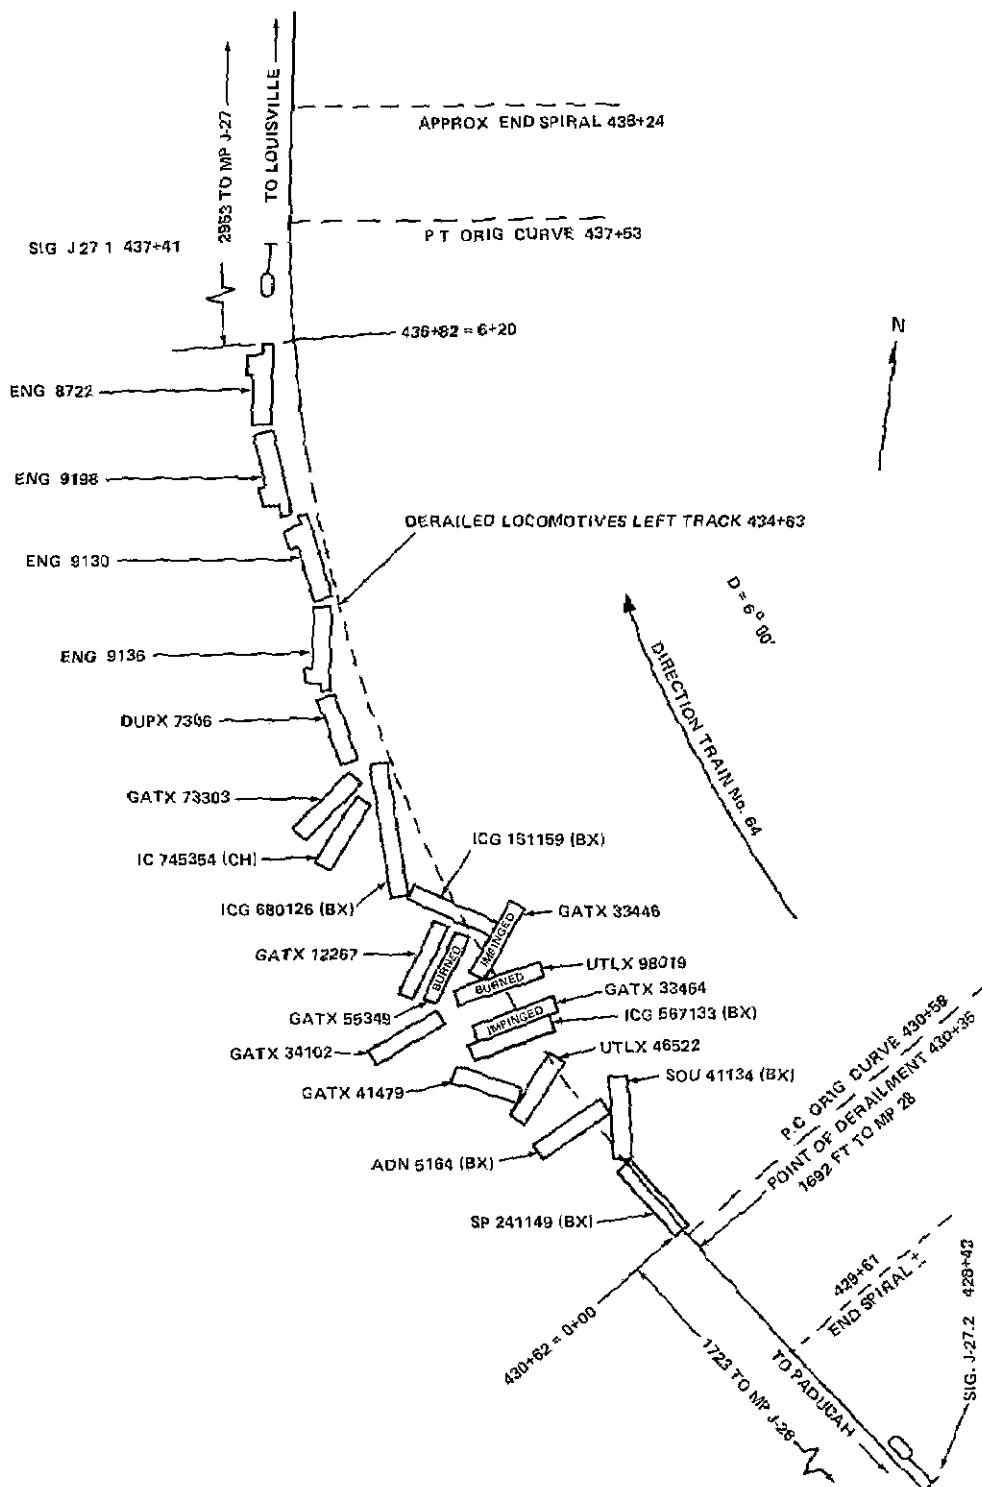
Figure 1.—Plan View of Accident

The following 17 cars were derailed. (See figure 1.) Seven were tank cars containing hazardous materials. Six of the tank cars carried vinyl chloride and one contained chlorine. Both vinyl chloride and chlorine produce toxic fumes when released to the atmosphere. Two of the tank cars of vinyl chloride were breached. The pressurized compressed gas escaped and formed a gas cloud around the derailed equipment.

Of the other 10 derailed cars, which did not carry hazardous materials, 3 sustained light damage, 2 were moderately damaged, 3 were heavily damaged, and 2 were destroyed.

The derailment destroyed or damaged about 645 feet of track. Broken rails and joint bars were found on both sides of the track. The estimated cost of the damage is listed below:
