**RAILROAD ACCIDENT INVESTIGATION**

REPORT NO 4094

**ILLINOIS CENTRAL RAILROAD COMPANY**

**MAY 31, 1966**

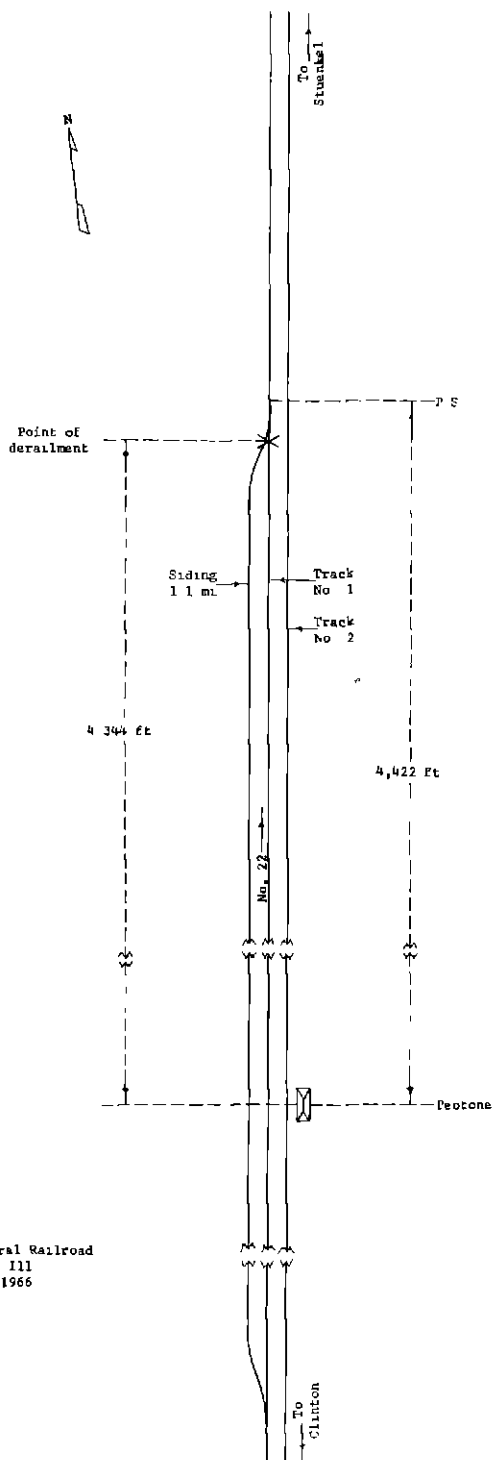
The spring wing rail of the frog was provided with hold downs 7 inches and 42 inches south of the frog point. The hold-down horns were riveted to the west side of the web of the spring wing rail. The flanges of the hold-down housings had their diagonal corners riveted to the frog plates and their outer edges welded to the frog plates. In addition, at the two remaining corners of each hold-down housing, spikes had been driven through the flanges and the frog plates into the switch ties. Examination of the frog after the derailment disclosed that the south hold-down horn was fractured at its outer end, and the three rivets securing the south end of the reinforcing bar to the spring wing rail were loose. At each hold-down housing the southwest corner was broken at the rivet. The weld along the south side of the housing and the flange on the north side of the housing were also broken. These defective conditions permitted independent vertical movements between the spring wing rail and the long point rail of the frog in excess of the maximum allowable one-eighth inch. The worn and polished appearance of the fractures of the broken pieces indicated that they had been broken and loose for a considerable time.

It is apparent that the south hold-down horn and both hold-down housings of the spring frog assembly had been broken a considerable time, indicating that the spring frog assembly had been inadequately maintained.

northern portion of this rail was deflected downward and the southern portion rocked upward. The front face of the rim of the following wheel then engaged the gage side of the raised spring wing rail and forced it outward as the wheel continued northward and dropped off the frog point into the throat of the frog. Some of the trailing wheels rerailed between the toe of the frog and the second straight closure rail. Apparently the northern end of the first straight closure rail was forced westward sufficiently to break loose from the rail joint and allow some of the wheels to rerail at the receiving end of the second closure rail. After being heavily battered by derailed wheels, the second closure rail broke 14-1/2 feet from the south end. The remaining 24-1/2 feet received considerable batter at the broken end and apparently was displaced by the 9th car, and resulted in the derailment of both trucks of the 9th to 12th cars, inclusive.

Sketch of frog showing position of wheel where a dangerous condition existed, due to defective hold downs, as shown in Section A-A

Section A-A  
Defective hold down

Section B-B  
Wheel derailed after passing  
over point of frog

It is recommended that the Illinois Central Railroad Company take such action as is necessary to insure thorough inspection and adequate maintenance of spring frog assemblies.
