RAILROAD ACCIDENT REPORT
ILLINOIS CENTRAL RAILROAD COMPANY
AND
INDIANA HARBOR BELT RAILROAD COMPANY
COLLISION BETWEEN
YARD TRAINS AT
RIVERDALE, ILLINOIS
ON SEPTEMBER 8, 1970

NATIONAL TRANSPORTATION SAFETY BOARD
Washington, D. C. 20591
REPORT NUMBER: NTSB-RAR-71-3

ADOPTED: NOVEMBER 24, 1971

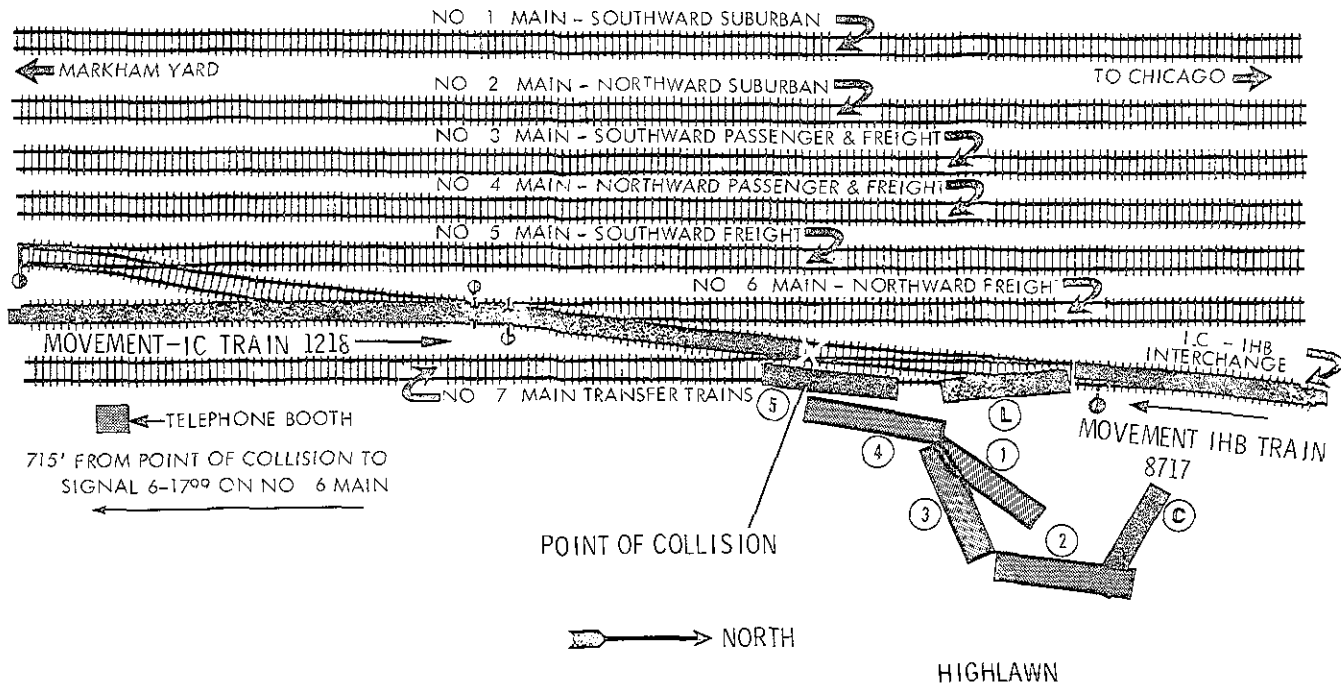
FIGURE 1
PLAN OF ACCIDENT AREA
HIGHLAWN IC-IHB ICT
RIVERDALE, ILL.

CAR LOCATION AND POSITION CHART			
DESIGNATION	TRAIN	FINAL POSITION	TYPE
L	IHB 8717	UPRIGHT, SO TRUCKS DERAILED	LOCO
C	IC 1218	UPRIGHT, UNDER ②	CABOOSE
1	IC 1218	ON SIDE	BOX
2	IC 1218	ON SIDE, ON TOP OF (C)	BOX
3	IC 1218	ON SIDE	BOX
4	IC 1218	ON SIDE	BOX
5	IC 1218	UPRIGHT, BOTH TRUCKS DERAILED	BOX

The IC caboose landed upright at the bottom of the 10-foot-high roadway embankment, turned approximately 115° from the direction of travel. The following three cars of the IC train were all box cars loaded with lumber. The first following car came to rest on the slope of the embankment. The second car landed on top of the upright caboose. In all, five boxcars and the caboose of the IC train derailed. The locomotive was the only derailed equipment in the IHB train. The relative positions of the derailed equipment following the accident are shown in Figure 1.

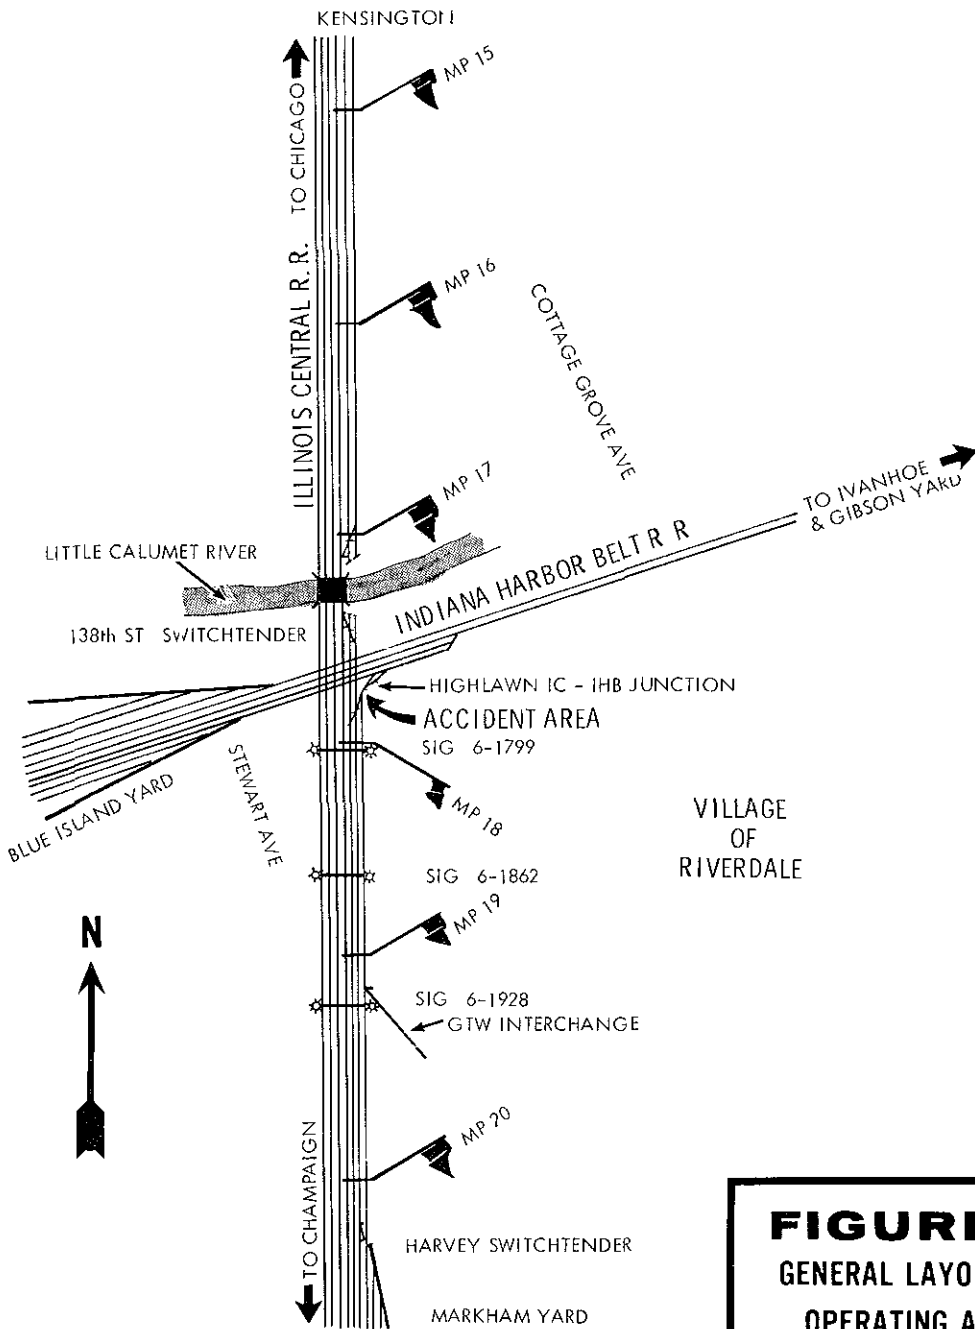
FIGURE 2
GENERAL LAYOUT OF
OPERATING AREA
RIVERDALE, ILL

A large-scale plan of the IC and IHB trackage in the immediate area is shown as Figure 1. A smaller scale layout, which covers all of the area involved, is shown as Figure 2.

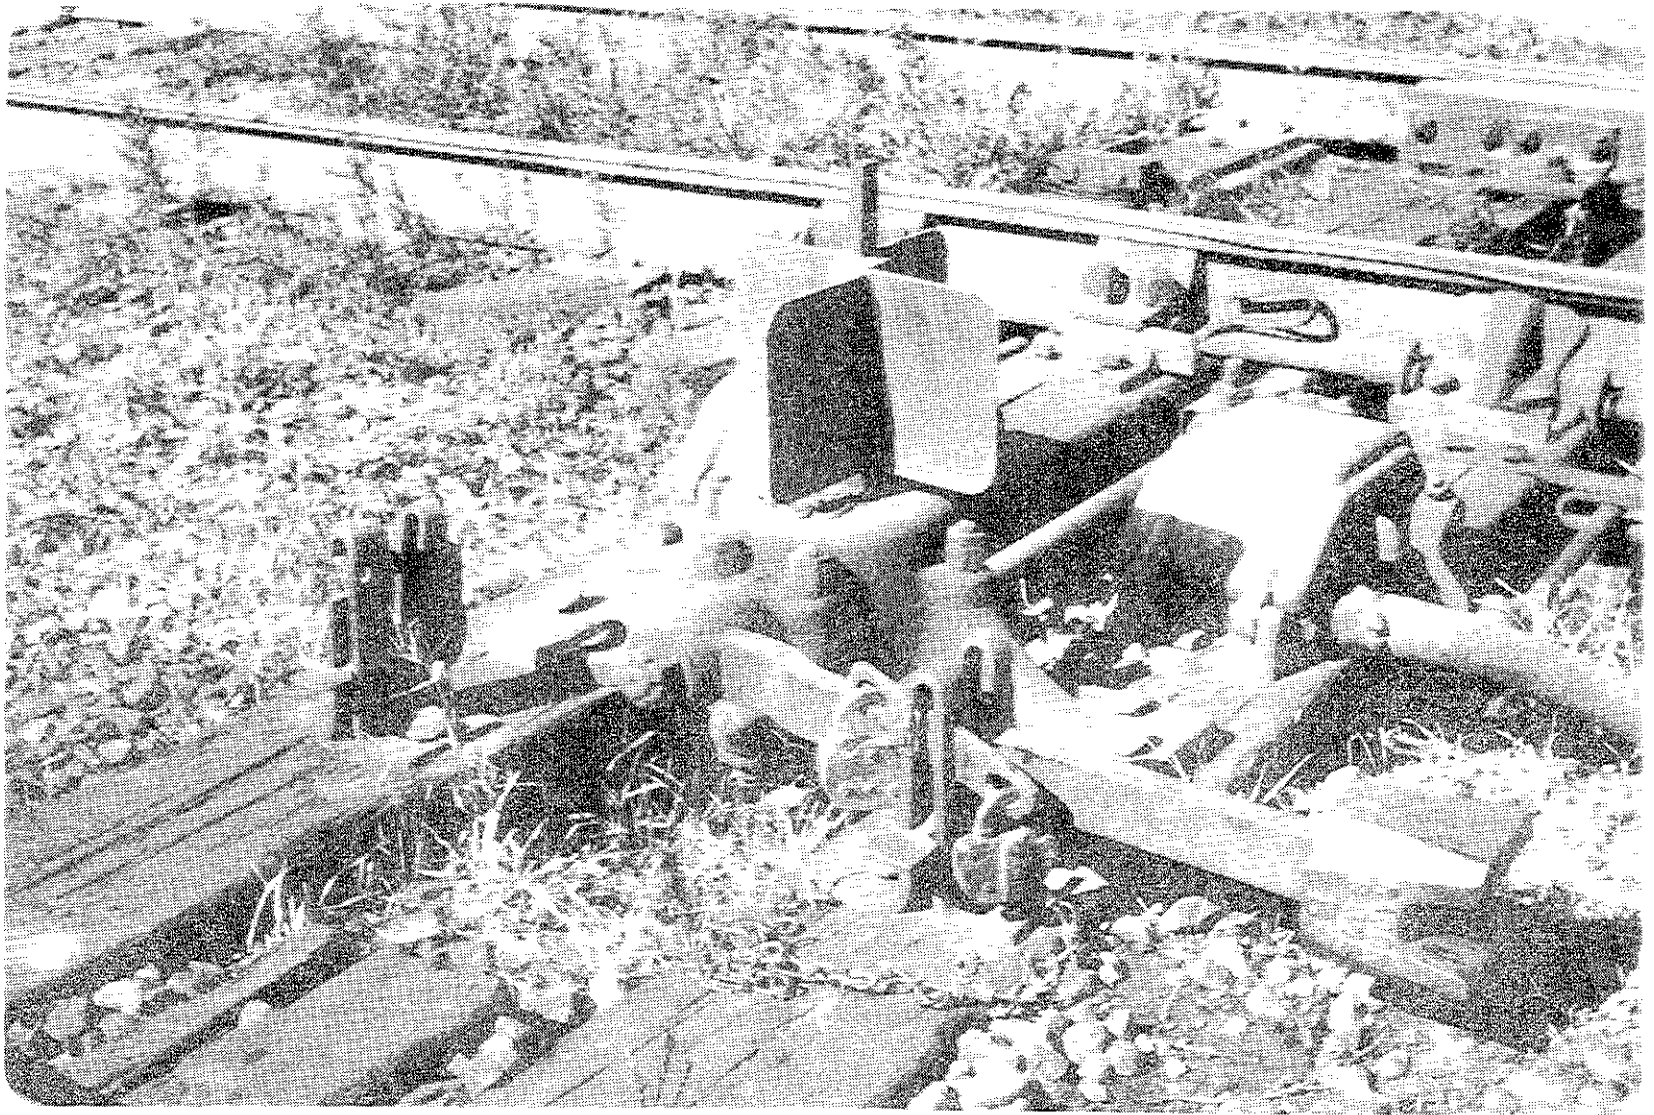
Figure 3 — Switch Stand of the No. 5 Track
Crossover Switch at Highlawn

The switches of the crossovers operate manually by means of groundthrow switch stands. The switches normally are locked with a connecting bar that allows use of either an IC or IHB switch padlock. Switch position is indicated by reflectorized targets, which display green for the through-track movement and red for the diverging position. Switch stand and target details are shown in Figure 3.
