INVESTIGATION NO. 3228
ILLINOIS CENTRAL RAILROAD COMPANY
REPORT IN RE ACCIDENT
NEAR WICKLIFFE, KY., ON
JANUARY 18, 1949

Accident near Wickliffe, Ky., on January 18, 1949, caused
by the sinking of a fill.

Inv. No. 3223
 Illinois Central Railroad
 Wickliffe, Ky.
 January 13, 1949

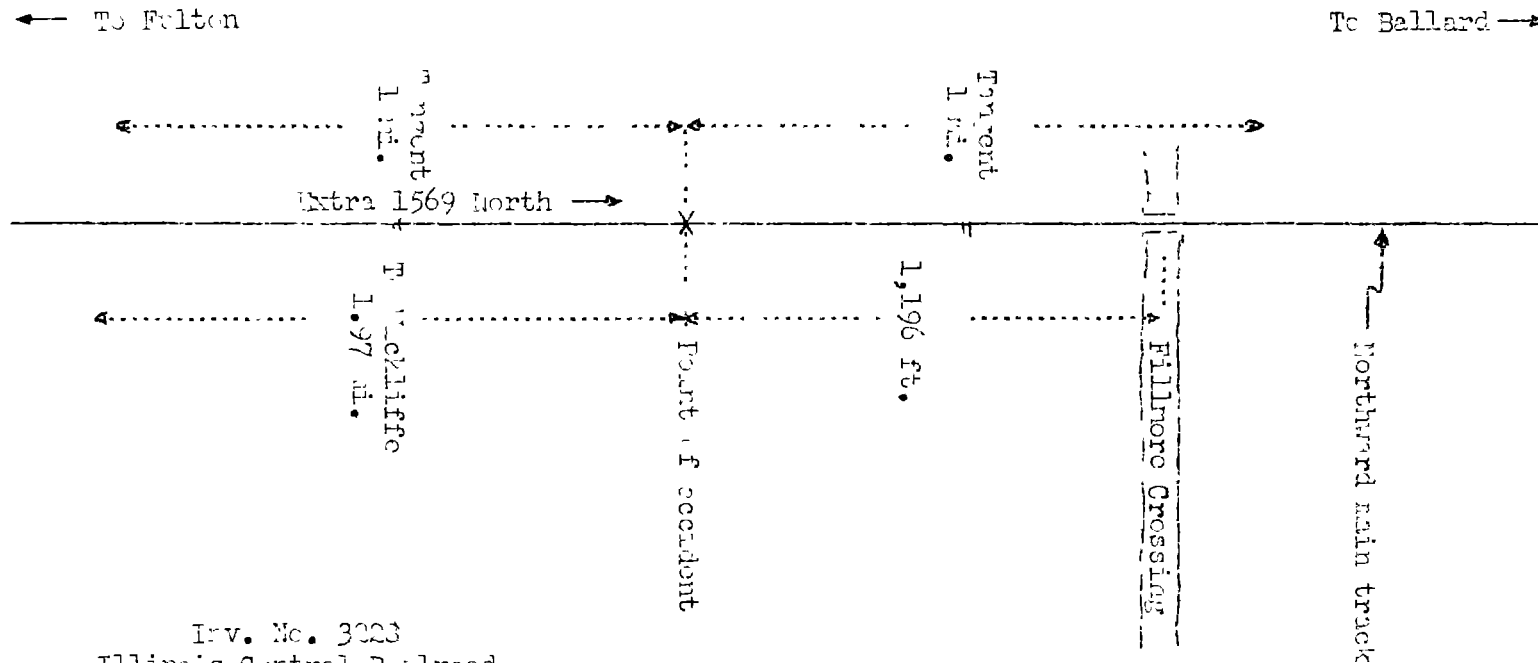
o Ballard, Ky.
o 2.90 mi.
o Fillmore
o 0.85 mi.
X Point of accident
o 1.97 mi.
o Wickliffe
o 3.10 mi.
o Winford Jet.
o 32.70 mi.
o Fulton, Ky.
