# NATIONAL TRANSPORTATION SAFETY BOARD

## RAILROAD ACCIDENT REPORT

**HEAD-ON COLLISION BETWEEN  
IOWA INTERSTATE RAILROAD EXTRA 470 WEST  
AND EXTRA 406 EAST WITH RELEASE OF  
HAZARDOUS MATERIALS  
NEAR ALTOONA, IOWA  
JULY 30, 1988**

NTSB/RAR-89/04

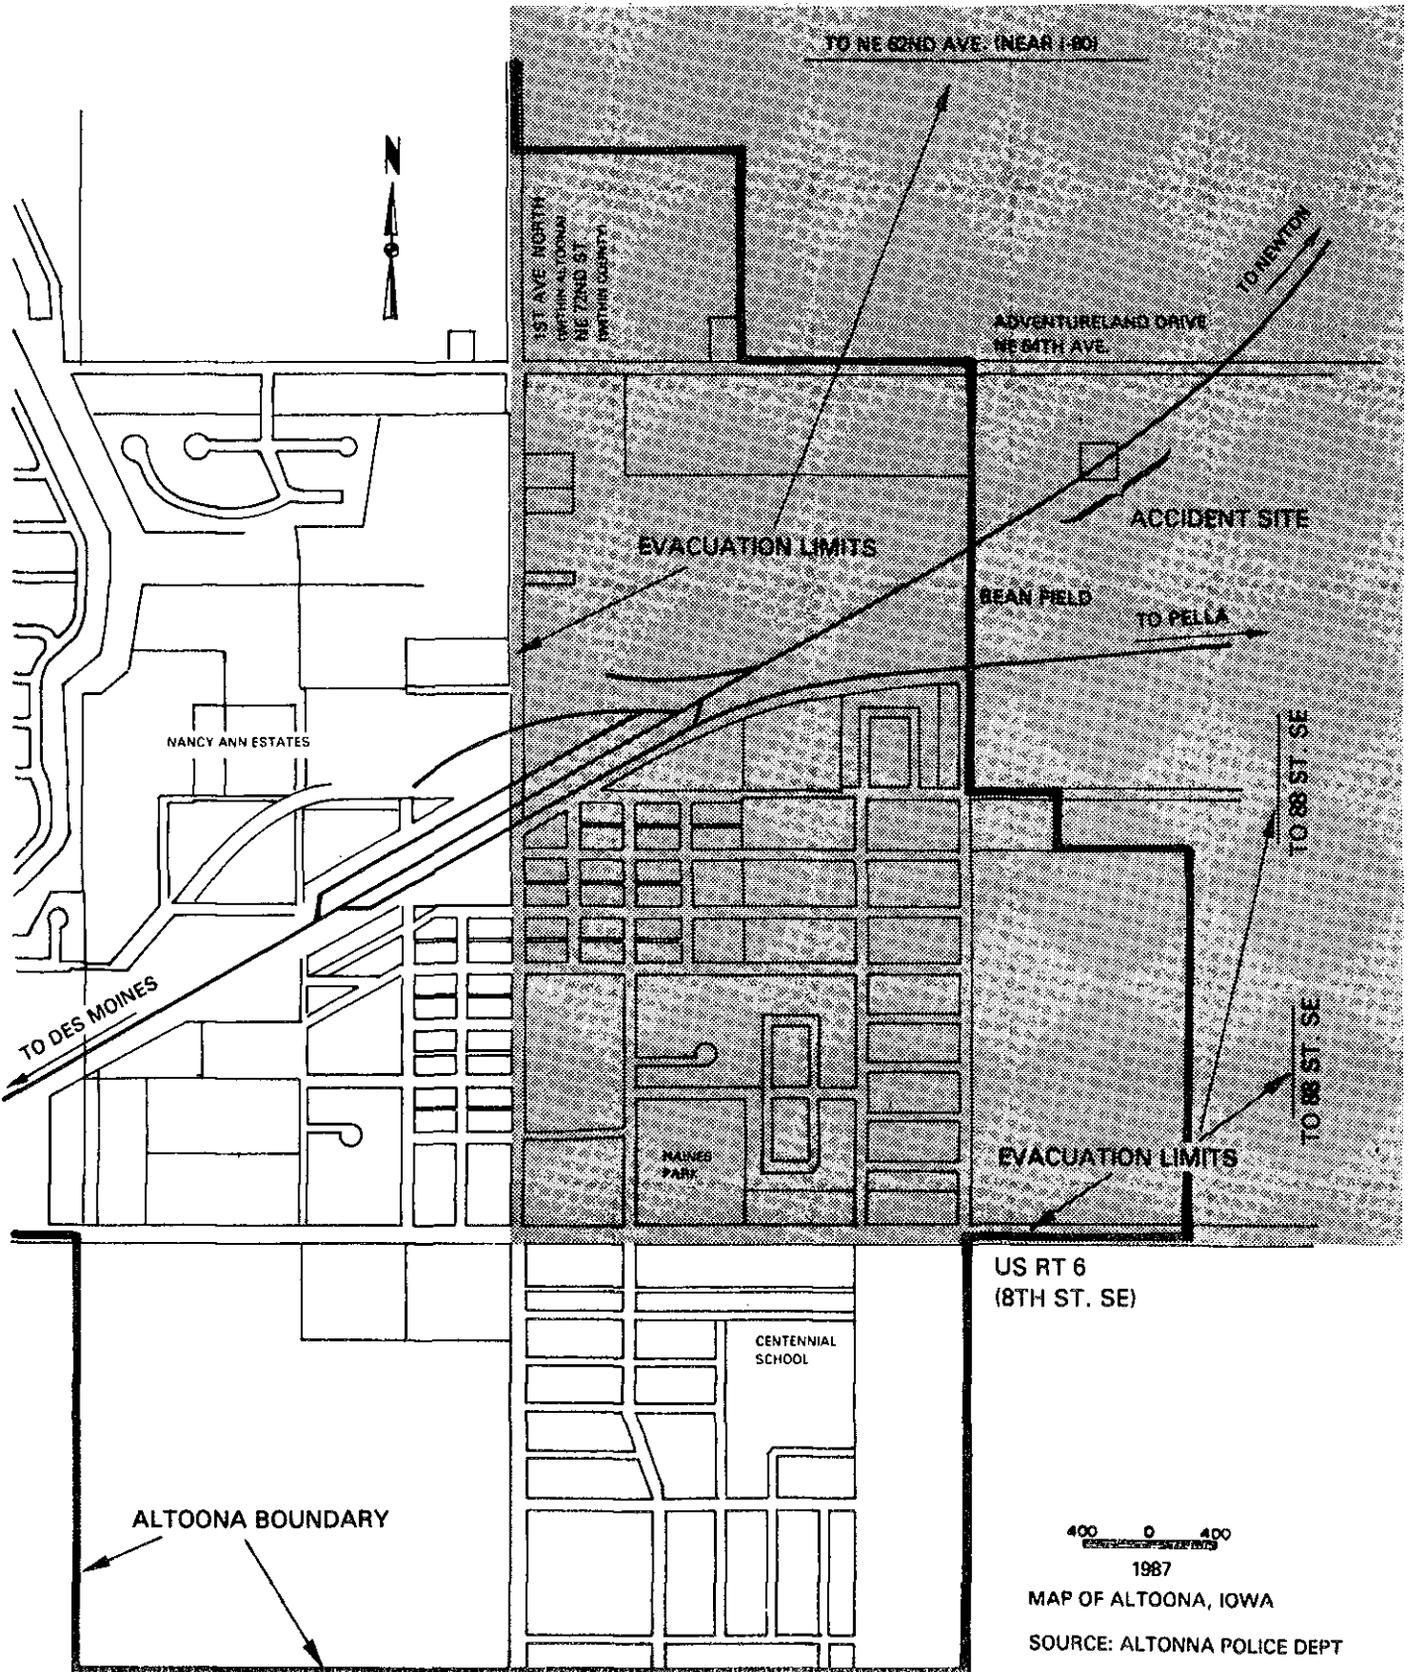
Figure 6.--Evacuation Area of Altoona.

Shortly after the second approach, representatives from the IAIS, the Iowa State Patrol, the Polk County sheriff's office, and the Altoona police and fire departments met and agreed to permit the tank cars to burn and initiate an evacuation of those residents living within a 1 1/2-mile radius of the burning tank cars. An approximate 3/4-mile radius evacuation was eventually established to allow for traffic flow around the area. The 1987 Emergency Response Guidebook recommends to "isolate for 1/2 mile in all directions if the tank car...is involved in fire." The evacuation area was bordered on the east by 88th Street SE and 80th Street, on the west by First Avenue North, on the north by NE 62nd Avenue, and on the south by US Route 6. (See figure 6.) An estimated 1,500 citizens were evacuated.<sup>5</sup>
