RAILROAD ACCIDENT INVESTIGATION

REPORT NO 4172,

KANSAS CITY SOUTHERN LINES

SEPTEMBER 23, 1970

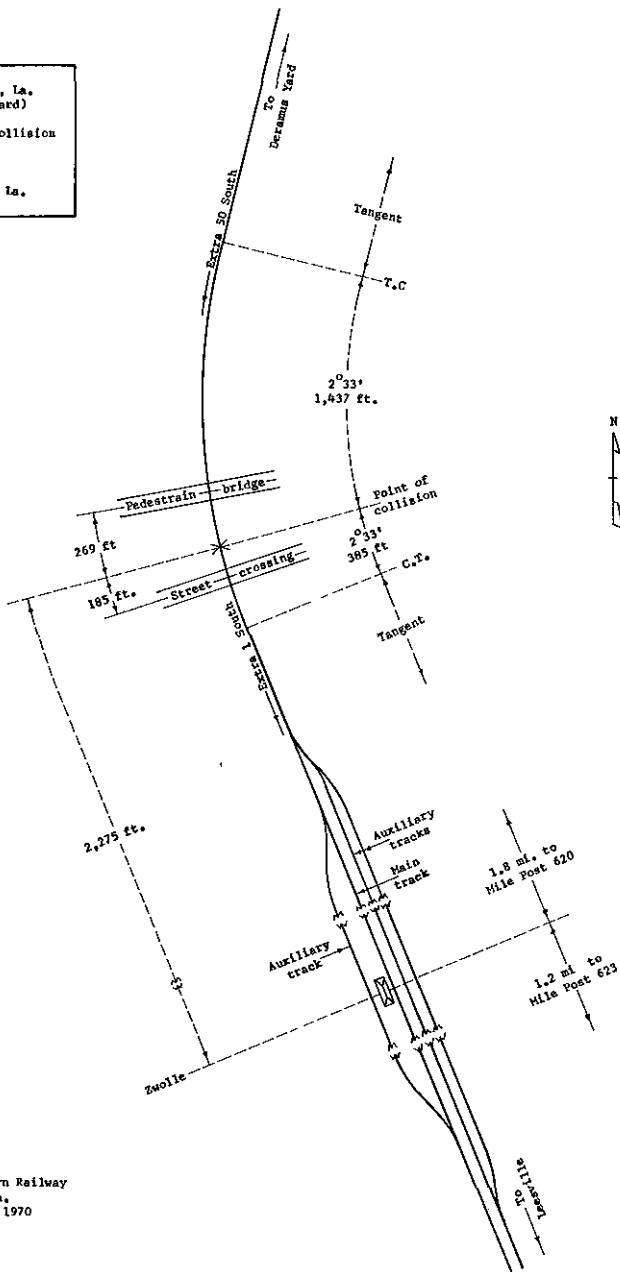
Kansas City Southern Railway  
Zwolle, La.  
September 23, 1970

The collision occurred on the main track, 68.1 miles south of Deramus Yard and 2275 feet north of the station at Zwolle.

Mile Posts 620 and 623 are 1.8 miles north and 1.2 miles south of the Zwolle station, respectively. Auxiliary tracks are along both sides of the main track in the station area, as indicated in Plate No. 1.
