RAILROAD ACCIDENT INVESTIGATION

REPORT NO. 4137

THE LONG ISLAND RAIL ROAD COMPANY

OCTOBER 18, 1967

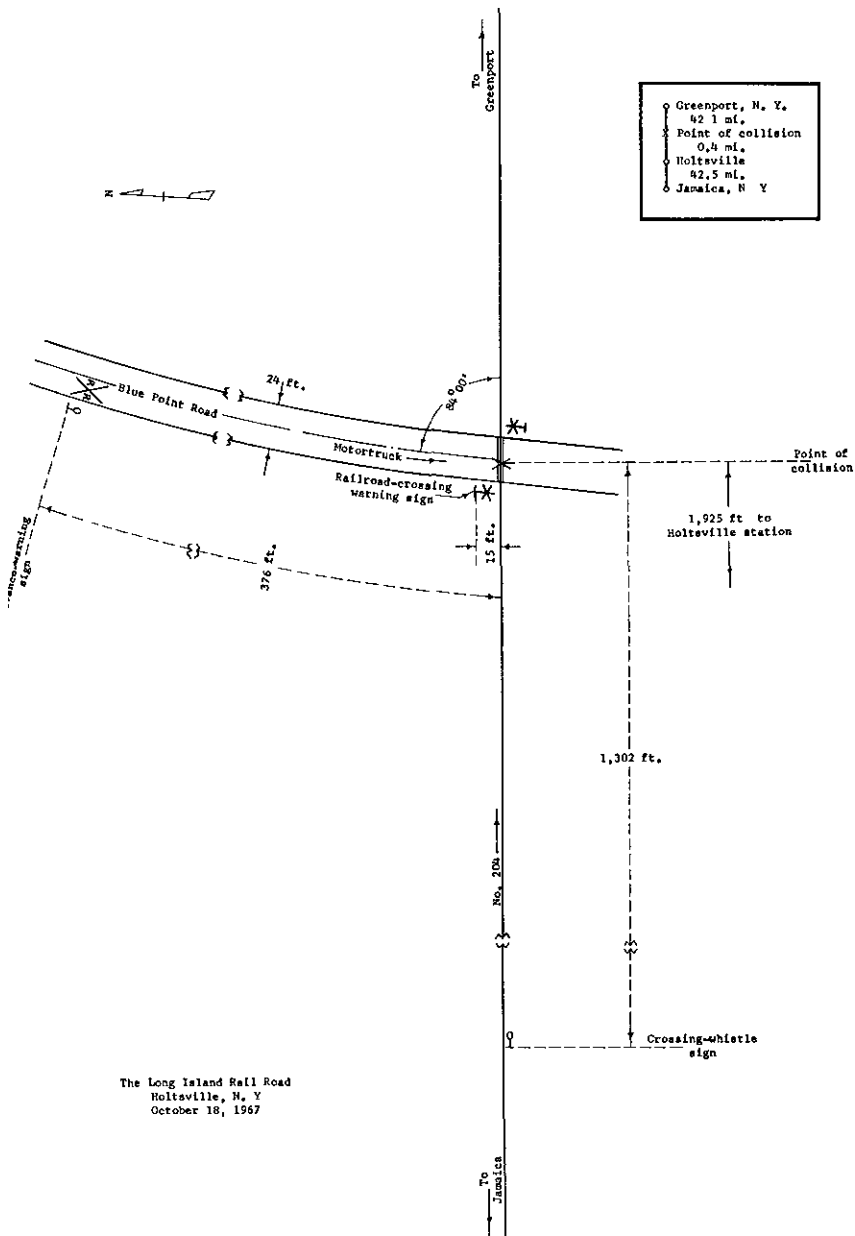
PLATE 1

No. 204, an eastbound first-class passenger train, consisted of diesel-powered passenger units 3101 and 3121, coupled in multiple-unit control. Each unit was of all-steel construction and had tightlock couplers. Unit 3101, the first unit, was 85 feet long and had vestibules at both ends. A control station was on the right side of the front vestibule. A doorway, 28 inches wide and 74 inches high, was at the rear of the vestibule, for entrance to, and exit from, the passenger compartment. The door opened inward to the passenger compartment aisle, which was 33 inches wide. See Plate 1 for details concerning the vestibule and control compartment at the front of unit 3101.
