RAILROAD ACCIDENT INVESTIGATION

REPORT NO 4079

LOUISVILLE AND NASHVILLE RAILROAD COMPANY

ERIN, TENN

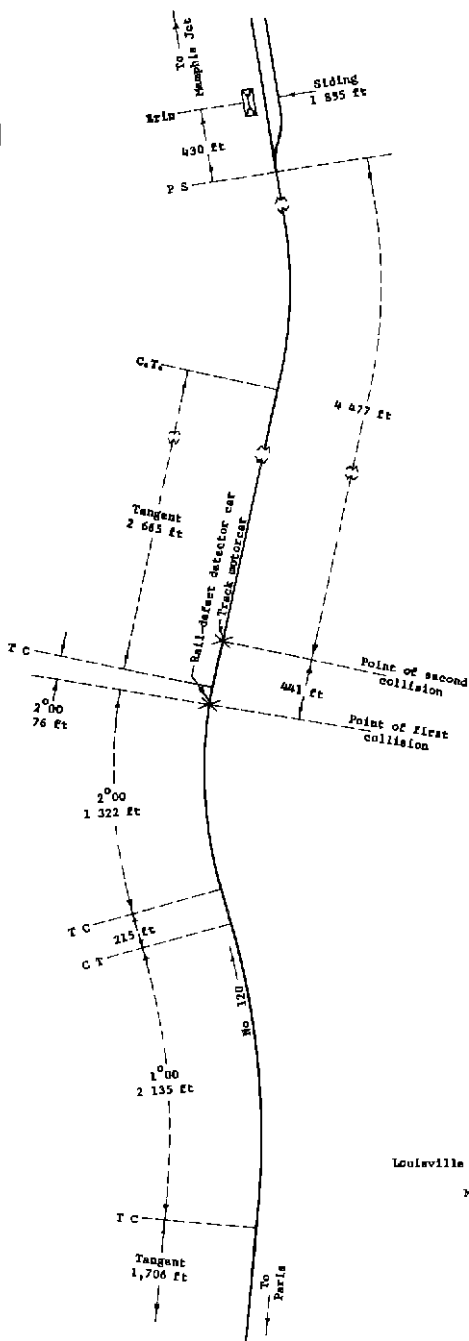
The rail-defect detector car was derailed. It was overturned and stopped on the west side of the track structure, 171 feet north of the first collision point and about 15 feet from the main track. It was destroyed.

Rail-defect detector car involved in accident
