## RAILROAD ACCIDENT REPORT

LOUISVILLE & NASHVILLE  
RAILROAD COMPANY FREIGHT TRAIN  
DERAILMENT AND PUNCTURE OF  
ANHYDROUS AMMONIA TANK CARS AT  
PENSACOLA, FLORIDA  
NOVEMBER 9, 1977

REPORT NUMBER: NTSB-RAR-78-4

LOUISVILLE & NASHVILLE RAILROAD COMPANY  
FREIGHT TRAIN DERAILMENT AT  
PENSACOLA, FLORIDA  
NOVEMBER 9, 1977

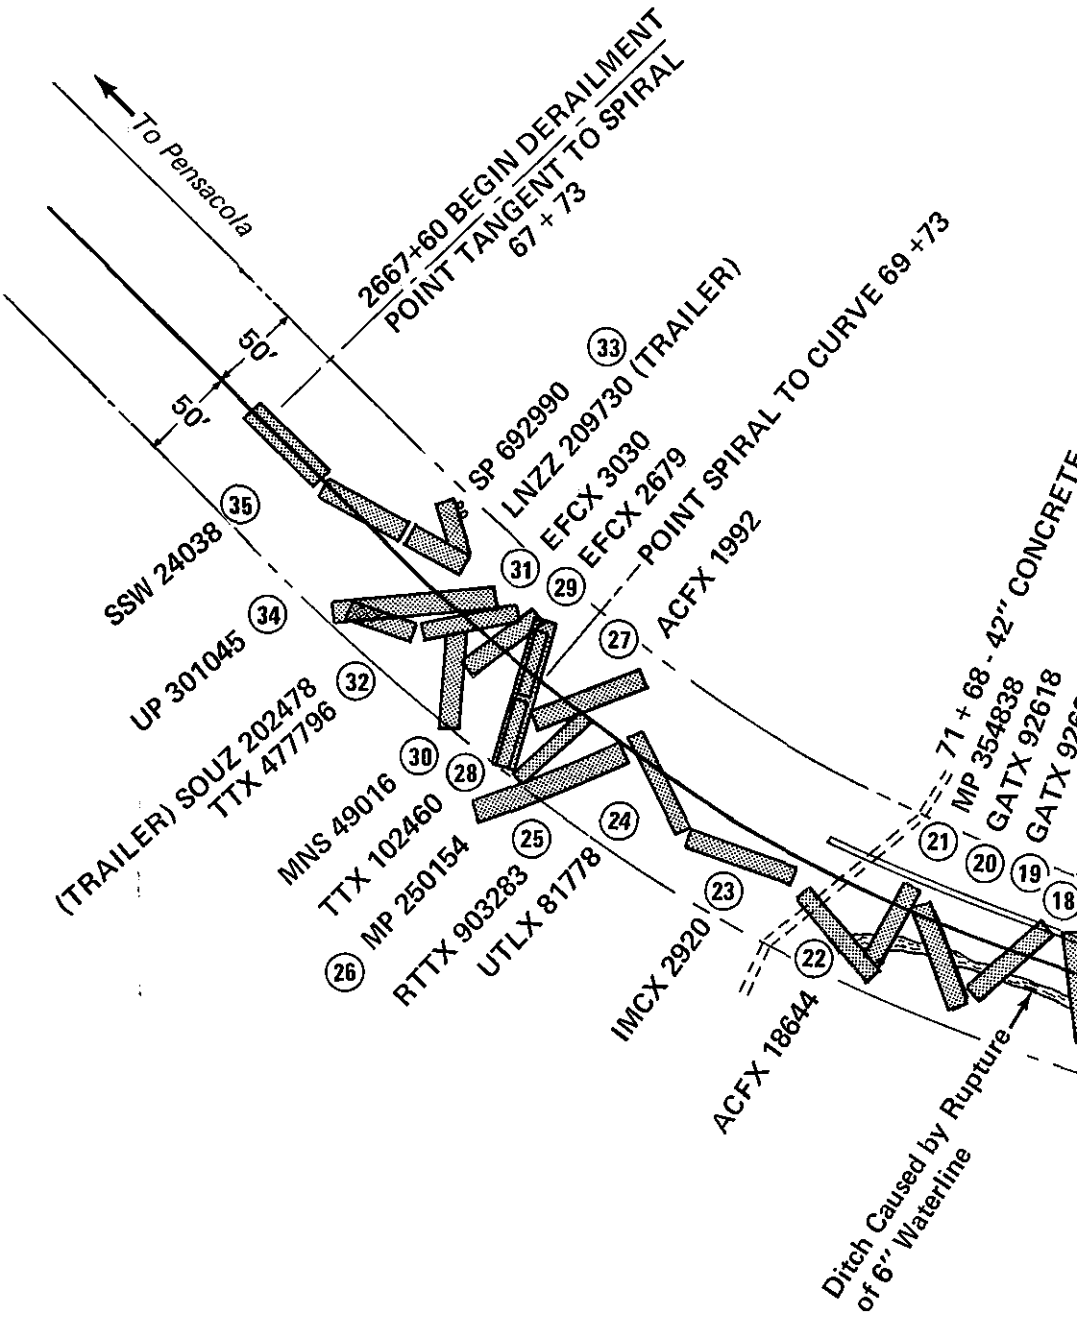
The locomotive and cars traveled 800 feet before stopping after the emergency brake application. The conductor and flagman, who were in the caboose at the rear of the train, stated that as the train stopped they noted no slack, jerking, or buff forces in the caboose. The conductor called the engineer on the radio when the train stopped at 6:06 p.m. and was told that the train had derailed. The first two cars, a long flat car loaded with one truck trailer and an empty covered hopper car, remained upright and coupled to the locomotive. The next 11 cars were tipped but remained in line along the following 900 feet of track. The 14th through 35th cars jack-knifed and piled up within the next 700 feet. (See figure 1.)

2667+60 BEGIN DERAILMENT  
POINT TANGENT TO SPIRAL  
67+73

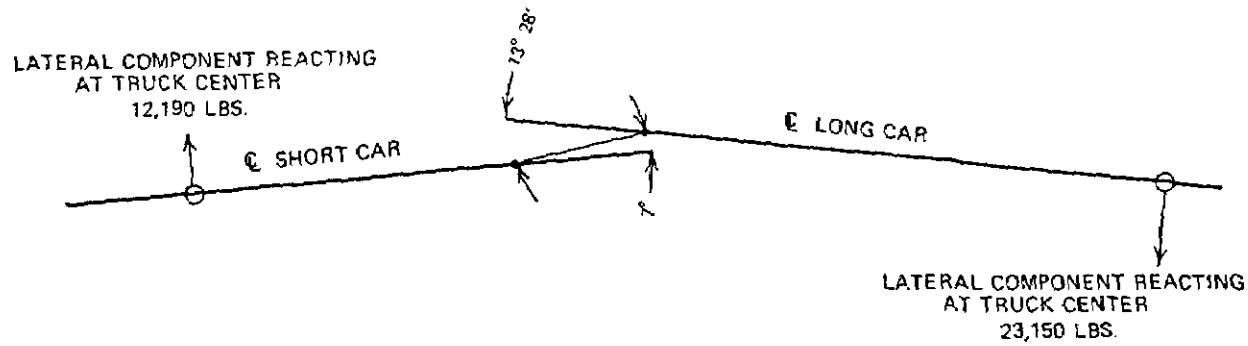
Figure 12.

Figure 12 illustrates the geometry of a long car - short car combination. Note the coupler angularity of the long car. It also illustrates the lateral forces produced by a 100,000 lb. drawbar force. When the coupler angle of the short car is 7 degrees the lateral force is 12,190 lbs. When the coupler angle is 13°28' the lateral force is 23,150 lbs.

Available research data has indicated that the lateral force produced by a drawbar reaction (draft) at a long car (89 ft in length, having a 43 inch coupler) approaches a maximum when coupled to a short car (50 ft. or less in length, having a 33 inch coupler).
