REPORT NO 3312  
LOUISVILLE AND NASHVILLE RAILROAD COMPANY  
IN RE ACCIDENT  
NEAR LONG BEACH, MISS., ON  
FEBRUARY 18, 1950

Date.	February 18, 1950
Railroad	Louisville and Nashville
Location	Long Beach, Miss.
Kind of accident:	Derailment
Train involved:	Passenger
Train number:	99
Engine number.	Diesel-electric units 777 and 775
Consist.	19 cars
Estimated speed	55 m. p. h.
Operation:	Timetable, train orders, automatic block-signal, cab-signal and train-stop systems
Track:	Single, tangent; level
Weather	Hazy
Time:	7 a. m
Casualties	32 injured
Cause.	Broken rail

Accident near Long Beach, Miss., on February 18, 1950,  
caused by a broken rail.

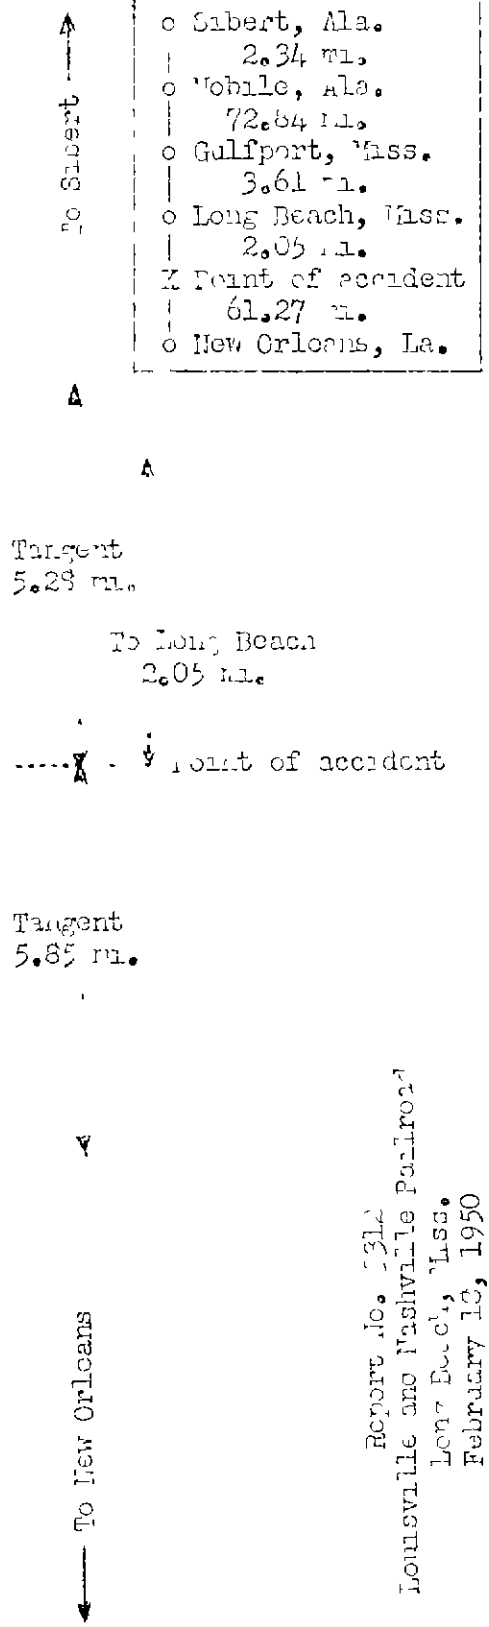
Report No. 1312  
 Louisville and Nashville Railroad  
 Long Beach, Miss.  
 February 10, 1950

o	Sibert, Ala.	2.34 mi.
o	Mobile, Ala.	72.84 mi.
o	Gulfport, Miss.	3.61 mi.
o	Long Beach, Miss.	2.05 mi.
Z	Point of accident	61.27 mi.
o	New Orleans, La.
