# NATIONAL TRANSPORTATION SAFETY BOARD

## ✓ RAILROAD ACCIDENT REPORT.

REAR END COLLISION OF METRO-DADE  
TRANSPORTATION ADMINISTRATION  
TRAINS NOS. 172-171 AND 141-142  
MIAMI, FLORIDA  
JUNE 26, 1985

✓✓  
NTSB/RAR-86/03.

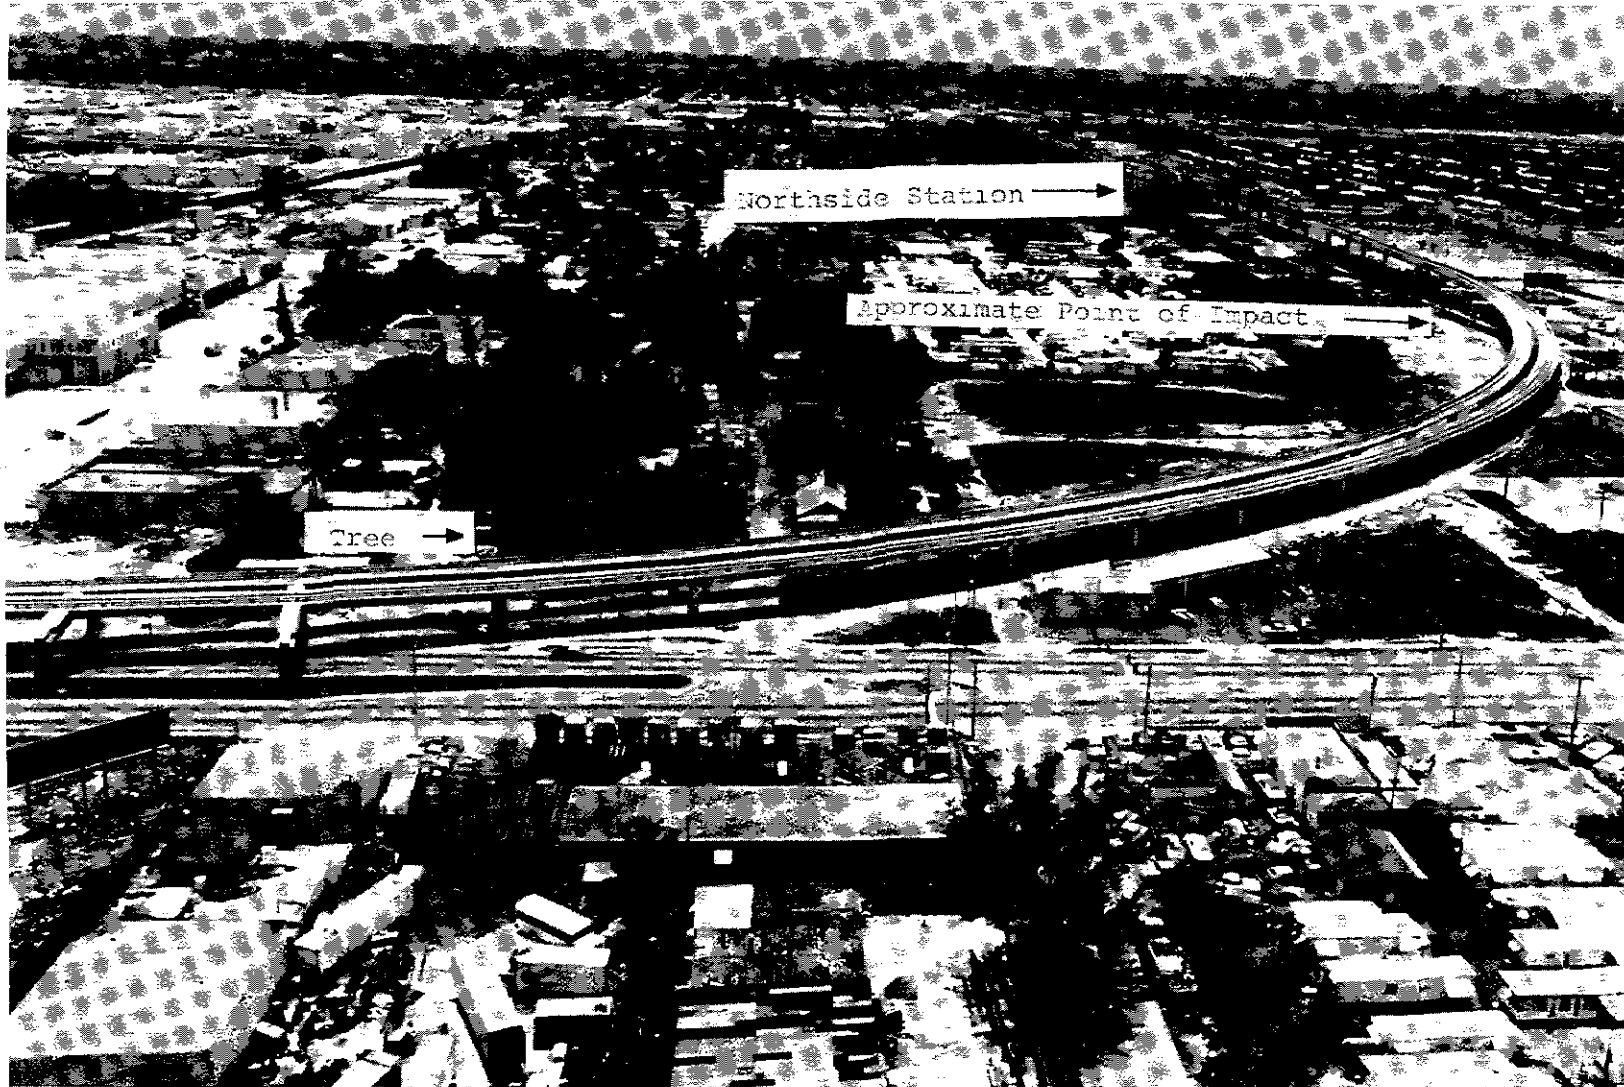
Figure 2.-- Accident site.

About 11:35 p.m., train No. 172-171 struck the rear of standing train No. 141-142, about 1,927 feet south of the Northside Station interlocking. Train No. 141-142 was moved forward about 68 feet, and train No. 172-171 moved about 52 feet beyond the point of impact. Slide marks found on the rails indicated that the front and rear truck wheels of car No. 171 were locked and sliding for 44 feet and 64 feet, respectively, before the impact. After initially contacting train No. 141-142, train No. 172-171 separated from car No. 142 and stopped about 20 feet from the rear of that car. (See figure 3.)

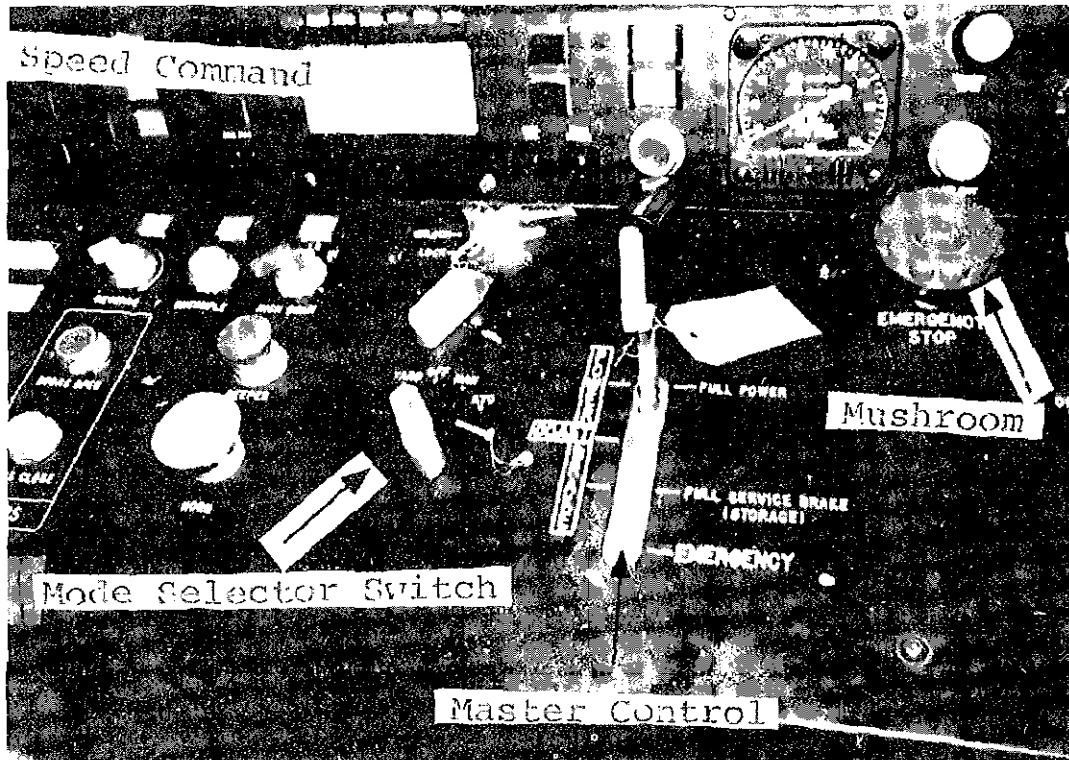
Figure 8.--Operator's console.

Modes of Operation-Equipment.--The MDTA equipment can be turned off or operated in three selectable modes. A selector switch enables the train operator to select either yard mode, manual mode, or automatic train operation mode (ATO). At the time of the accident, the ATO was not operational and trains were being operated in the manual mode. When the equipment is being operated in the manual mode with the ATP operative, the rail attendant controls the train's speed and braking by use of the master control handle. The train's maximum allowable speed is based on the speed commands displayed to the rail attendant on the operator's console. (See figure 8.)

When the ATP is operative, and the train is in the yard mode of operation, and a zero speed command is being displayed to the rail attendant on the operator's console, the train can only be operated at a maximum speed of 15 mph. If the ATP

is bypassed while the train is in the yard mode of operation, the speed is unlimited (except for equipment limitations). The equipment cannot be operated with the ATP bypassed unless it is in the yard mode of operation.
