RAILROAD ACCIDENT REPORT

DERAILMENT OF MISSOURI PACIFIC
RAILROAD COMPANY'S TRAIN 94 AT

Houston, Texas
October 19, 1971

NATIONAL TRANSPORTATION SAFETY BOARD
Washington, D. C. 20591
REPORT NUMBER: NTSB-RAR-72-6

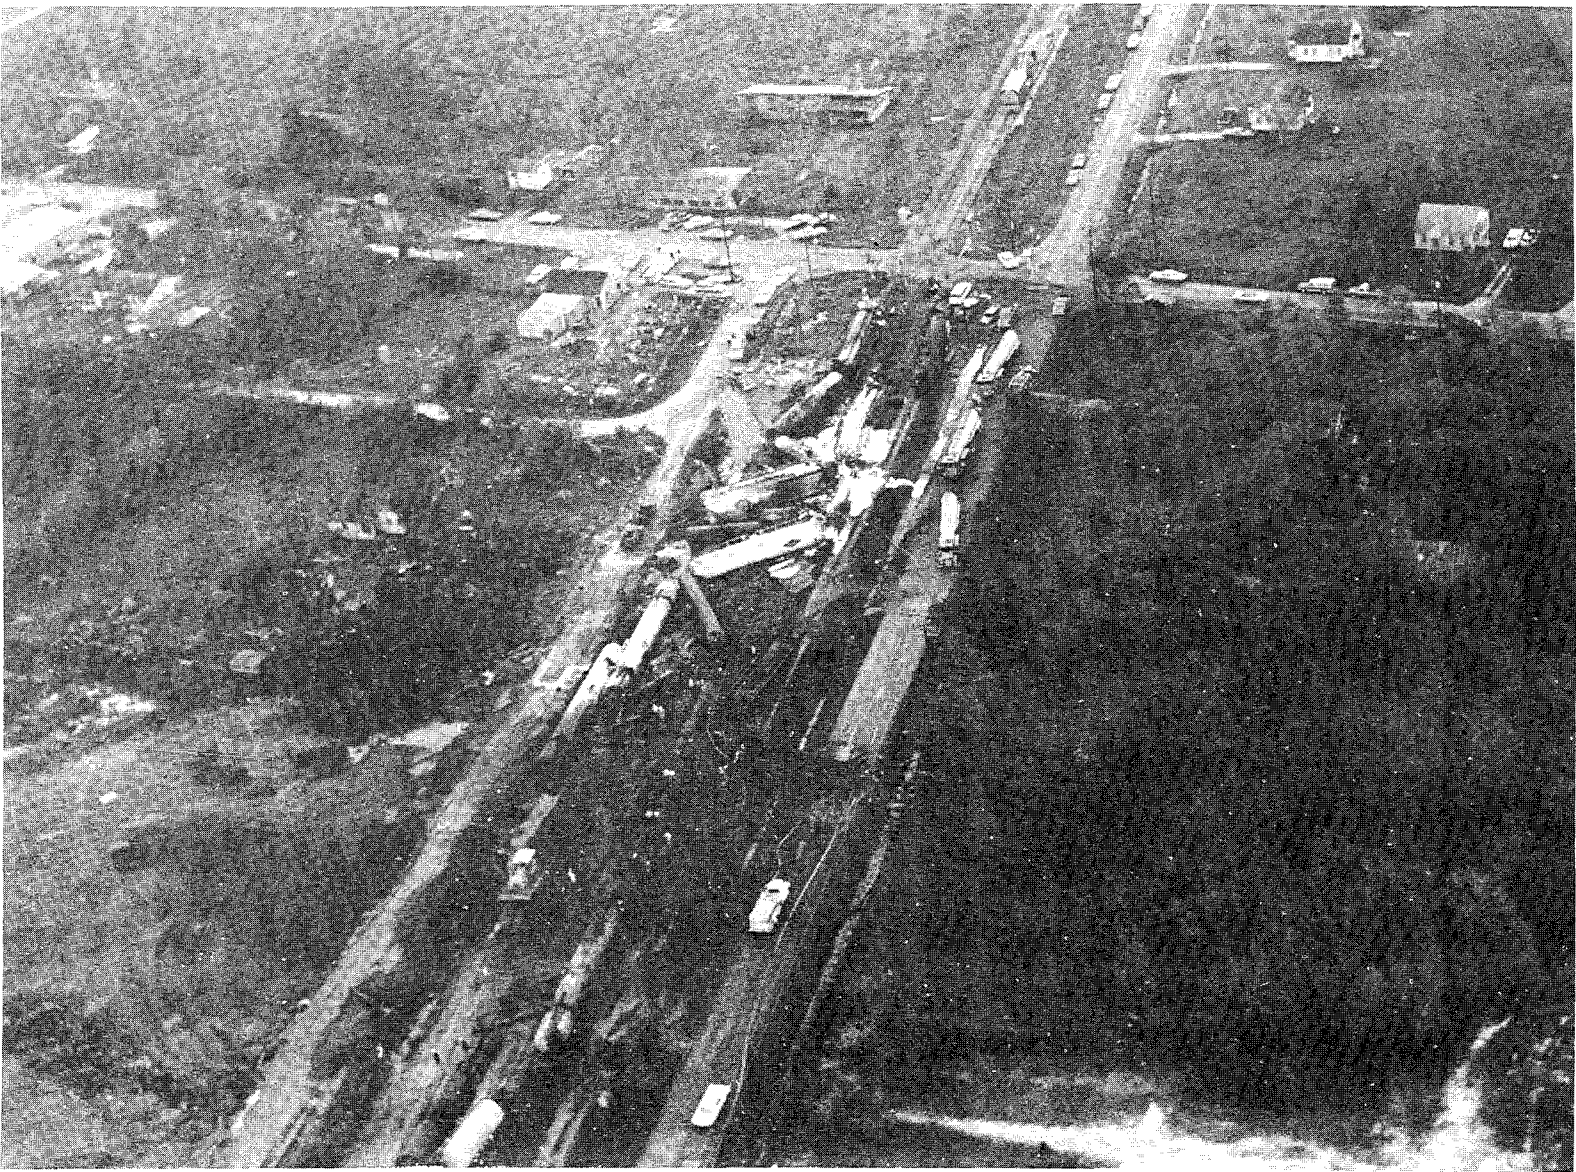
The population density in this area is light. Most of the buildings are adjacent to Alameda-Genoa Road, which intersects the Santa Fe's tracks just south of the accident site. Figures 1 and 2 show the general arrangement of tracks, roads, and other pertinent features in the vicinity of Mykawa.

Figure 1 and Appendix 4 show the configuration of the wreckage after the derailment. Appendix 3 provides information on the characteristics of the derailed cars and the commodities involved.
