RAILROAD ACCIDENT INVESTIGATION

Report No 3838

MISSOURI PACIFIC RAILROAD

JANUARY 22, 1959

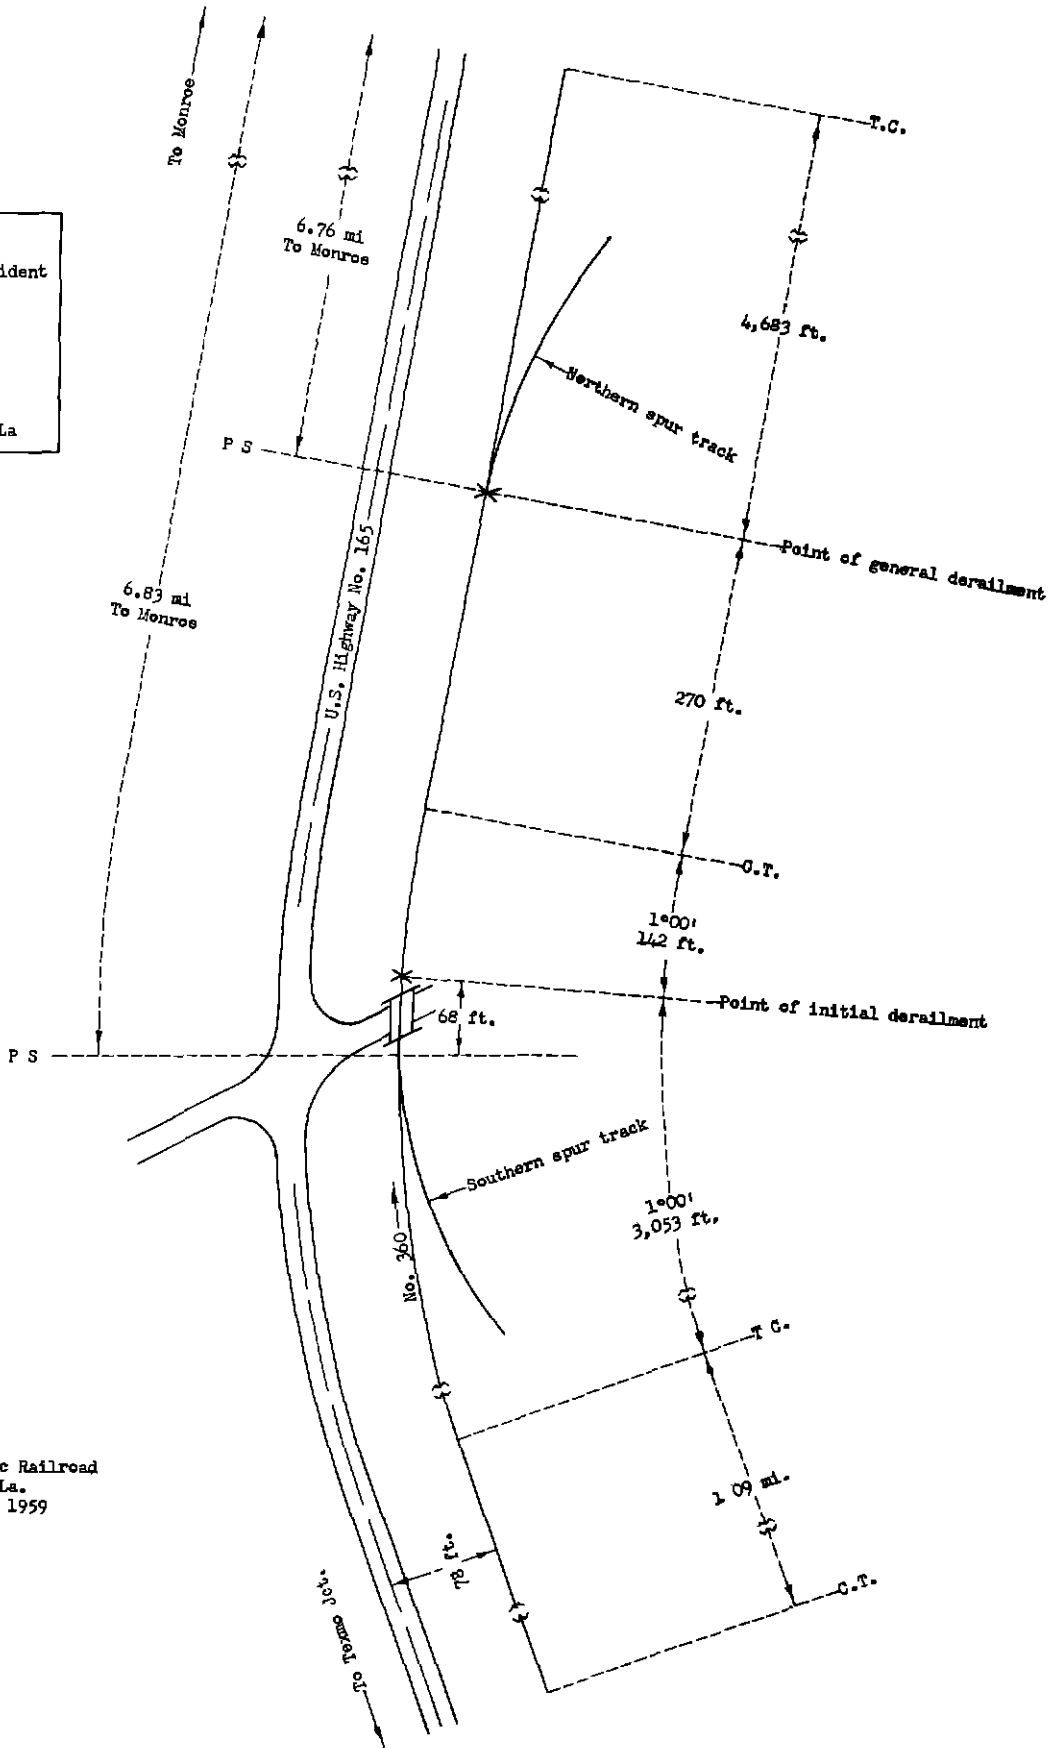
Missouri Pacific Railroad
 Monroe, La.
 January 22, 1959

- Monroe, La
6.82 mi.
- ✕ Point of accident
7.36 mi.
- Bosco
18.54 mi.
- Grayson
26.48 mi.
- Georgetown
36.19 mi.
- Texmo Jet, La

Location of Accident and Method of Operation
