NATIONAL TRANSPORTATION SAFETY BOARD

RAILROAD ACCIDENT REPORT

COLLISION AND DERAILMENT
OF MONTANA RAIL LINK FREIGHT TRAIN
WITH LOCOMOTIVE UNITS
AND HAZARDOUS MATERIALS RELEASE
HELENA, MONTANA
FEBRUARY 2, 1989

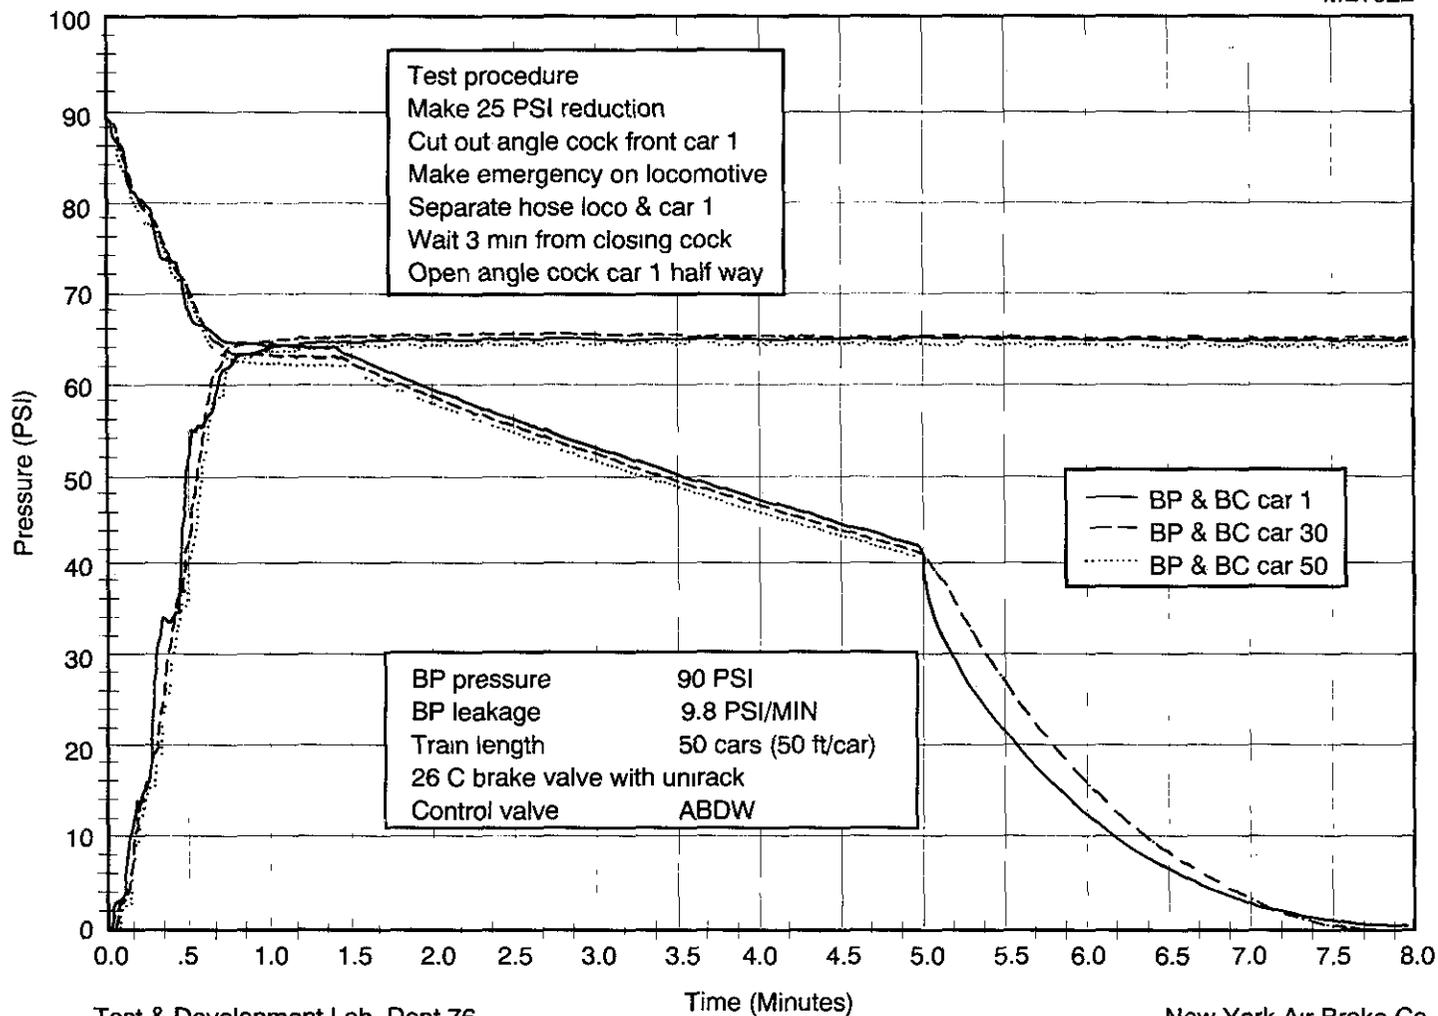
9/12/89
ML1022

Test procedure
 Make 25 PSI reduction
 Cut out angle cock front car 1
 Make emergency on locomotive
 Separate hose loco & car 1
 Wait 3 min from closing cock
 Open angle cock car 1 half way

BP & BC car 1
 BP & BC car 30
 BP & BC car 50

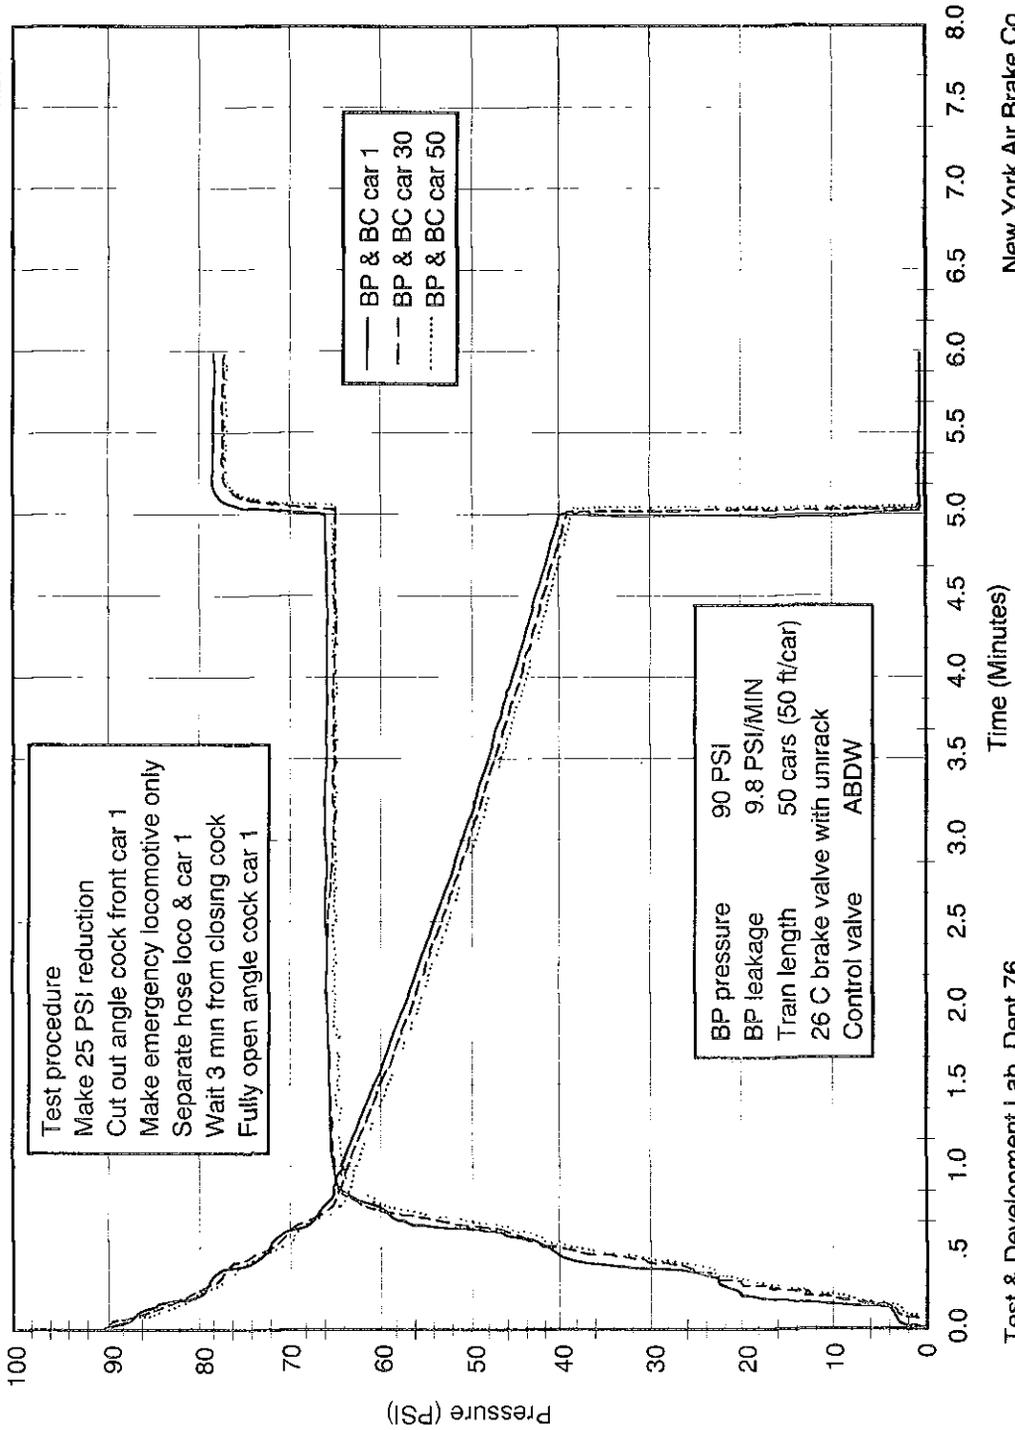
9/12/89
ML1023

Test procedure
Make 25 PSI reduction
Cut out angle cock front car 1
Make emergency locomotive only
Separate hose loco & car 1
Wait 3 min from closing cock
Fully open angle cock car 1

BP pressure 90 PSI
BP leakage 9.8 PSI/MIN
Train length 50 cars (50 ft/car)
26 C brake valve with unirack
Control valve ABDW
