NATIONAL TRANSPORTATION SAFETY BOARD

HEAD-ON COLLISION OF NATIONAL RAILROAD
PASSENGER CORPORATION (AMTRAK)
PASSENGER TRAINS NOS. 151 AND 168
ASTORIA, QUEENS, NEW YORK, NEW YORK
JULY 23, 1984

✓
NTSB/RAR-85/09.

RAILROAD ACCIDENT REPORT

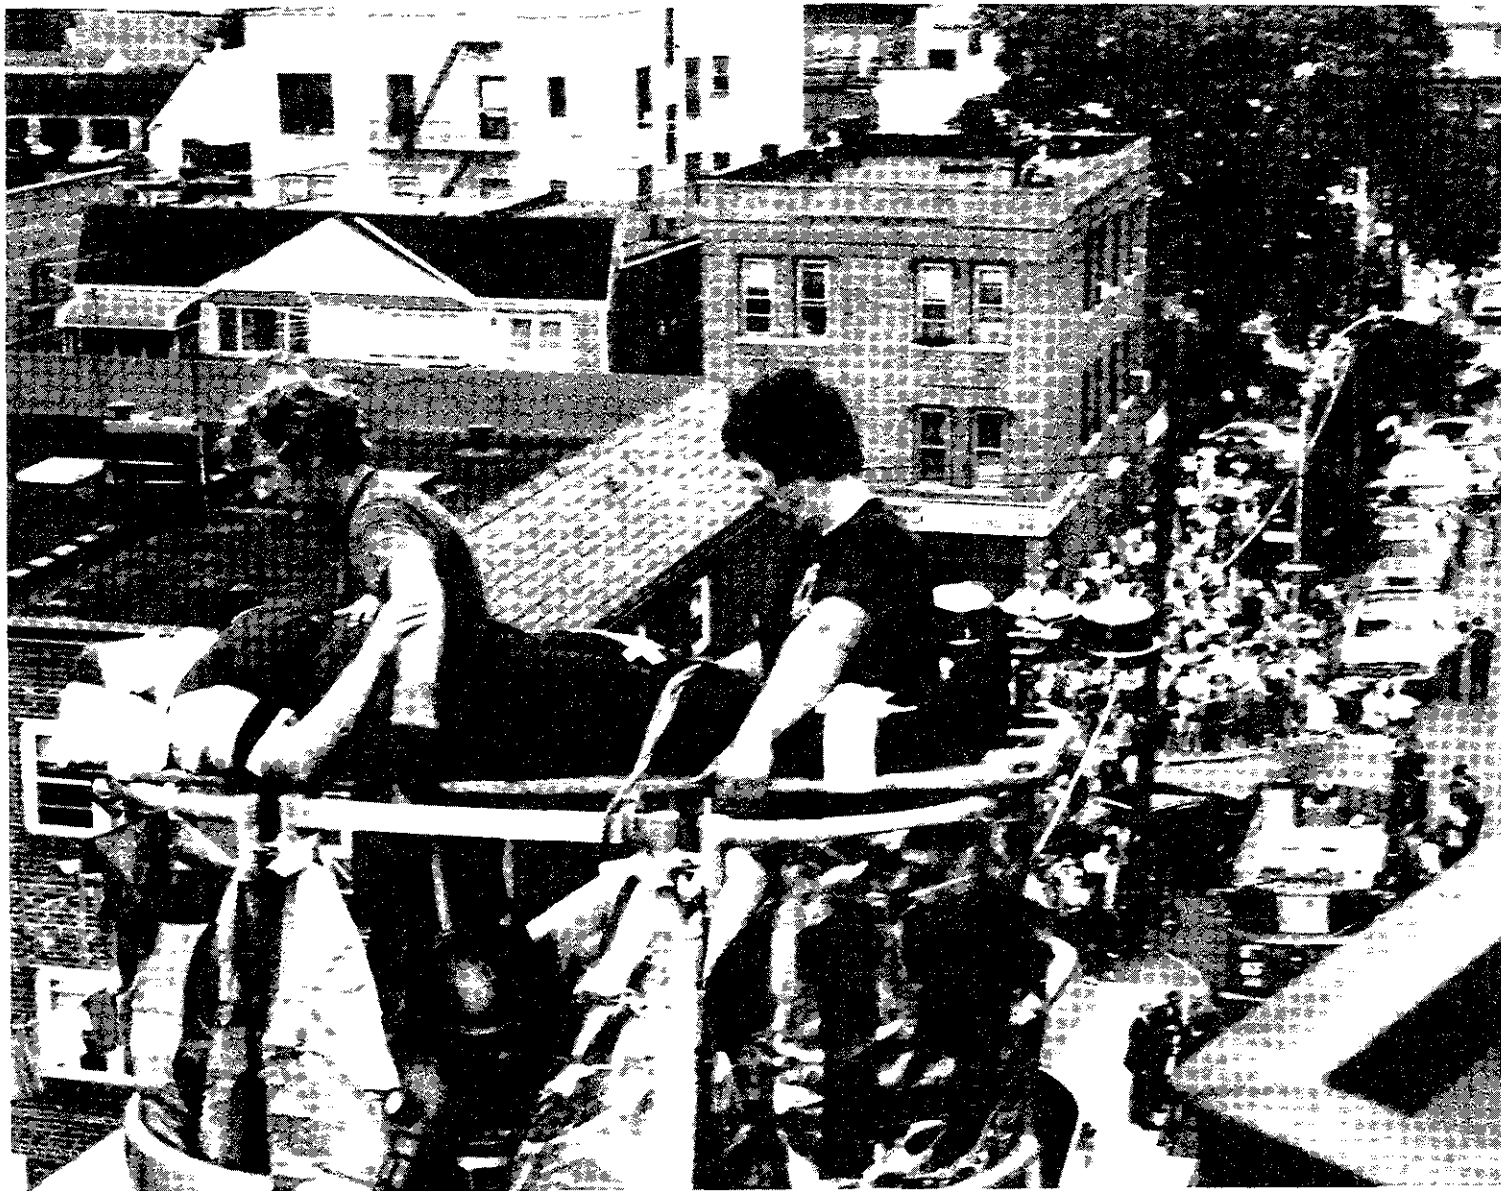
Emergency response personnel pooled their resources to facilitate the removal of injured passengers. In coaches with heavy end damage, windows were removed and passengers were taken out through the window openings. There was no difficulty reported in removing the windows. Some passengers were lowered to the street using "cherry pickers" (see figure 11) and tower ladders. Three triage ^{20/} centers were established

Figure 11.--Injured passengers being removed from the 80-foot viaduct by rescue workers.

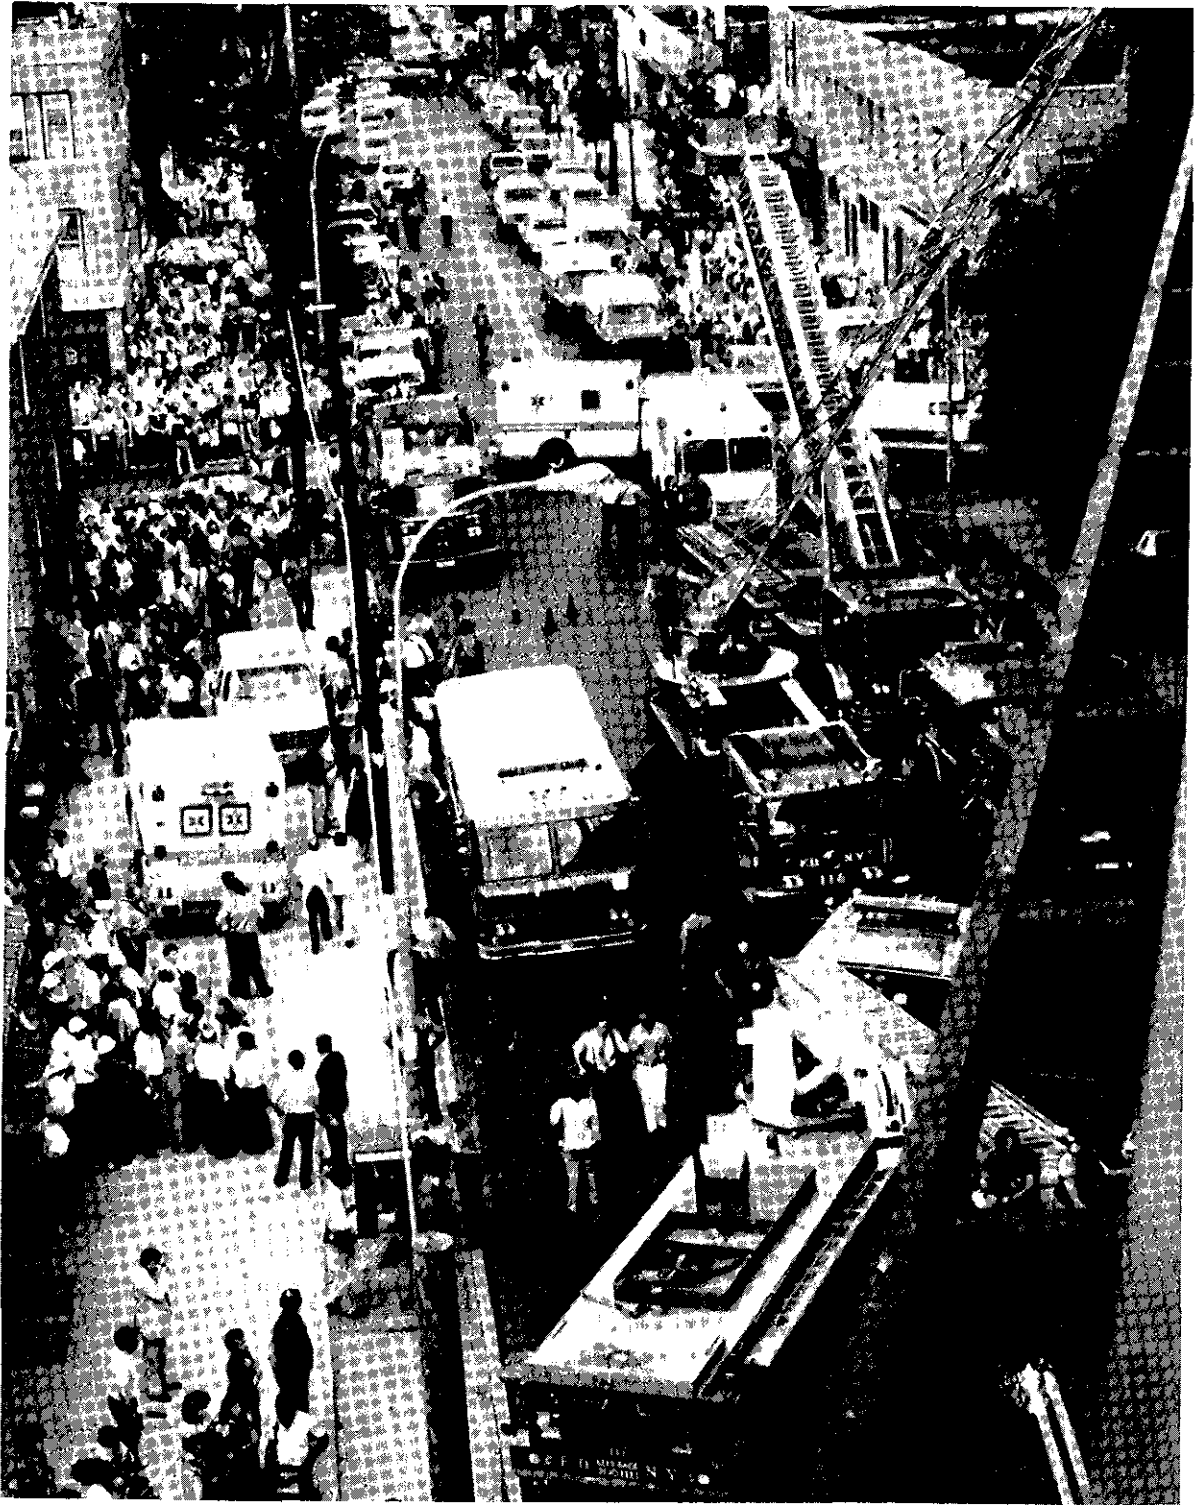
At the time of the accident, there was no formal disaster plan in effect between Amtrak and the New York emergency forces. Rescue efforts were hindered because some emergency response personnel carelessly parked and abandoned their vehicles, creating confusion in the streets below the wrecked trains. (See figure 12.) Also, emergency personnel were unfamiliar with Amtrak's catenary and power distribution system. Power was removed from the catenary system about 11 a.m. and restored over part of the impact area about 12:45 p.m. Power restoration and passenger removal was delayed because the Fire Department would not permit the restoration of catenary power until the request for restoral had been channeled through and approved by the Borough Alarm office. Both Amtrak and the Fire Department procedures require that the restoral of catenary power only be authorized by the same individual who asked for its removal.

Figure 12.--Street scene below the viaduct at the accident site.
