RAILROAD ACCIDENT REPORT

DERAILMENT OF
NATIONAL RAILROAD PASSENGER CORPORATION
TRAIN 7
ON BURLINGTON NORTHERN RAILROAD
NEAR SACO, MONTANA
AUGUST 5, 1988

NTSB/RAR-89/03

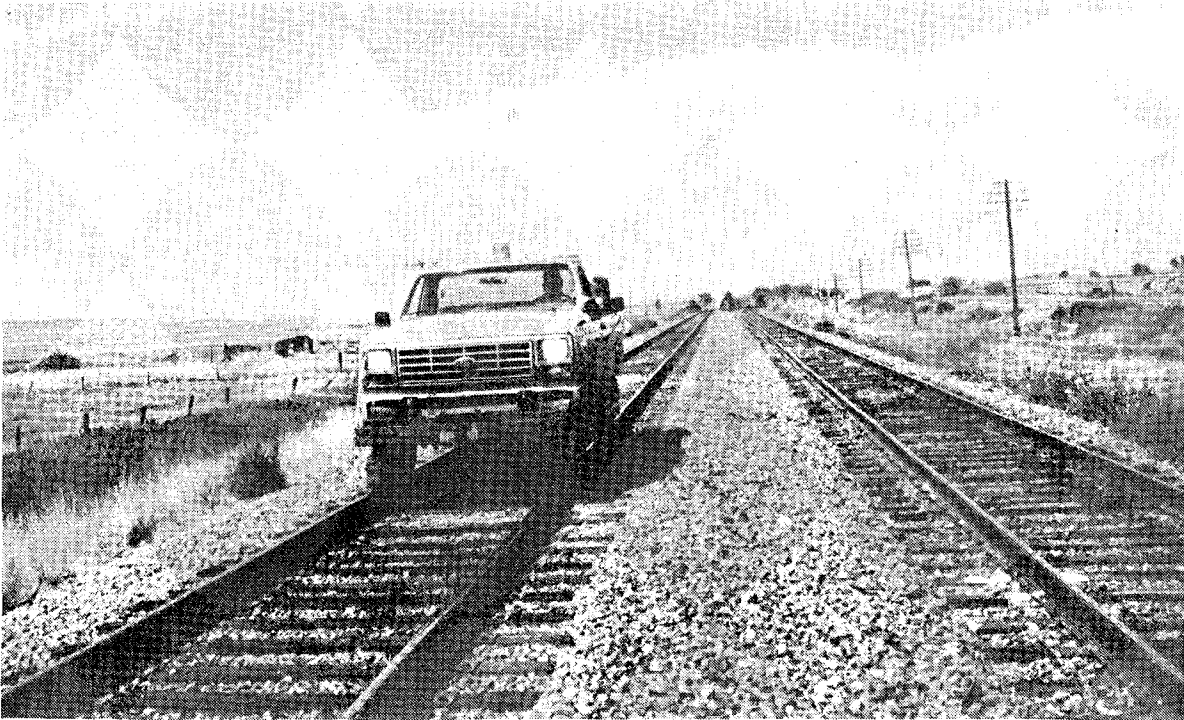
Figure 1.--Track inspector in high-rail vehicle near mp 317

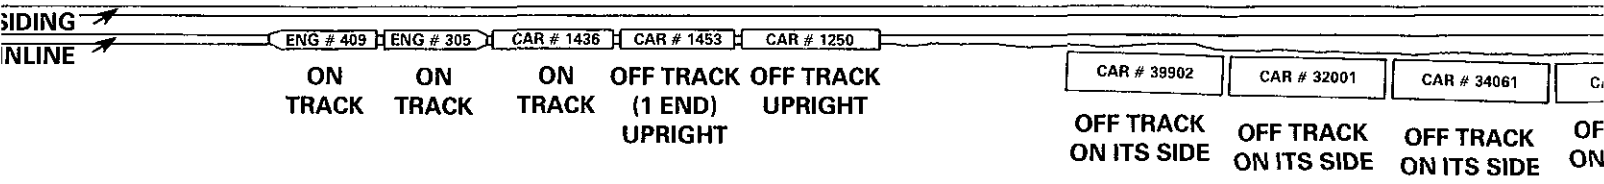
About 4 to 5 seconds later, the locomotive entered the area of the sun kinked track and began to rock violently from side to side. Both engine crewmembers were thrown about the control compartment; however, the locomotive did not derail. The dormitory/coach, a sleeper, two coaches, and the diner overturned onto their sides; the lounge car came to rest listing at about a 45° angle. The baggage/coach car, a sleeper car, a coach car, the second baggage car, and the trailing end of the first baggage car derailed upright. The derailed equipment came to a rest approximately parallel to the track structure. (See figure 3.)

Figure 3. - - Plan view of a

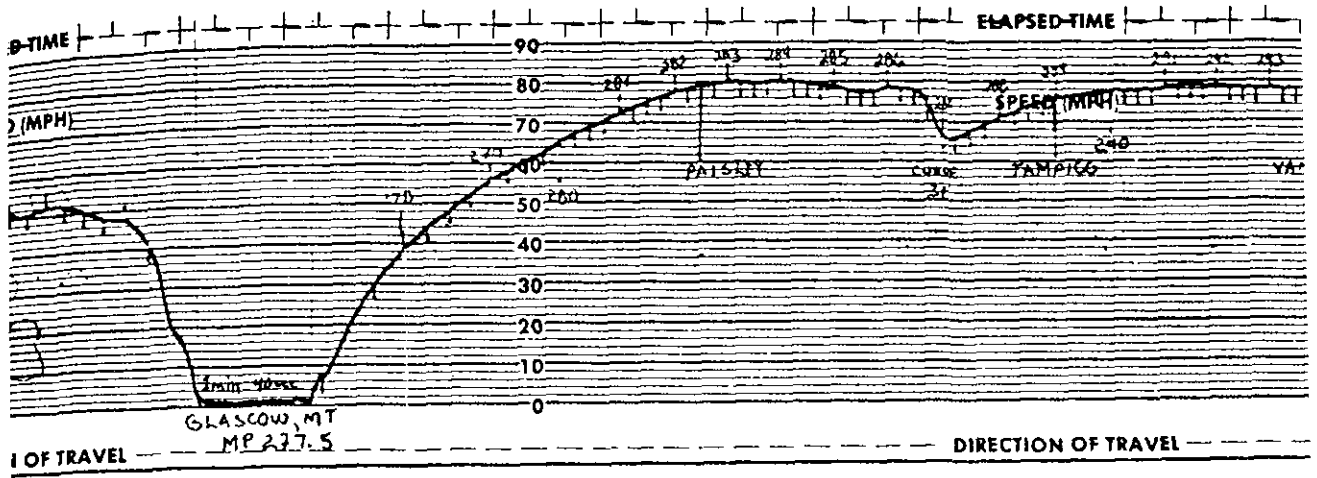
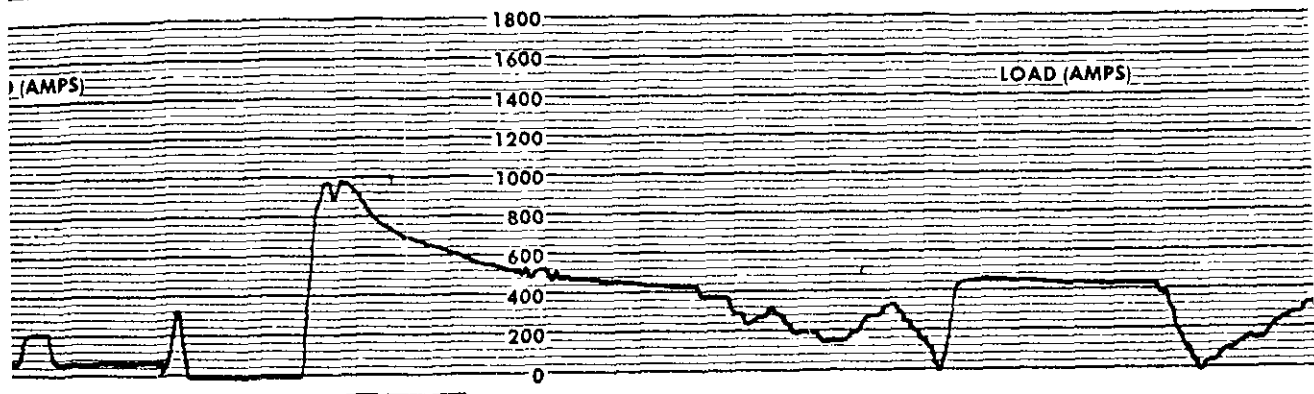
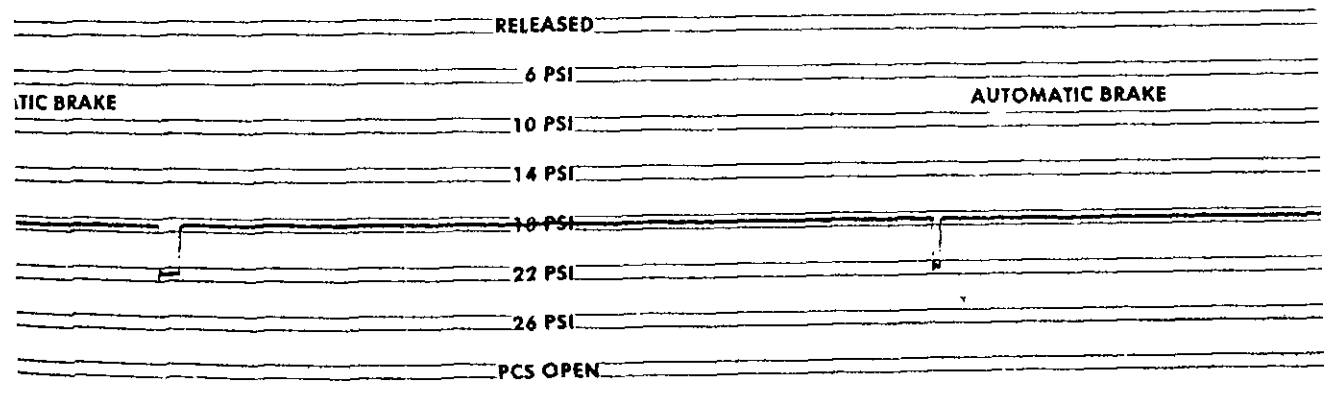
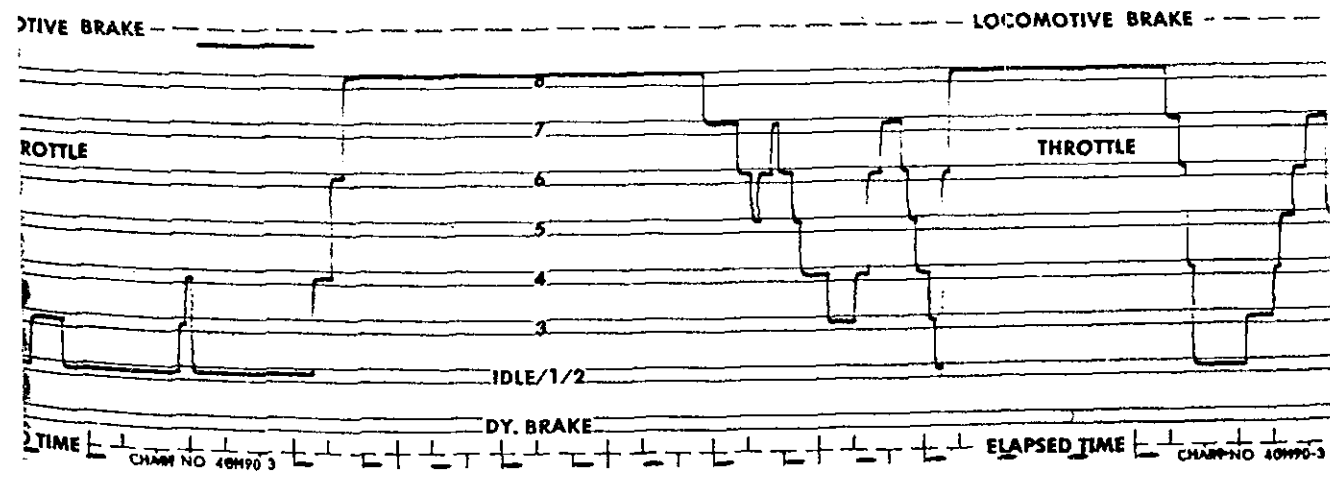
The multi-event recorder cassette was removed from AMT 409 at 5:10 p.m. on August 5 by a BN operating officer while the locomotive was still at the accident site. (See appendix D.) BN personnel used a Pulse Electronics, Inc., desk-top playback system to prepare a paper printout from the information contained in the cassette. (See figure 4.) The printout indicated a continuous 18-psi automatic air brake application with further reductions to 22 psi. The cassette was taken to the Safety Board's laboratory to determine why the brake pipe reduction did not appear to correspond with the other data recorded at the same time on the cassette. Before beginning any detailed laboratory analysis of the cassette, the Safety Board prepared a paper printout using a Pulse Electronics, Inc., playback system similar to that used by the BN. The brake pipe reduction did not appear in the Safety Board's printout. (See figure 5.)

Figure 4. - - BN p

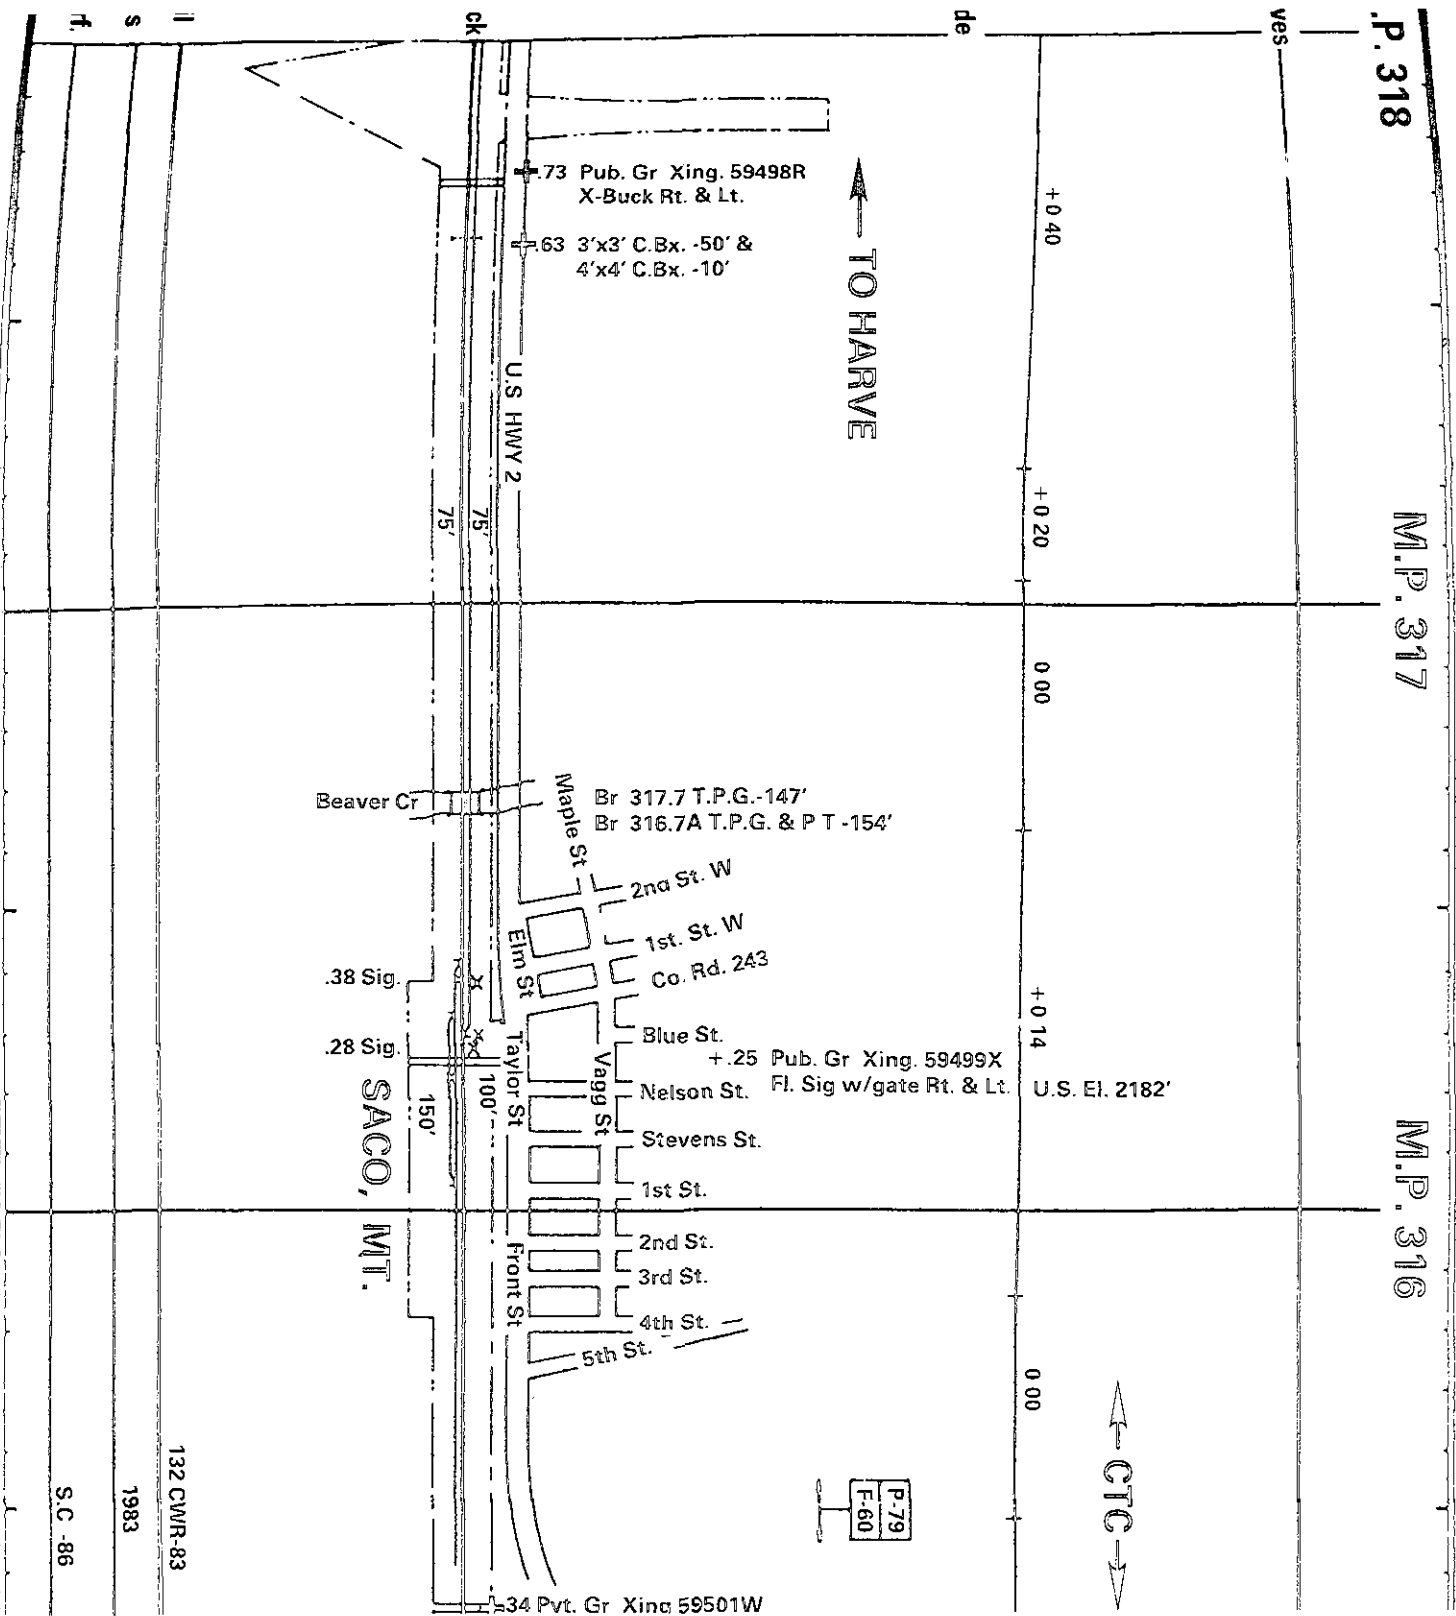
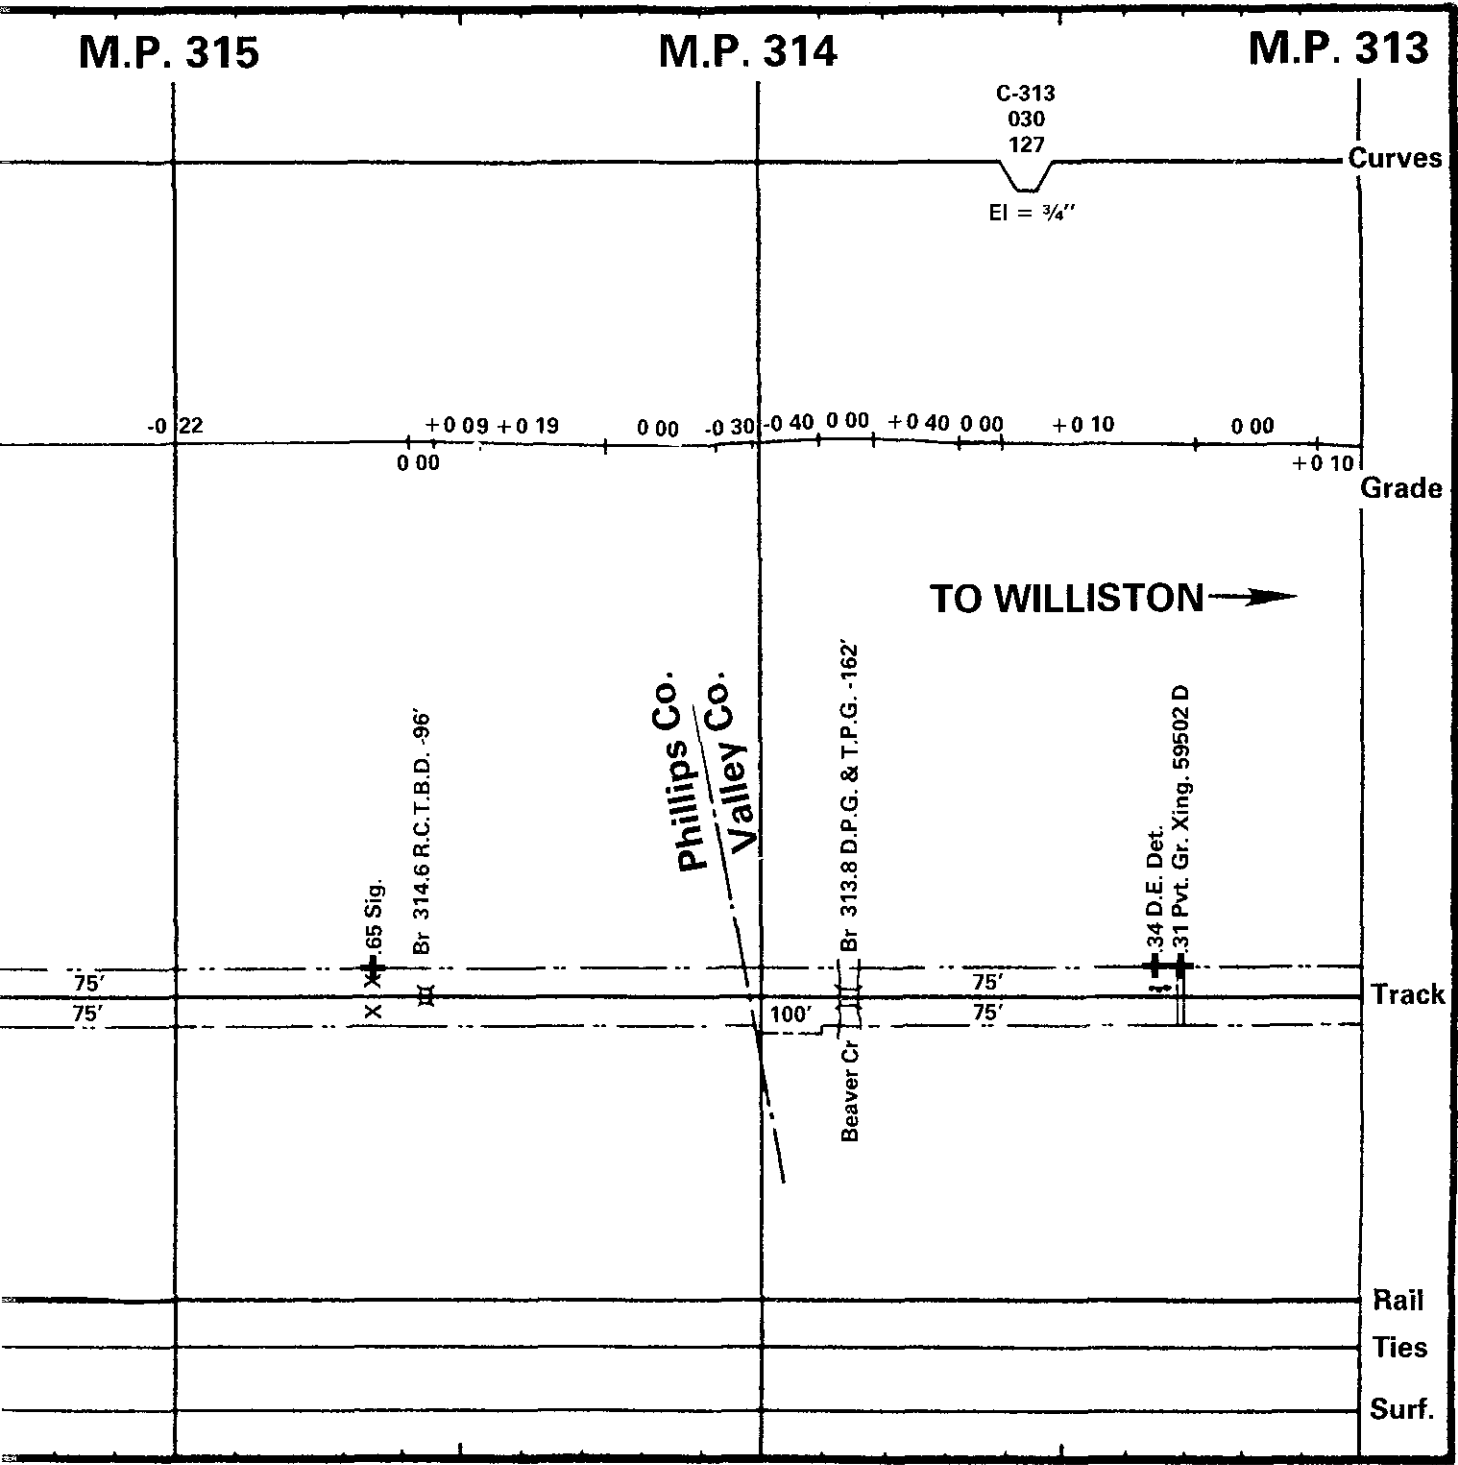
General.--Train 7 derailed on BN's Montana Division, First Subdivision, in the area of mp 316.94. The track structure in the accident area consists of a single main track and a single passing track. (See figure 9.)

Figure 9. - - BN consoli

9
lated track chart.

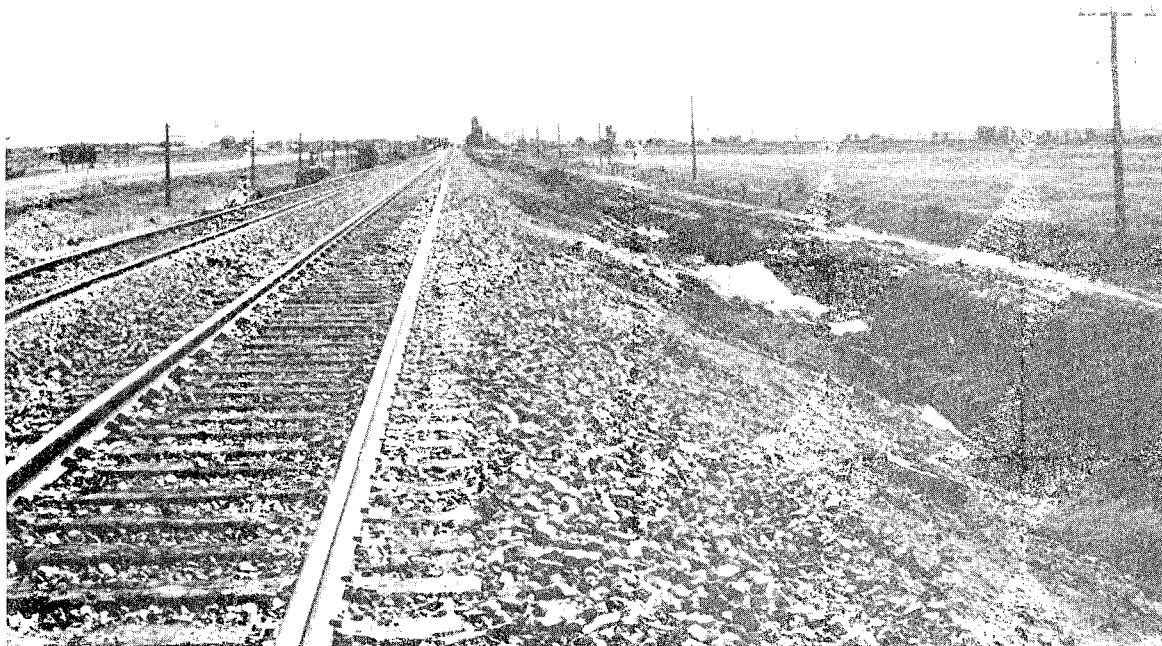
Figure 10.--Eastward view of accident site after track restoration
