RAILROAD ACCIDENT INVESTIGATION

Report No. 4115

THE NEW YORK CENTRAL RAILROAD COMPANY

HARBOR CREEK (CP 79), PA.

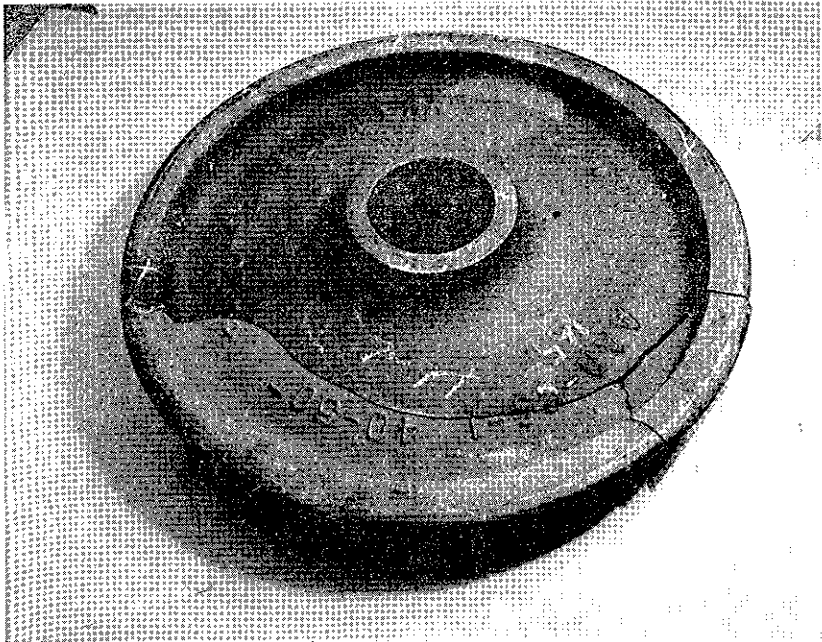
Examination of the equipment of No 23 after the accident disclosed that a large section of the front wheel on the north side of the front truck of the 31st car, a baggage-express car, was broken (see photos). Two large pieces of the broken off section of the wheel were found on the north side of track No. 1, 1.2 miles east of the initial derailment point. One of the pieces was $34\frac{1}{2}$ inches in length along the flange and $6\text{-}\frac{3}{8}$ inches deep through the flange and rim, and into the plate. The other piece was about 8 inches in length along the flange and $4\text{-}\frac{3}{8}$ inches deep. That part of the broken wheel remaining on the axle disclosed no evidence of the wheel having been loose or having turned on the axle wheel seat. Flange and tread wear were within limits of wear prescribed by standards of the Association of American Railroads. There was no evidence of slid flat wheels.

Laboratory analysis of the broken wheel disclosed that the steel met the chemical requirements of AAR Specification M-208-66 for cast carbon steel wheels. It also disclosed that the rim of the wheel had been overheated due to braking action and that there were numerous thermal cracks in the tread. At one end of a broken off piece, a progressive fracture, $\frac{7}{8}$ inch wide and $1\text{-}\frac{3}{4}$ inches long, appeared in the plate and rim. It originated at a thermal crack in the outer tread. Adjacent to the progressive fracture, a secondary fracture consisting of both old and new break, 1 inch wide and 3 inches long, also appeared in the rim and plate. It also originated at a crack in the outer tread and progressed into the rim and plate.

It is evident that the accident was caused by a broken wheel of the 31st car of No. 23, resulting in derailment of this car and following cars and derailed equipment fouling the adjacent main track immediately in front of an approaching freight train

Front wheel on north side of
front truck of 31st car
