RAILROAD ACCIDENT REPORT

DERAILMENT OF
NEW YORK CITY TRANSIT AUTHORITY
SUBWAY TRAIN
DEKALB AVENUE STATION
BROOKLYN, NEW YORK
MAY 15, 1985

NTSB/RAR-86/01

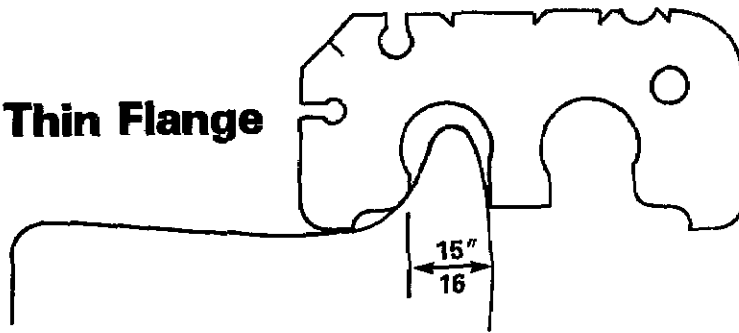
Thin Flange

When rail wheels are inspected, the flange of the wheel is checked to determine if, through wear, it is thin, vertical, or high. (See figure 5.) The NYCTA has no minimum height requirements for a wheel flange nor a minimum radius that has to be maintained for it to continue in service.

Figure 5.--Gauging of wheels when inspected.
