# NATIONAL TRANSPORTATION SAFETY BOARD

## RAILROAD ACCIDENT REPORT

**DERAILMENT OF  
NEW YORK CITY TRANSIT AUTHORITY  
SUBWAY TRAIN  
NEW YORK, NEW YORK  
DECEMBER 12, 1978**

NTSB-RAR-79-8

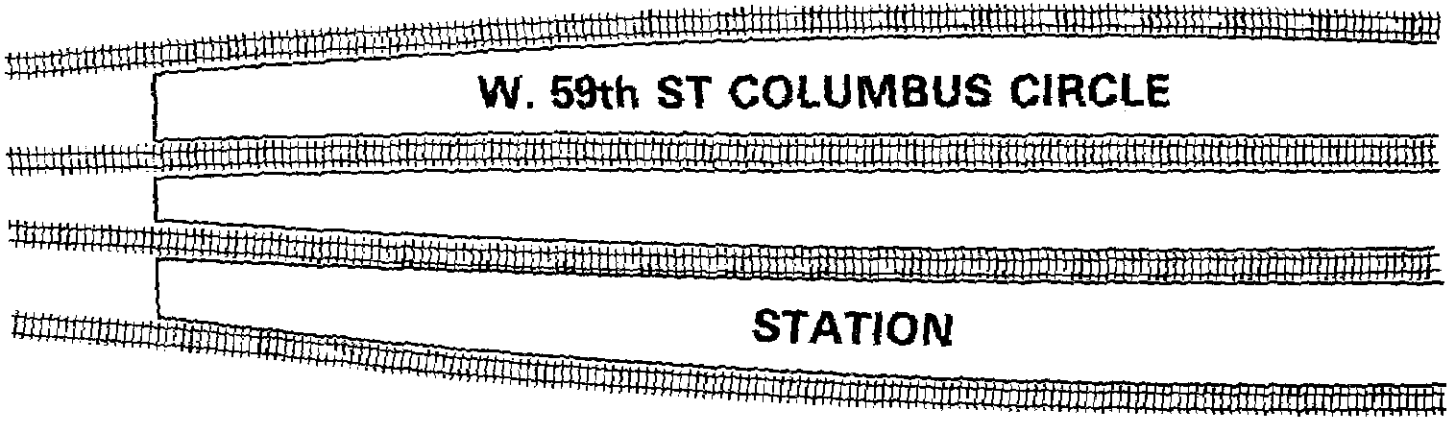
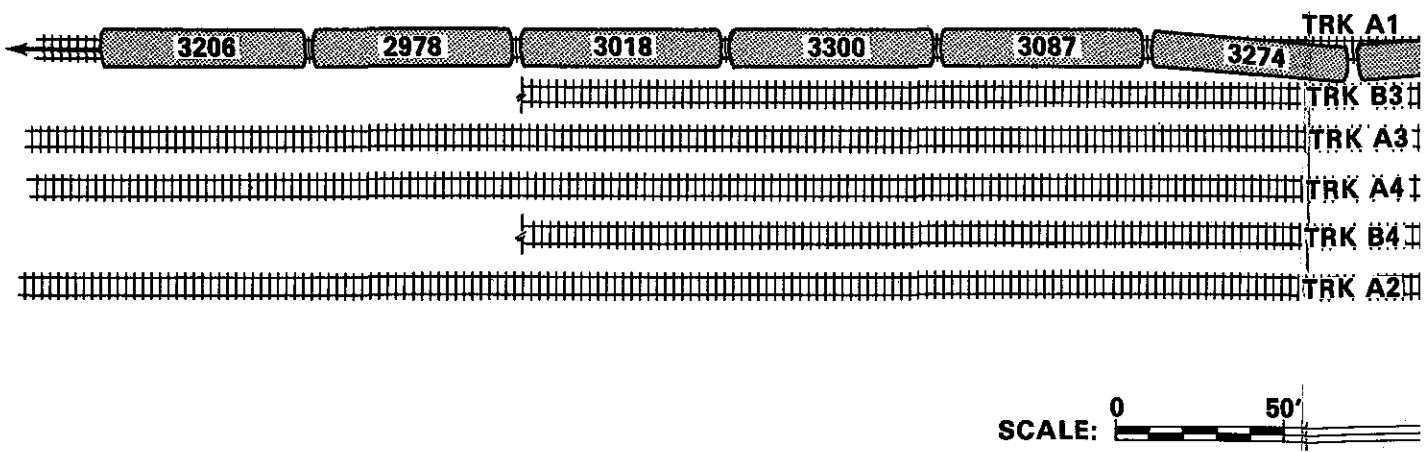
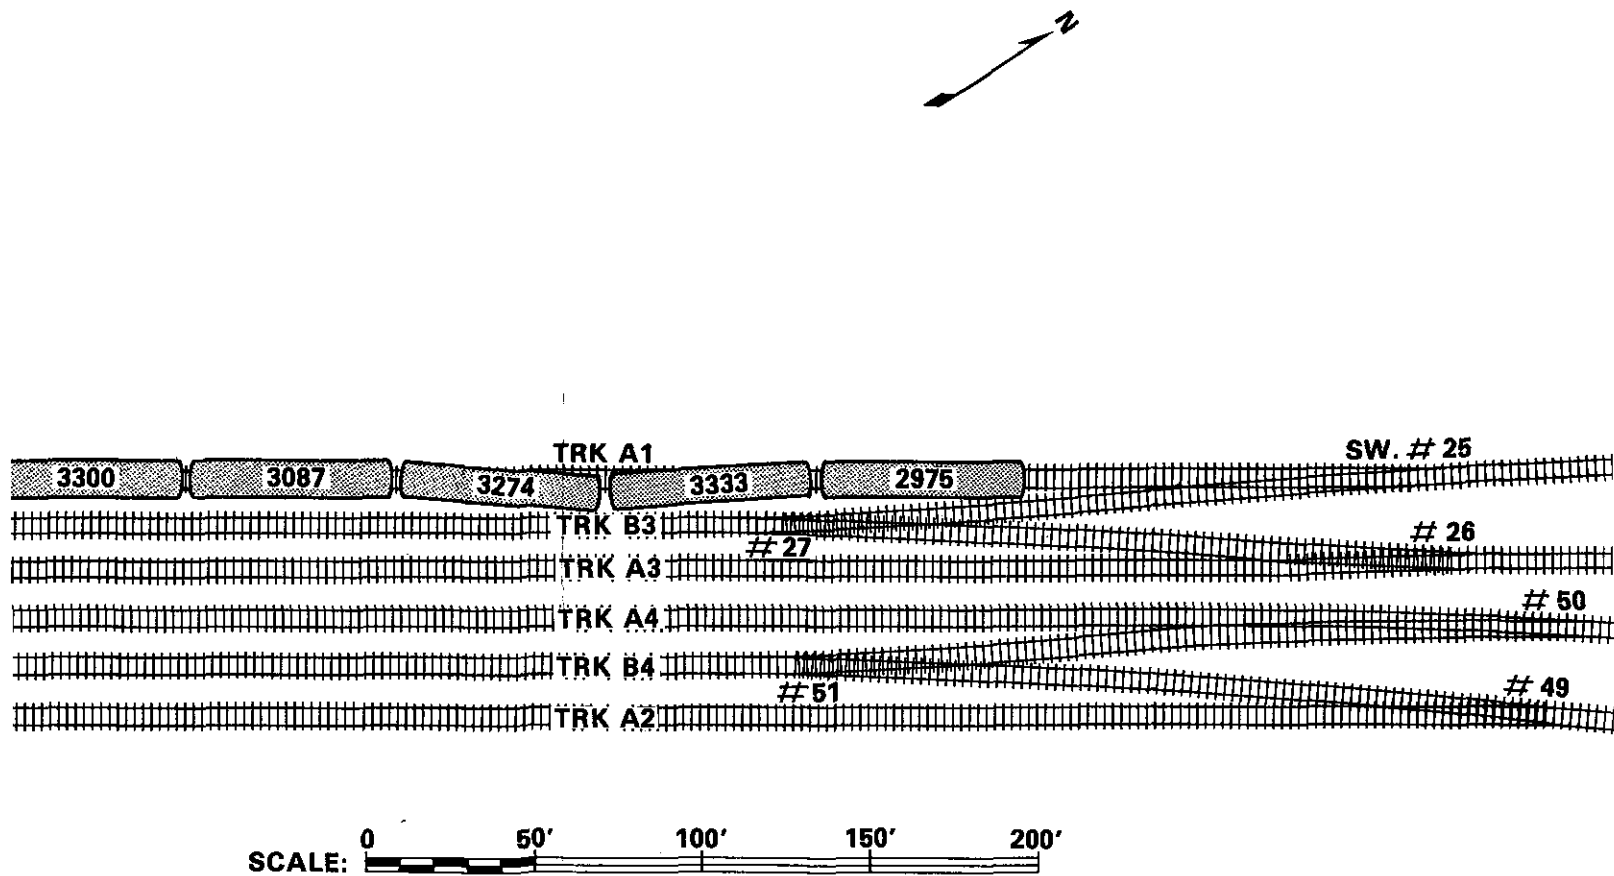
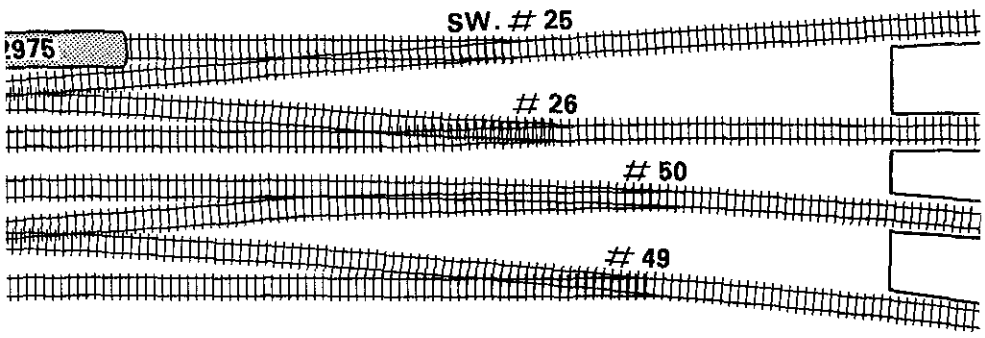
**FIGURE 1. PLAN OF DERAILMENT — COLLISION AREA.**

The derailment of December 12, 1978, occurred at a crossover switch 120 feet south of the 59th Street station platform. The train was operating on the track designated as A1, which is the most westward track of six tracks which are numbered from west to east A1, B3, A3, A4, B2 and A2. (See figure 1.) There is also a series of crossovers that connect the six tracks. An opening in the curtain wall between tracks A3 and B3 is provided to permit the tracks to converge. Beyond the crossovers the curtain wall is used to separate tracks and to protect a line of columns that support 8th Avenue and 57th Street. The curtain wall was constructed of fabricated H-beams using 3-inch by 3-inch by 1/4-inch angle iron and 1/4-inch flat plate riveted together and secured to a concrete base at the bottom. Six-inch-thick concrete was used between the H-beams to form the wall.
