PB90-916301
NTSB/RAR-90/01

RAILROAD ACCIDENT REPORT

**REAR-END COLLISION OF TWO
NEW YORK CITY TRANSIT AUTHORITY TRAINS
103RD STREET STATION
NEW YORK, NEW YORK
MARCH 10, 1989**

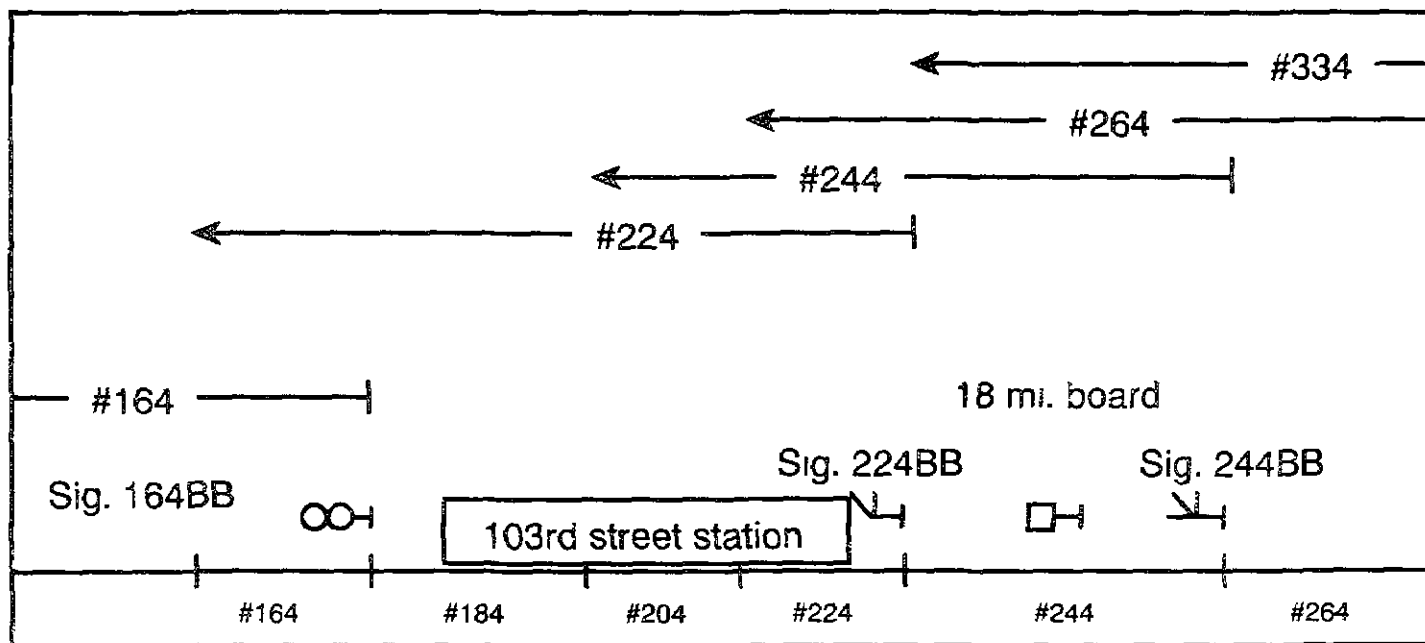
Figure 4.-- Track Circuits in 103rd Street Station.

The NYCTA uses a train control system with an automatic block signal system to direct the movements of trains. The signal system includes a three-color light displaying green, which indicates clear; or yellow, which indicates approach; or red, which indicates stop. The signal system constructed in 1912 is designed so that generally, the two signals immediately behind a train display red and the third signal behind a train displays yellow (see figure 3). There are three track circuits for track 1 in the 103rd Street Station; track circuit 184, which is 157 feet long, track circuit 204, which is 214 feet in length, and track circuit 224 which is 196 feet long. The station platform is about 500 feet in length. At the 103rd Street Station, the three block protection (two red signals and one yellow signal) is not always provided. When a train enters the 103rd Street Station, track circuit 224 will provide the three block protection as described and if the train proceeds into the track circuit 204 or overlaps from 204 into 244 the system is designed to still provided the three block protection. However, if the train moves into track circuit 184 and does not overlap into 204 the system is designed so that signal 224 at the entrance to the station will remain red, but signal 244 will be yellow, providing only a two block protection (see figure 4). Train 3A was completely within track circuit 204 at the time of the accident.

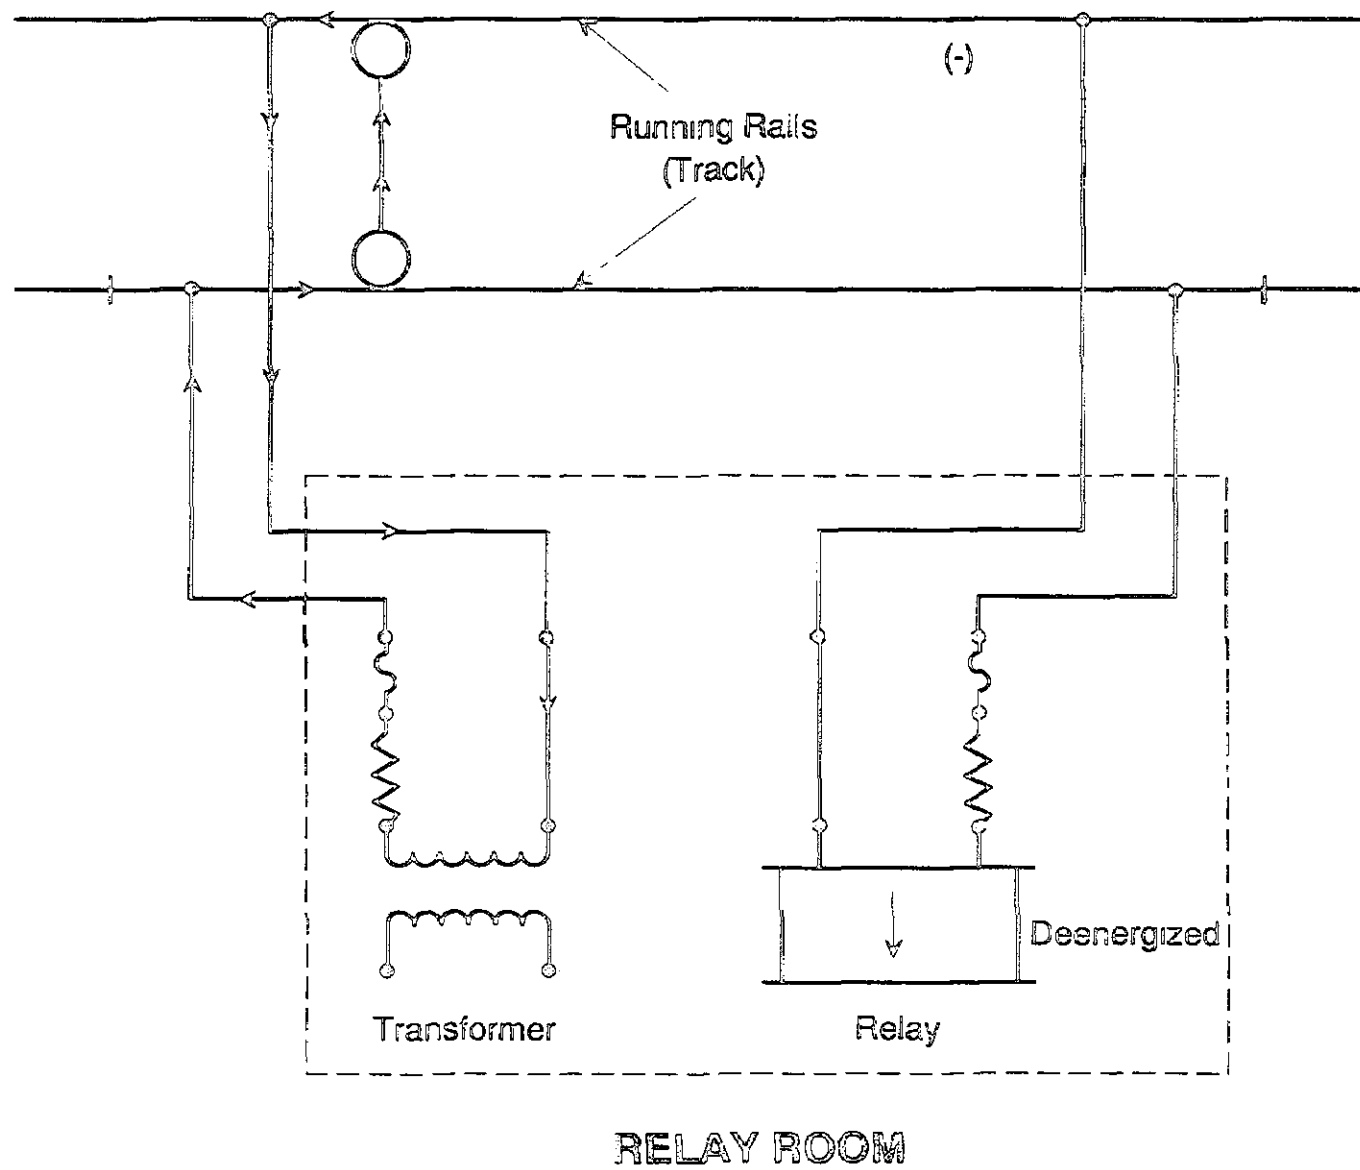
Figure 6.-- Track Circuit Shunting.

The track circuits are designed so that when a track circuit is unoccupied, current flows from the transformer through a resistor, a fuse and electrical wire to the positive (signal) rail, then through electrical wire, a fuse, a resistor, and a relay to the negative (propulsion) rail, and then again through electrical wire to the transformer; much of electrical wire is routed through the concrete inverts which support the tracks. When the relay is energized the signal system will display a clear indication (see figure 5). When a set of wheels are on the rail, the track circuit is shunted. Thus, current will not flow to energize the relay and the signal system will display a stop indication (see figure 6).

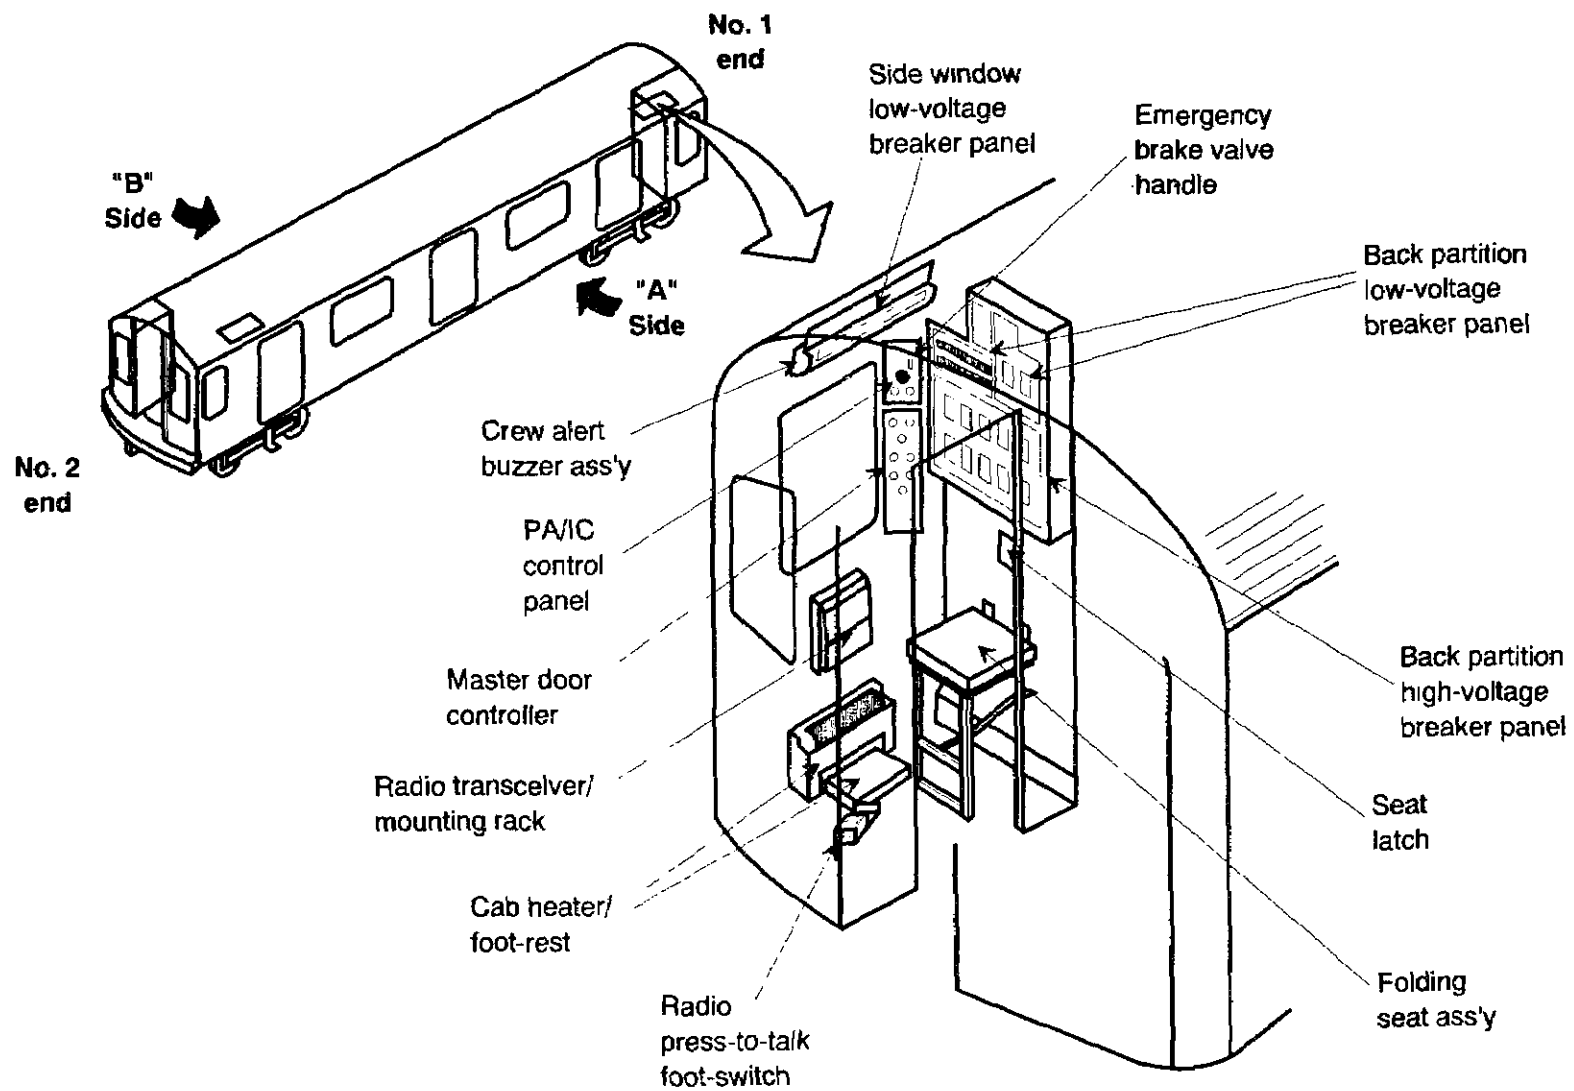
Figure 10.--Operating Cab Configuration.

Each car is equipped with an operating cab at each end. The R-62A car is designed with hinged doors and partitions so that the operator's compartment can extend across the entire width of the end of the car or across only the right portion of the end of the car (with the leading edge of the door forward and the full length door hinge at the trailing end). NYCTA does not operate the cars with the full front cab configuration but instead uses only the portion of the cab area on the right side of the car and requires that train operators close the cab door (see figure 10). This NYCTA arrangement allows more passenger seating in the area opposite the train operator's cab. The operating cab contains a brake valve and a master controller. The brake system uses both dynamic and electropneumatic blended braking and is controlled by the train operator with the brake handle. The propulsion master controller regulates the speed of the train and its handle must be kept depressed while the train is moving under power; otherwise, the "deadman" feature will apply the emergency brakes. The operating cab has a train operator's side door master controller; the opposite cab side is also equipped with a door master controller (see figure 10).

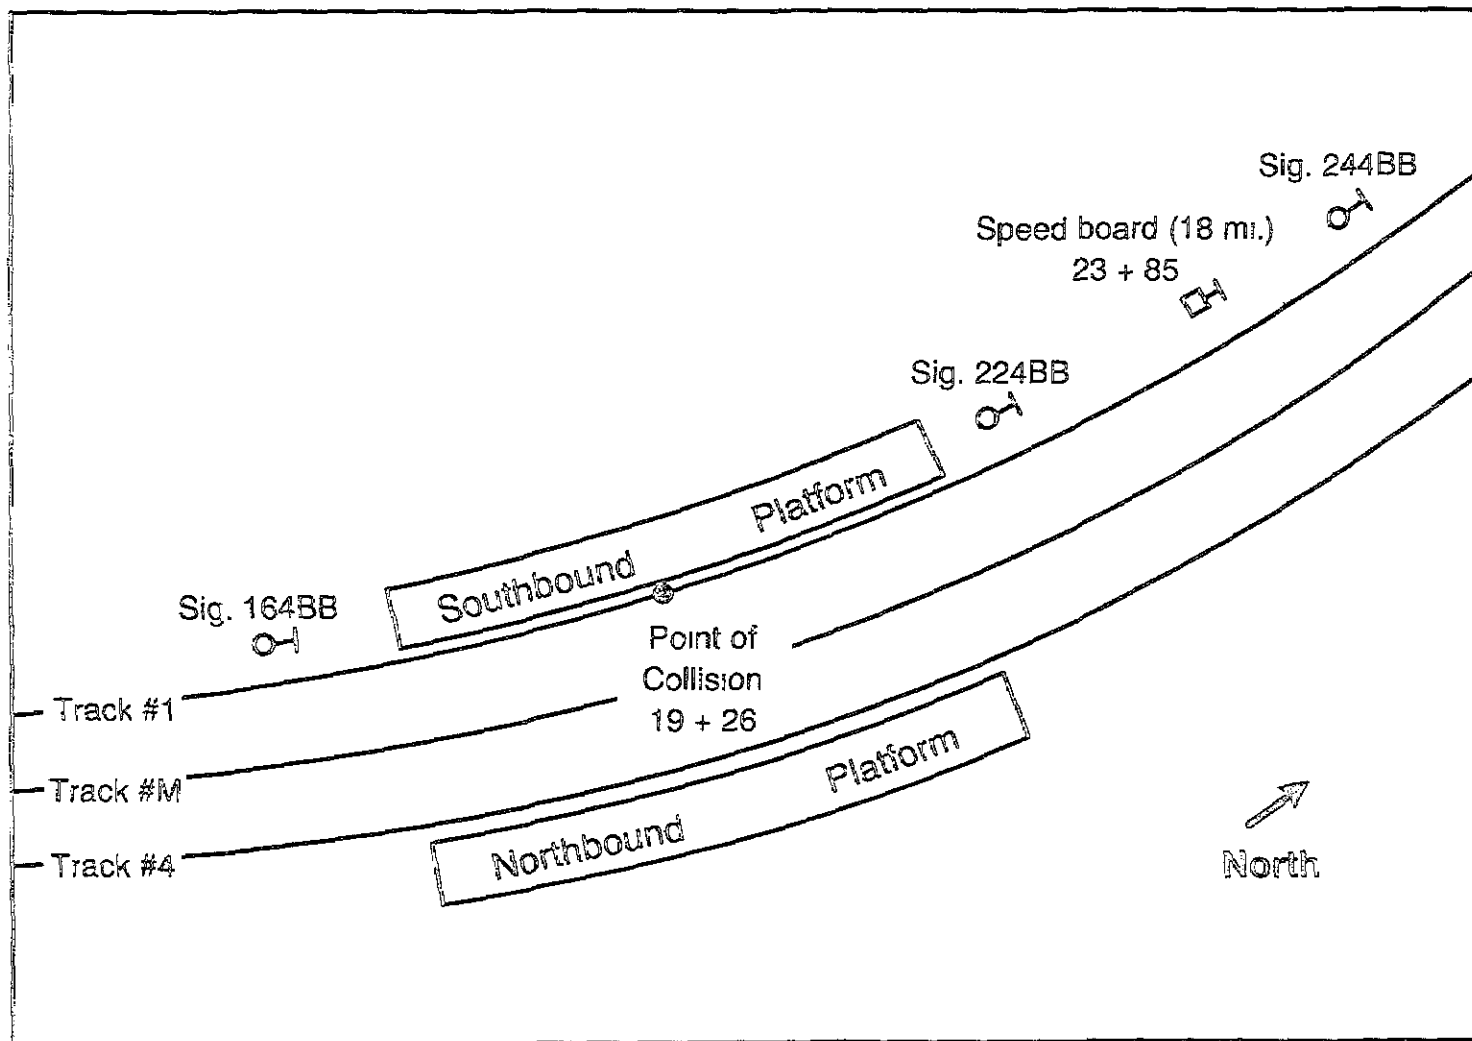
Figure 11.--103rd Street Station Track Layout.

In the area of the accident there are three tracks numbered from west to east. The track on which the accident occurred was the westerly track, designated as number 1 track. The middle track was designated as the middle track and the east side track was designated as number 4 track (see figure 11).
