RAILROAD ACCIDENT INVESTIGATION

REPORT NO. 4165

NORFOLK AND WESTERN RAILWAY COMPANY

COLBY, OHIO

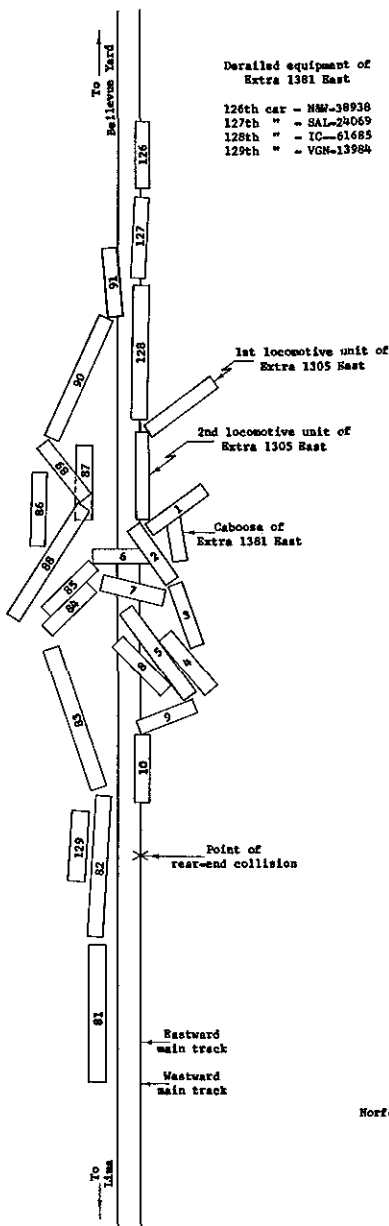
Norfolk and Western Railway  
 Colby, Ohio  
 September 21, 1969

# Derailed equipment of Extra 1305 East

1st car - C&O--76227  
 2nd " - VGN--30394  
 3rd " - GATX--51603  
 4th " - GATX--21041  
 5th " - C&O--21957  
 6th " - NWM--38781  
 7th " - NWM--74058  
 8th " - NWM--7496  
 9th " - NWM--66673  
 10th " - NWM--278544

Both locomotive units and the first 10 cars of this train derailed. The first locomotive unit stopped on its right side, and on the south side of the eastward main track, with the front end about 270 feet east of the rear-end collision point (see following photograph). The second unit stopped upright on and in line with the eastward main track structure immediately to the rear of the first unit. The 10 derailed cars stopped in various positions on or near the main track structure, as indicated in Plate No. 2. The two locomotive units were heavily damaged. Of the 10 derailed cars, 7 were destroyed, 2 heavily damaged, and 1 slightly damaged.
