NATIONAL TRANSPORTATION SAFETY BOARD

RAILROAD ACCIDENT REPORT

SIDE COLLISION AND DERAILMENT OF
NORFOLK & WESTERN RAILWAY
COMPANY TRAINS NOS. 6BS78,
YARD SHIFTER, & 67HNP,
CREWE, VIRGINIA
NOVEMBER 28, 1981

NTSB-RAR-82-3

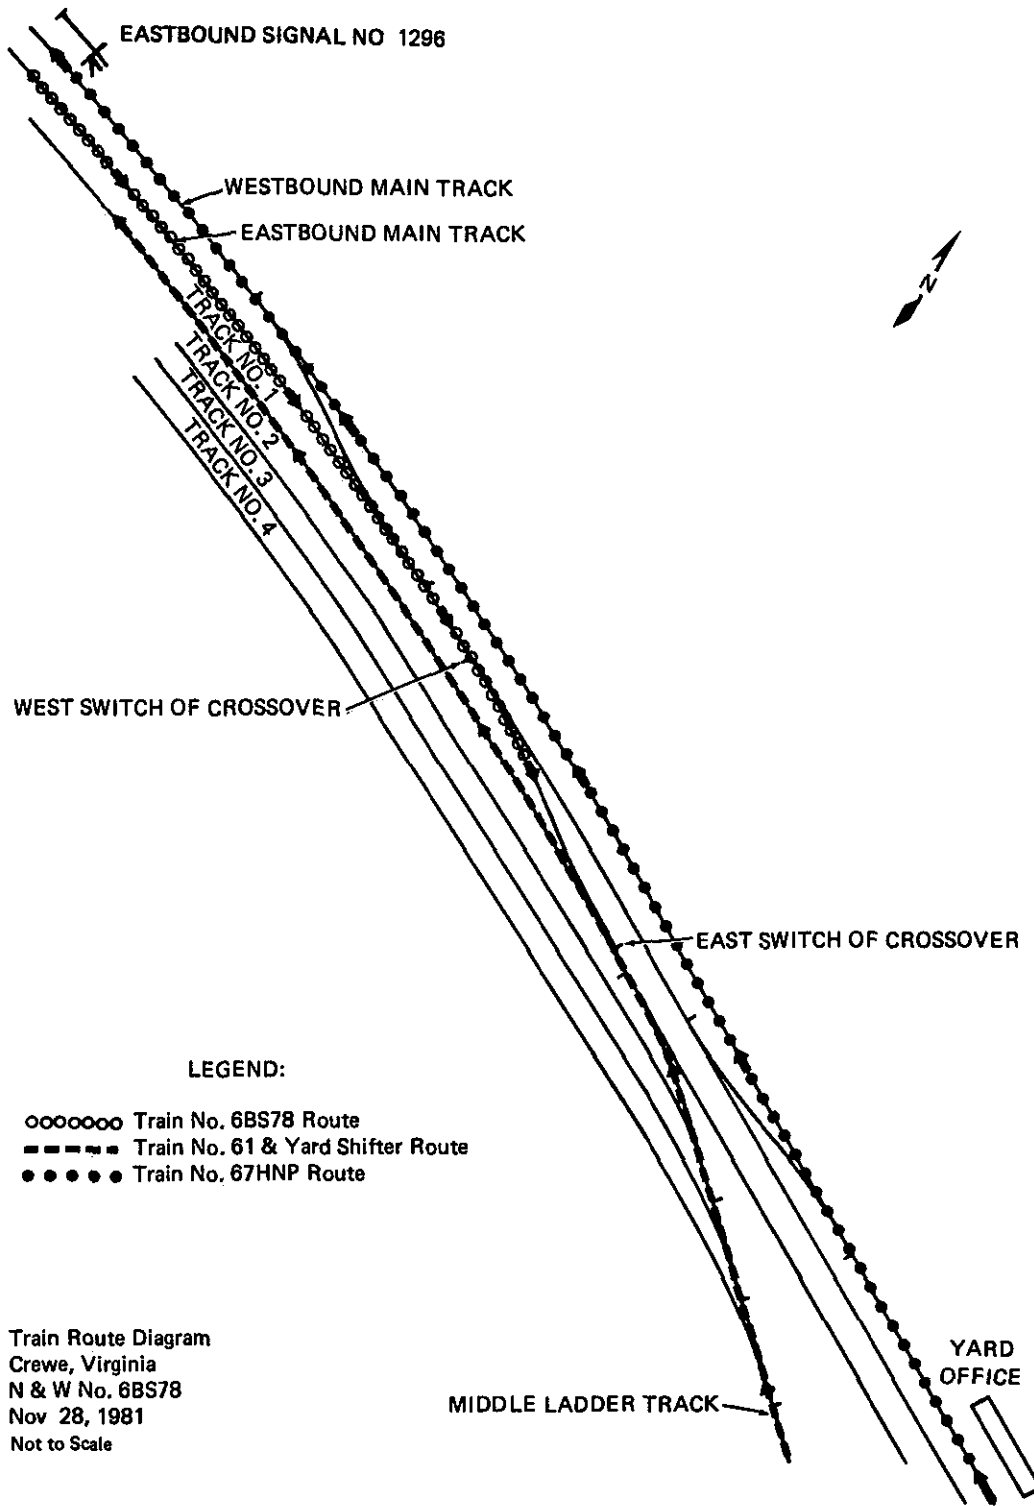
Figure 1.--Crewe Yard.

About 6:30 a.m. on November 28, 1981, three locomotive units were dispatched from the engine shop at Crewe, Virginia, and traveled west on the westbound main track, the most northerly of the tracks at Crewe. The eastbound main track is adjacent to and south of the westbound main track. The body of Crewe yard is to the south of the main tracks, and the yard office is on the north side of the main tracks. (See figure 1.)

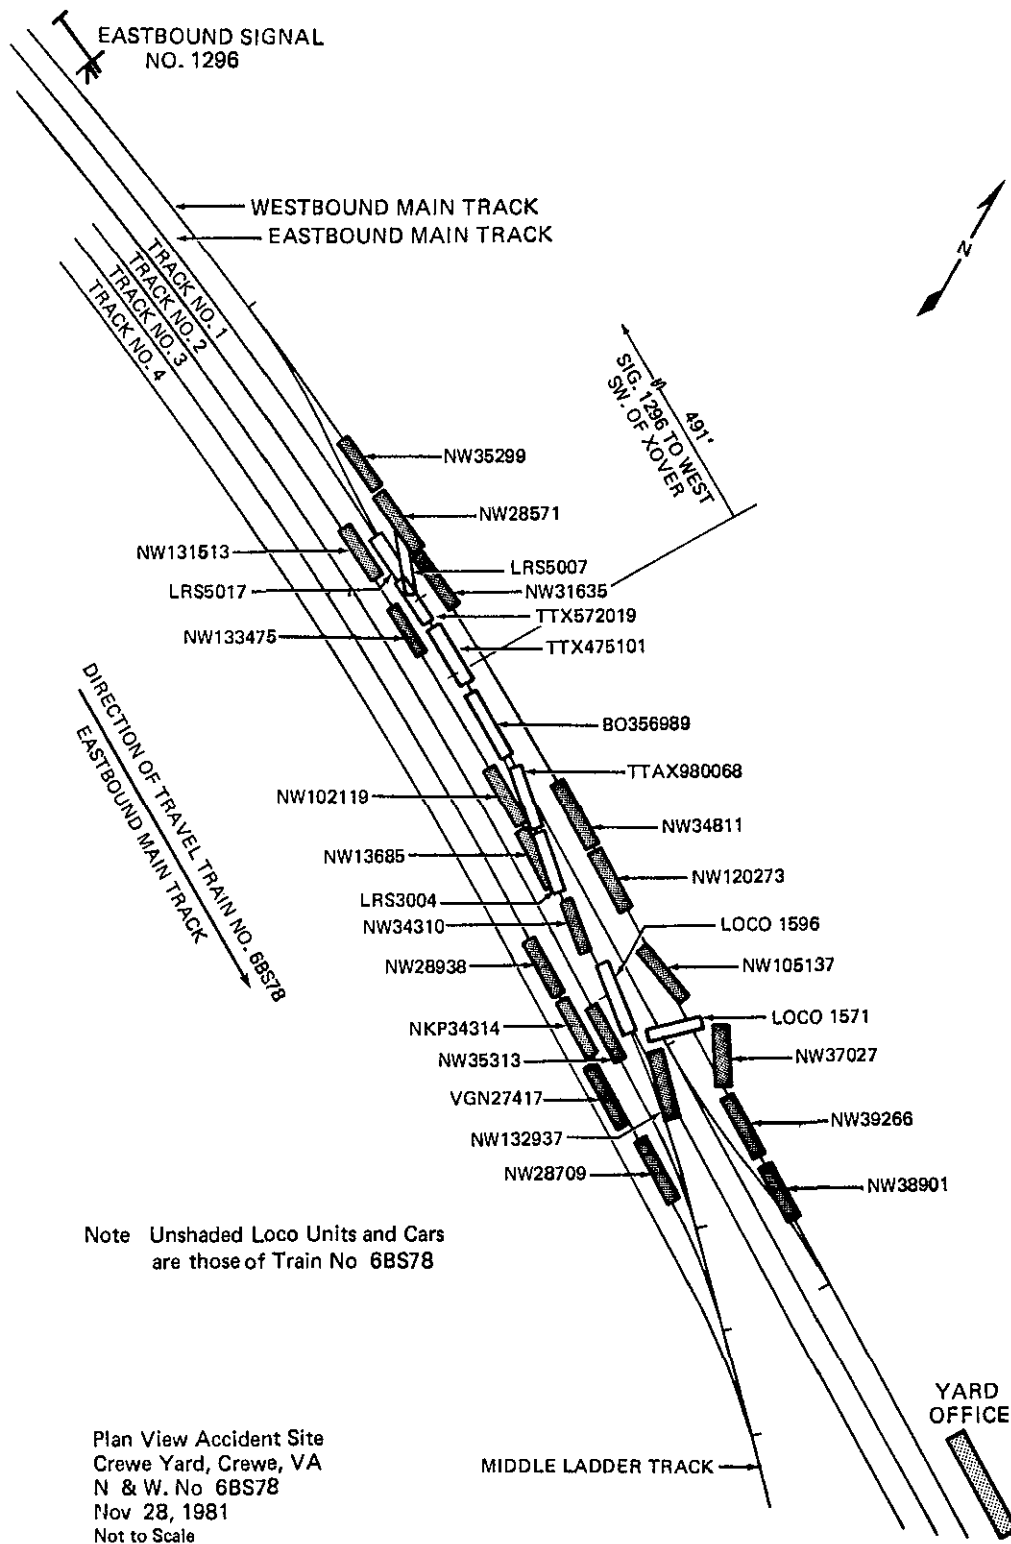
Figure 2.--Plan view of accident site at the Crewe yard.

Shortly before 8:20 a.m., train No. 6BS78 was arriving at the Crewe yard on the eastbound main track. The 3,345-ton train, consisting of 2 locomotive units, 29 loaded and 35 empty cars, and a caboose was equipped with a two-way radio. The engineer radioed the yardmaster and received permission to pass the green (clear) eastbound signal No. 1304 at the west end of the yard. Timetable instructions require all eastbound trains entering Crewe yard limits to contact the yardmaster and receive permission to proceed. The engineer and front brakeman testified that they called out the signal indications to each other as required by the carrier's operating rules. They also called out the green (clear) indication on the eastbound signal No. 1296. As the train approached the crossover from the eastbound main track to yard track No. 1, it was proceeding through a 2-degree curve to the right. Because the engineer was preparing to stop the train for a change of crews, the speed of the train had been reduced from about 45 miles per hour to about 27 miles per hour. The locomotive was equipped with a speed recording tape. (See appendix C.) The engineer and brakeman said that they observed the switch lined into yard track No. 1 when they were about one car length away from the switch and that they both applied the automatic air brake in emergency at the same time. They stated that they then lay on the floor because of the impending collision. The train entered the west switch of the crossover at about 27 miles per hour and was routed from the eastbound main track to yard track No. 1 where it collided with the coal hopper cars being handled by the yard shifter. No. 6BS78 then struck the empty hopper cars of train No. 67HNP on the westbound main track. The locomotive of train No. 6BS78 derailed and jackknifed across the two main tracks. (See figure 2.) Four coal hopper cars on yard track No. 3 were also derailed by impact from the cars on yard track No. 1. The front brakeman on train No. 6BS78 and the conductor on train No. 67HNP received minor injuries as a result of the accident. Damage was estimated at \$690,305.

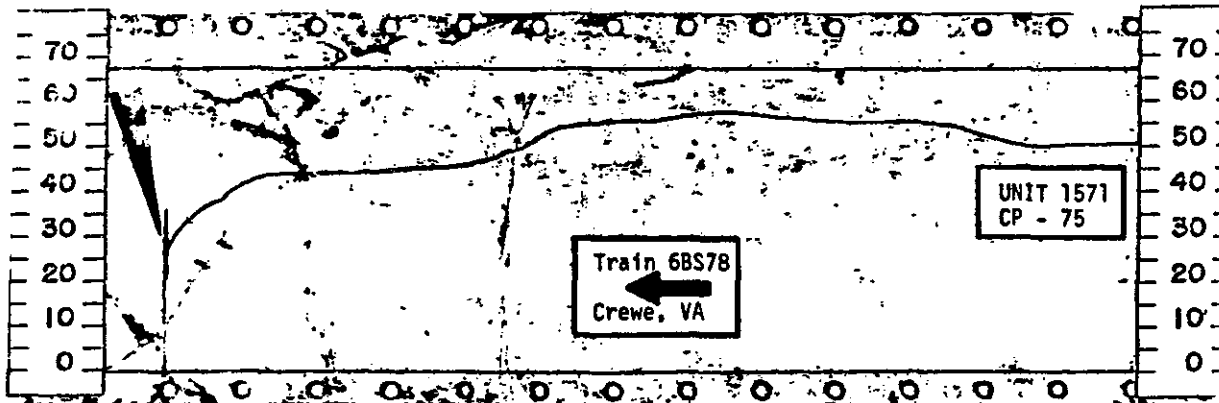
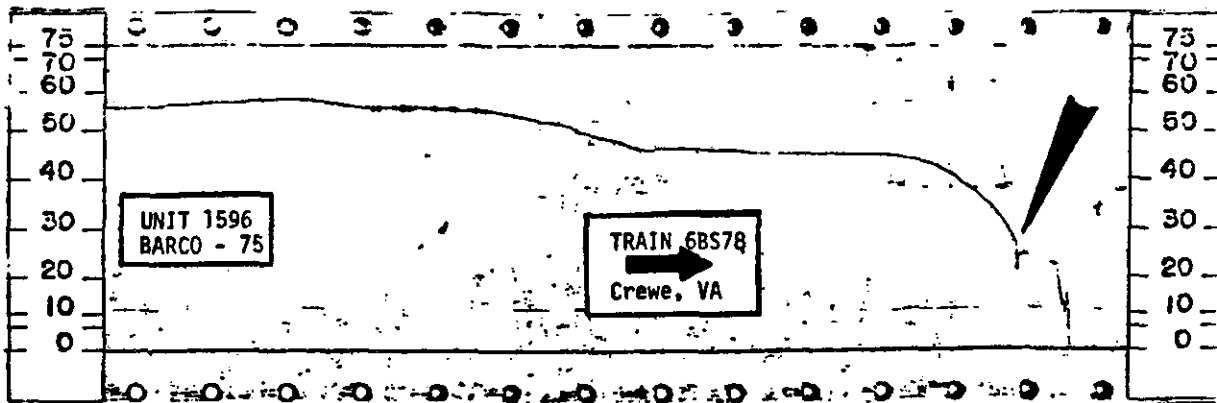
APPENDIX C
SPEED RECORDING TAPE

DERAILMENT TRAIN 6BS78 - November 28, 1981
Norfolk Division Crewe, VA
Locomotives 1571 - 1596
29 Loads 35 Empties 3,337 Tons
