NATIONAL TRANSPORTATION SAFETY BOARD

**SIDE COLLISION OF
NORFOLK AND WESTERN RAILWAY COMPANY'S
TRAIN NO. 86 WITH EXTRA 1589 WEST
NEAR WELCH, WEST VIRGINIA
SEPTEMBER 6, 1980**

NTSB-RAR-81-2

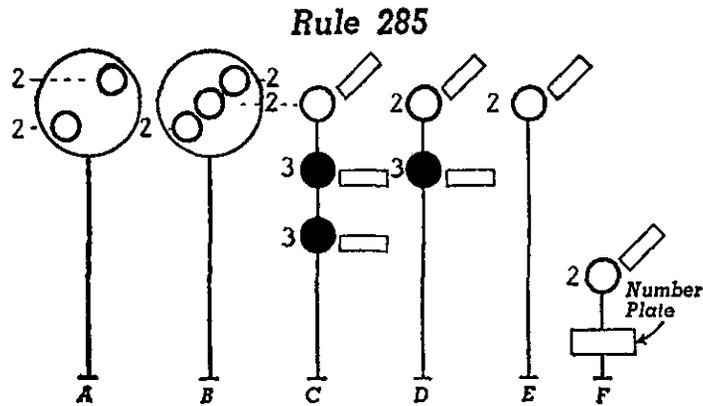
Indication—Proceed preparing to stop at next signal. If exceeding medium speed immediately take action to reduce to that speed.

Name—Approach

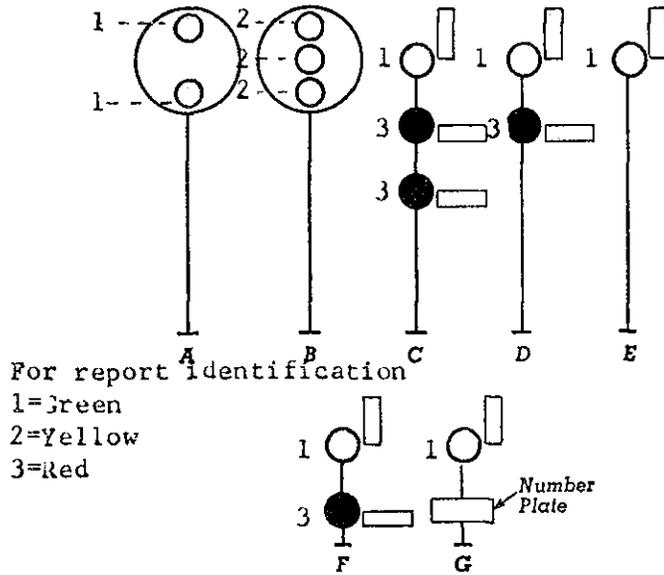
Rule 281

Indication—Proceed at prescribed speed.

Name—Clear.
