RAILROAD ACCIDENT INVESTIGATION

Report No 3865

NORFOLK AND WESTERN RAILWAY COMPANY

DECEMBER 15, 1959

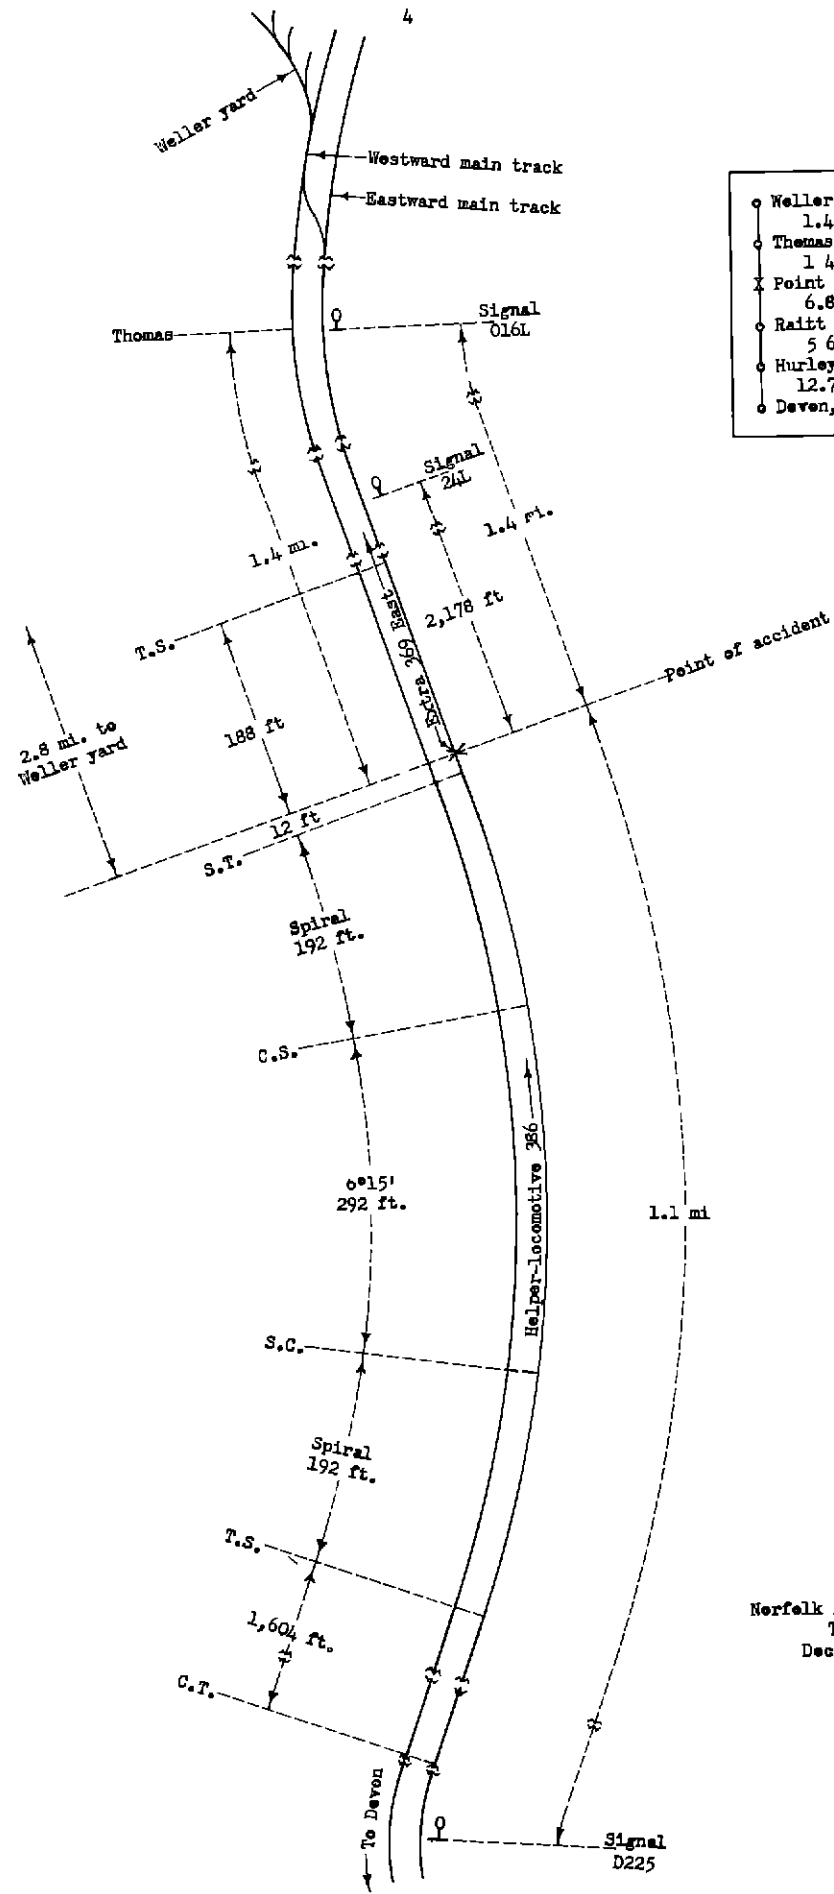
Norfolk And Western Railway
 Thomas, Va.
 December 15, 1959

- Weller Yard, Va. 1.4 mi
- Thomas 1.4 mi
- X Point of accident 6.8 mi
- Raitt 5.6 mi
- Hurley, Va 12.7 mi
- Devon, W. Va.

Location of Accident and Method of Operation
