REPORT NO. 3763
NORFOLK SOUTHERN RAILWAY COMPANY
IN RE ACCIDENT
NEAR EDENTON, N. C., ON
JULY 5, 1957

Accident near Edenton, N. C., on July 5, 1957, caused by
failure of a trestle.

Report No. 3763
Norfolk Southern Railway
Edenton, N. C.
July 5, 1957

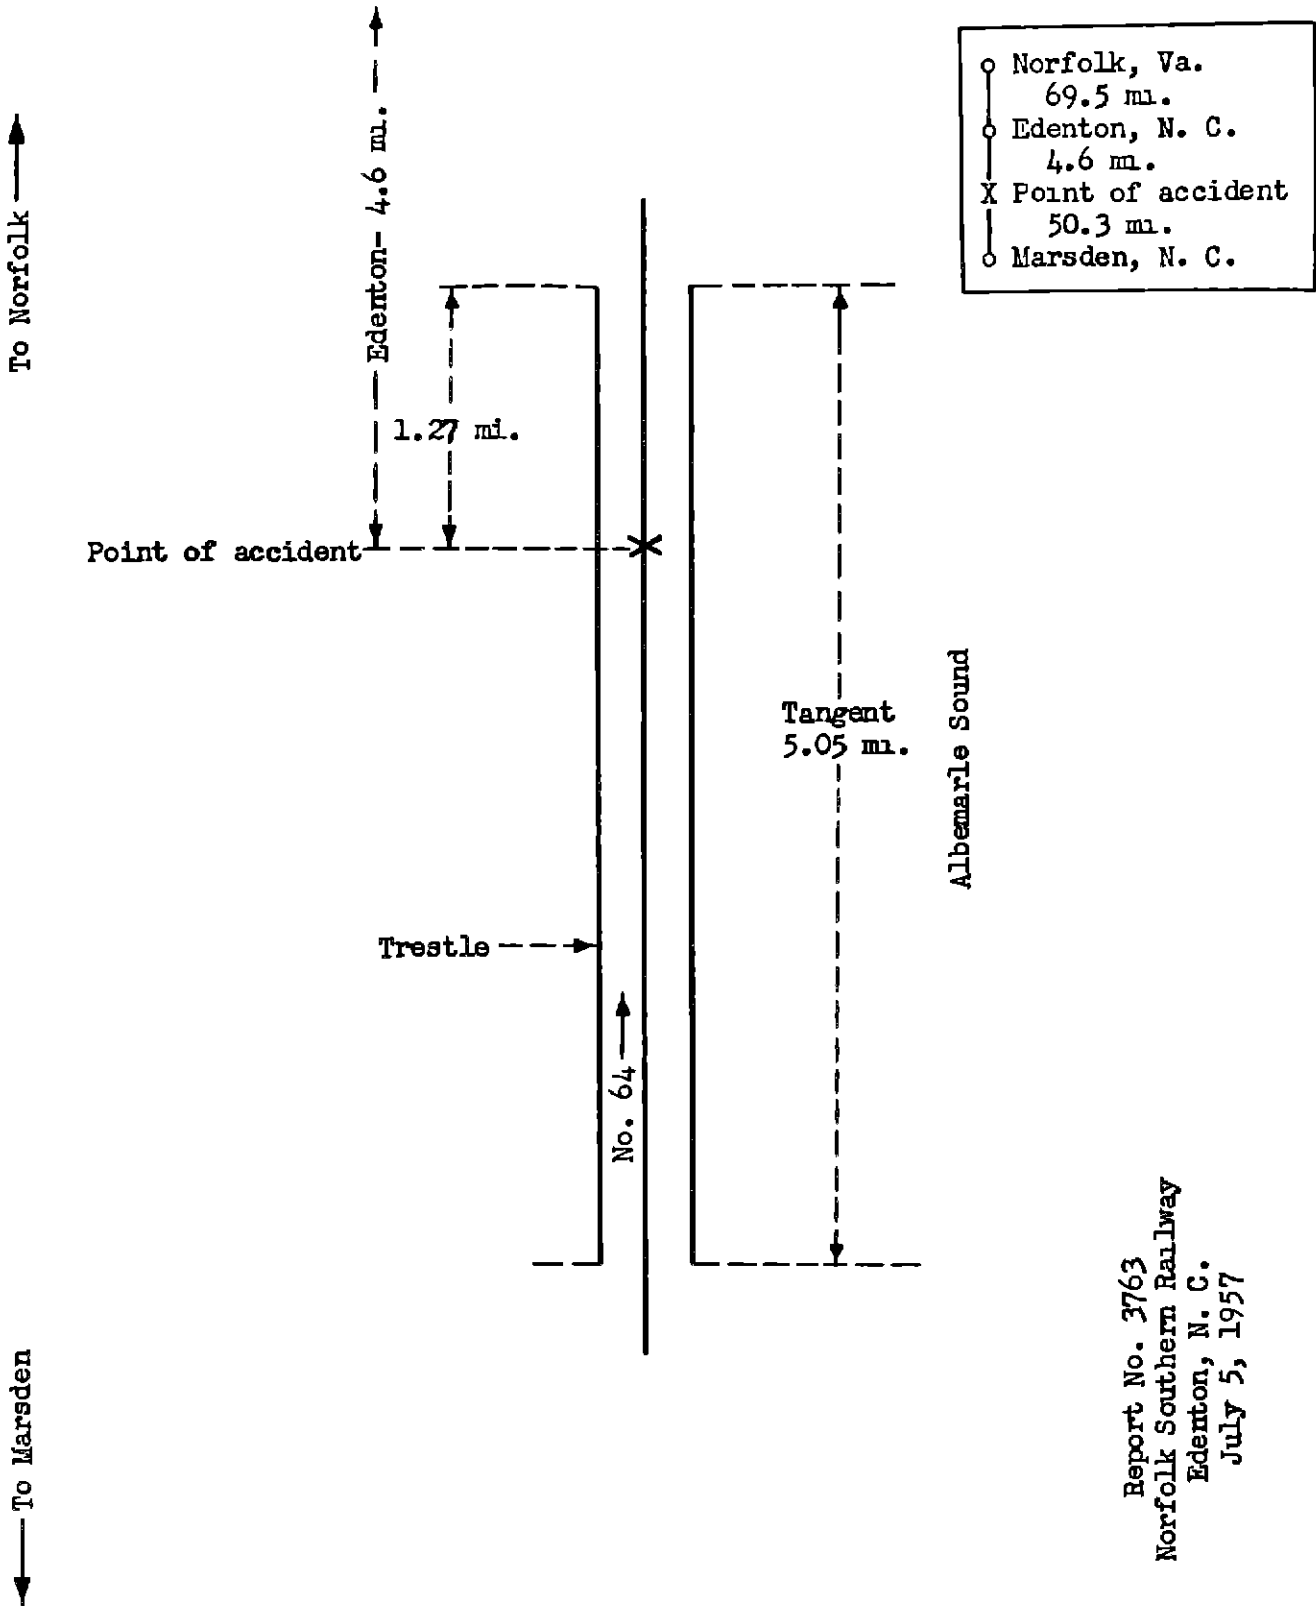
In the vicinity of the point of accident the trestle consisted of frame-type bents. The penetration of the piles was approximately 40 feet. At low tide the depth of the water is about 20 feet. The water level varies approximately 2 feet. There was no indication that equipment had been derailed before the trestle failed. The frames of 11 bents were destroyed when the accident occurred. Twenty-one piles of these bents remained in place. Since only about 20 percent of the trestle members involved in the accident were recovered, the sequence of events that led to the failure of the trestle could not definitely be determined. There was no indication of damage to the piles by marine borers. One batter post of a frame involved in the accident was decayed near the bottom end to the extent that only approximately 30 percent of the original cross-sectional area was effective in bearing the load applied to the post. (See Plate 1.)

Plate 1. Showing the extent of decay found at the bottom end of a batter post of one of the frame-type bents involved in the accident.
