RAILROAD ACCIDENT REPORT

COLLISION BETWEEN NORTHERN INDIANA
COMMUTER TRANSPORTATION DISTRICT
EASTBOUND TRAIN 7 AND WESTBOUND TRAIN 12
NEAR GARY, INDIANA, ON JANUARY 18, 1993

Abstract: On January 18, 1993, Northern Indiana Commuter Transportation District (NICTD) eastbound commuter train 7, traveling from Chicago, Illinois, to South Bend, Indiana, and NICTD westbound commuter train 12, traveling from South Bend to Chicago, collided at milepost 61.1 in Gary, Indiana. Seven passengers died and 95 people sustained injuries.

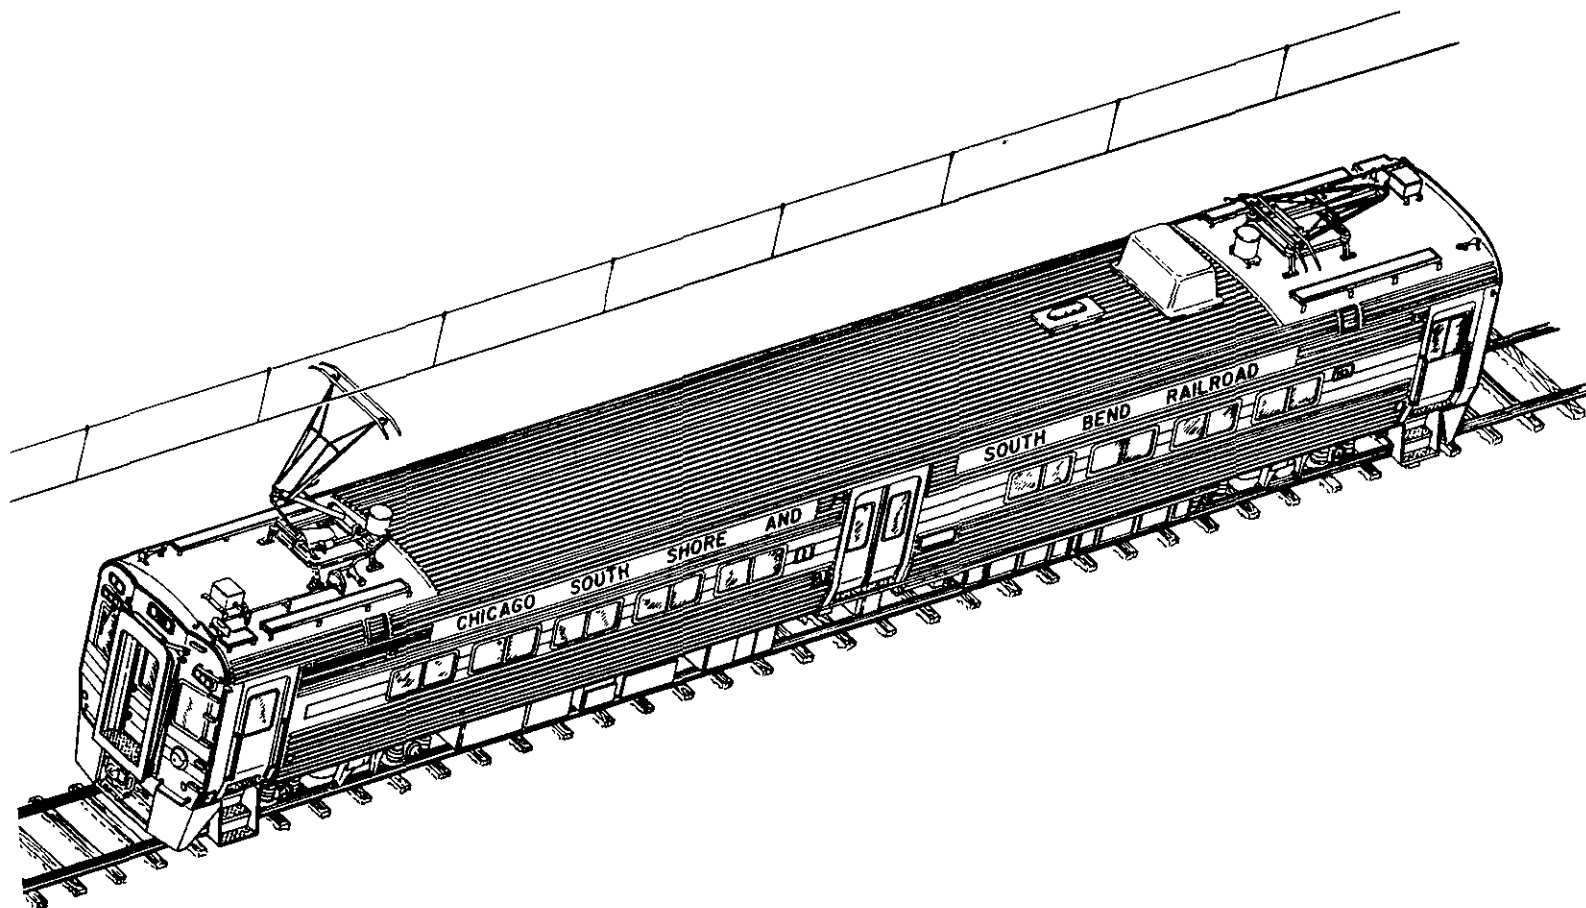
Figure 3 --Exterior view of NICTD electric passenger railroad car
Source: *NICTD Running Maintenance and Trouble Shooting Manual*, September 1982.

The self-propelled, MU, electric-powered, light-weight stainless steel construction, passenger rail cars¹⁴ that the NICTD operates in revenue service (see figure 3) are typical of the self-propelled electric cars used in suburban commuter rail service. Each 85-foot-long, 118,000-pound car operates on 1,500 volts, direct current, supplied by overhead catenary wire. The operator controls are in a control compartment at both ends of each car. The NICTD operates its trains in consists of up to eight cars, however, the operator controls at both ends allow individual unit operation. Each car has a 93-passenger seating capacity and is generally fitted with bench seats that accommodate 2 passengers each. The benches are mounted so that the seated passengers face the middle of the car.

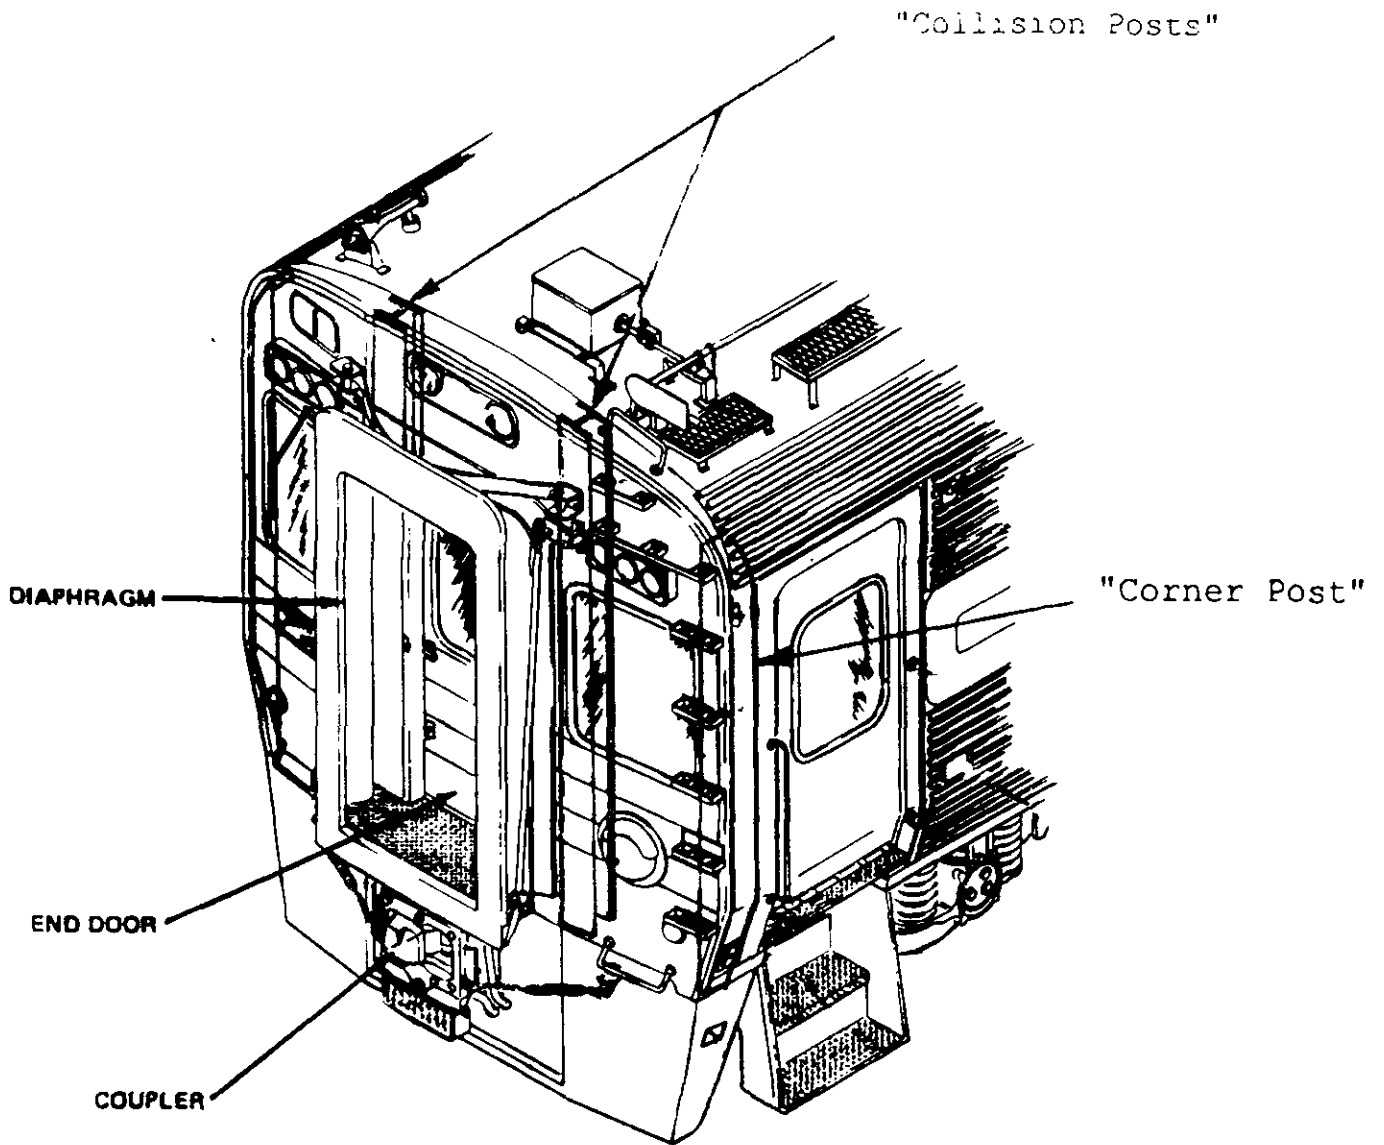
Figure 5 --Diagram showing position of collision posts and corner post on passenger rail car

Car Body Design Requirements and Considerations -- The passenger rail cars (MU locomotives) operated by the NICTD that are described in this investigation must comply with the car body design requirements for MU locomotives in 49 CFR 229 141. Several design features, such as collision posts,¹⁵ provide for the protection of vulnerable areas of the car body in a head-on collision. (See figure 5) By deforming on impact, collision posts absorb substantial kinetic energy (crash forces) in a coupler-to-coupler collision and prevent, or at least reduce, the tendency for car body telescoping, in which one car body intrudes longitudinally into another. However, collision posts do not afford protection to corner areas in a corner-to-corner collision because the posts are generally adjacent to the control compartment door. Moreover, the design requirements in 49 CFR 229 141 do not address car body corner post structural requirements. How much car body intrusion protection that the corner post structure will provide without such requirements before it yields and experiences complete structural failure is relative to how much kinetic energy it can absorb in a collision.
