RAILROAD ACCIDENT INVESTIGATION

Report No 3848

PANHANDLE AND SANTA FE RAILWAY COMPANY

JUILLIARD, TEXAS

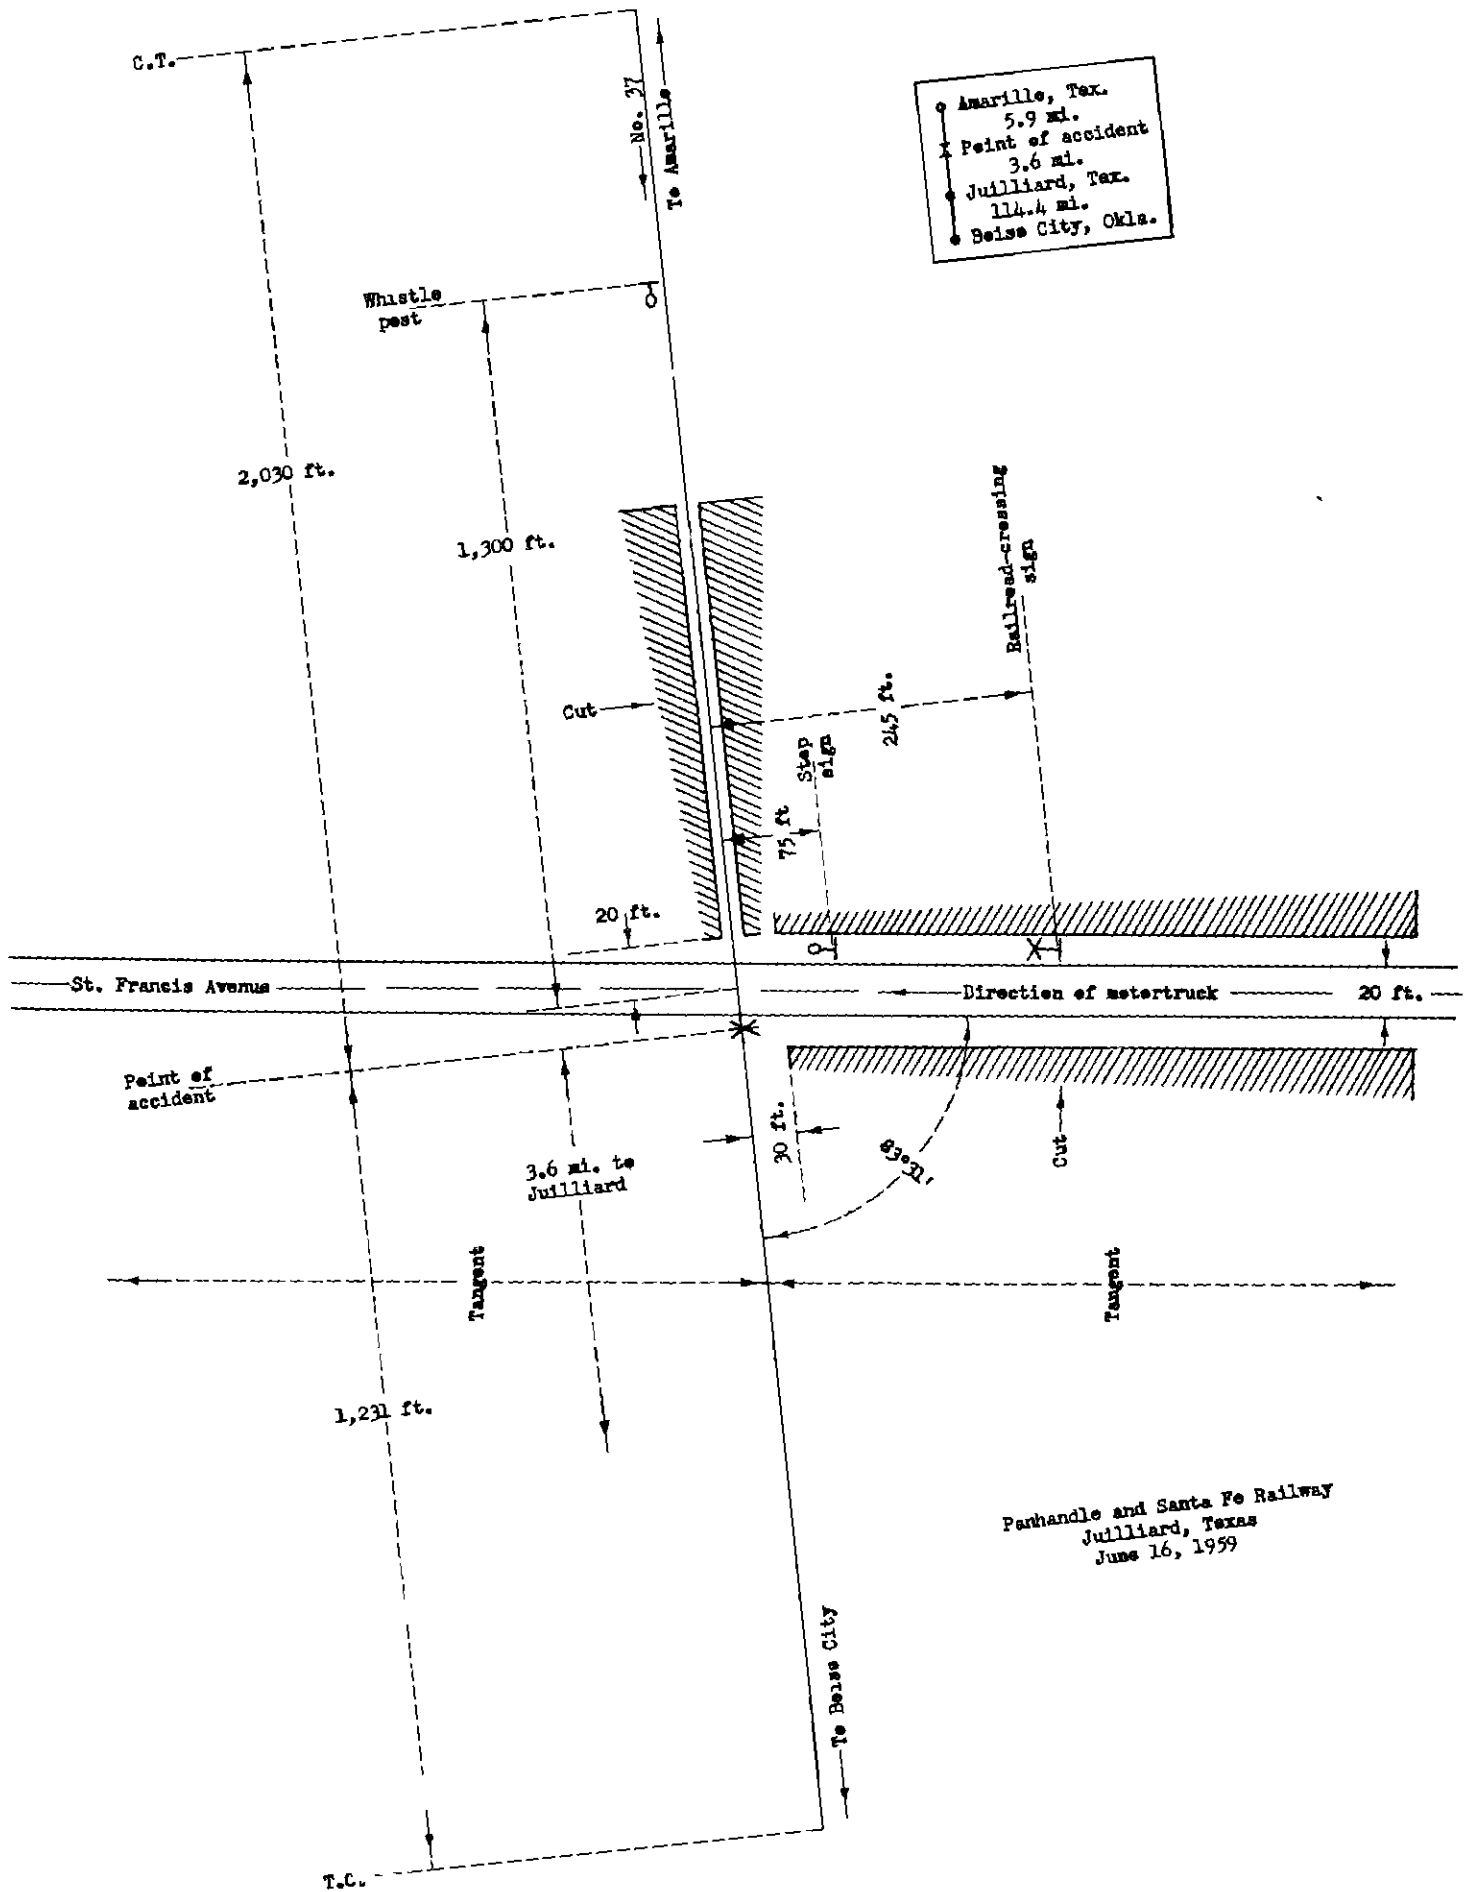
• Amarillo, Tex.
 5.9 mi.
 * Point of accident
 3.6 mi.
 • Juilliard, Tex.
 114.4 mi.
 • Boise City, Okla.

The accident occurred on the main track at a point 5.9 miles west of the station at Amarillo and 3.6 miles east of Julliard, Texas, where the railroad is crossed at grade by St. Francis Ave. (PLATE 1). From the east the track is tangent throughout a distance of 2,030 feet to the point of accident and 1,231 feet westward. The grade is 1.0 percent descending westward.
