RAILROAD ACCIDENT INVESTIGATION

REPORT NO. 4167

PENN CENTRAL COMPANY

SEPTEMBER 23, 1968

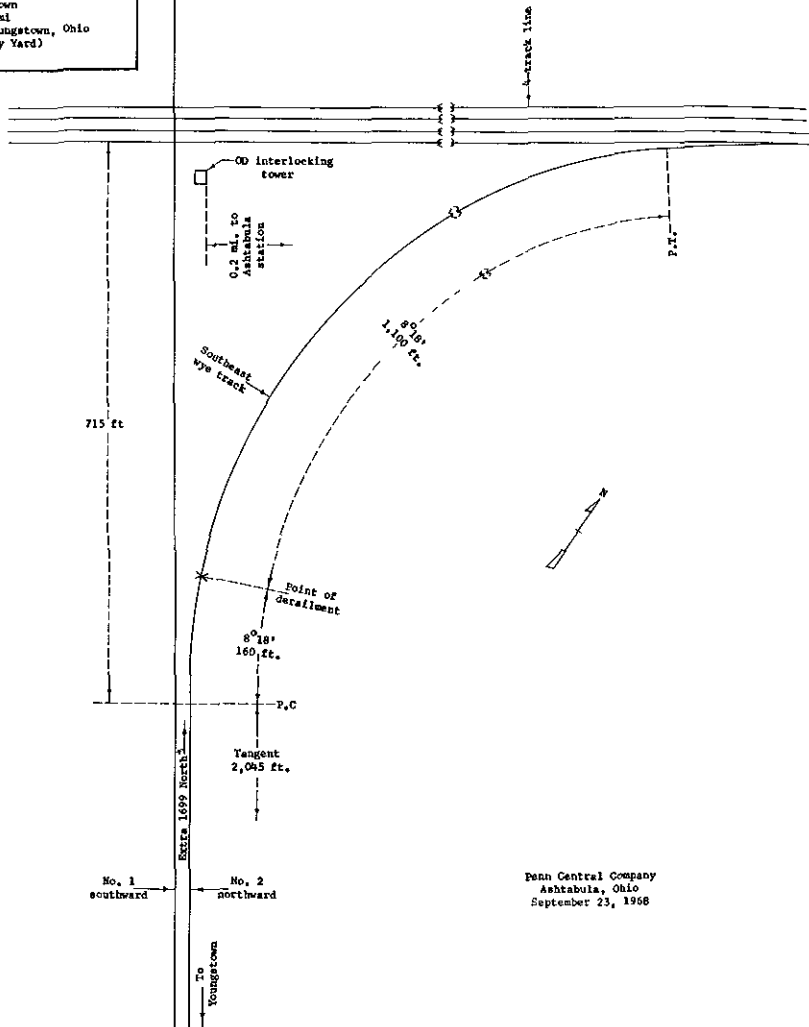
Ashtabula

- Ashtabula, Ohio
0.2 mi
- OD Interlocking
0.1 mi.
- × Point of derailment
4.2 mi.
- Caron
53.1 mi.
- Valley Street Interlocking
0.7 mi.
- Youngtown
2.8 mi
- East Youngtown, Ohio
(Gateway Yard)
