RAILROAD ACCIDENT INVESTIGATION

REPORT NO. 4144

PENN CENTRAL COMPANY

FEBRUARY 17, 1968

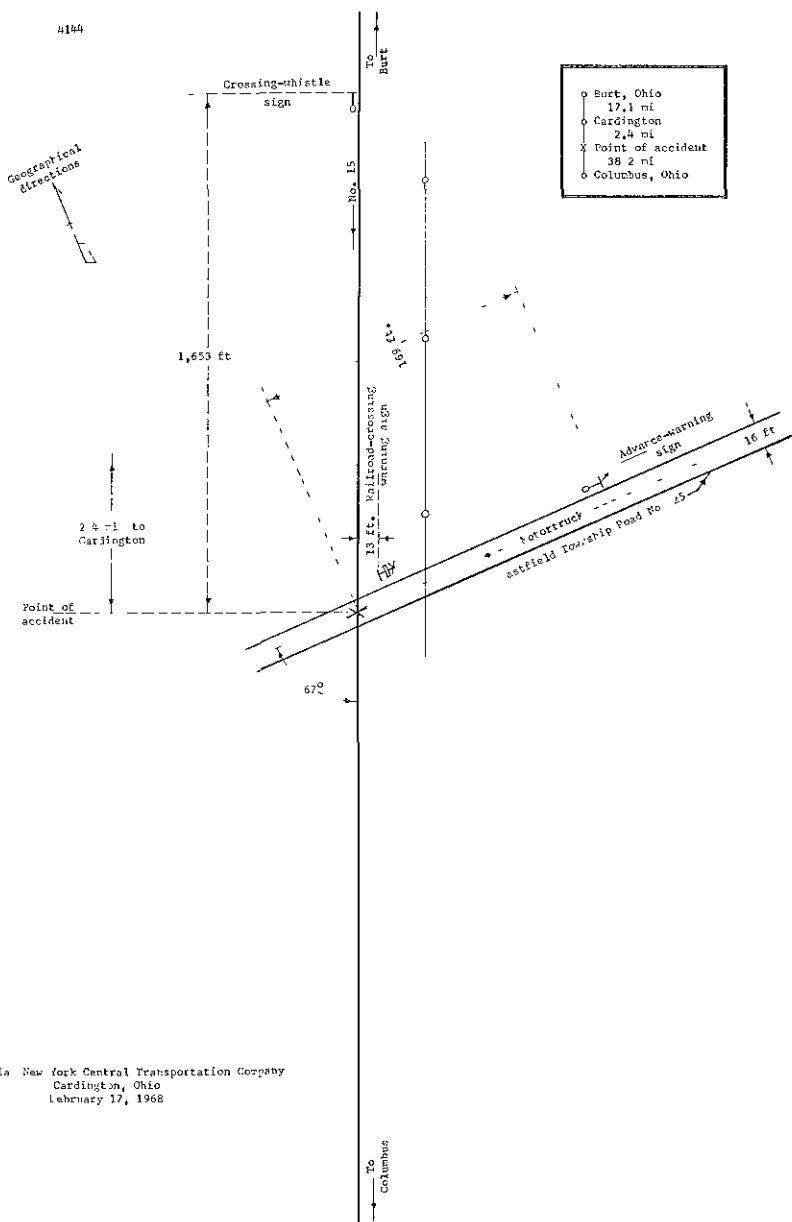
Examination of the motortruck revealed no defective condition of its brake system.

Motortruck (after removal from railroad right-of-way).
