NATIONAL TRANSPORTATION SAFETY BOARD

# RAILROAD ACCIDENT REPORT

PENN CENTRAL COMPANY  
COLLISION OF TRAINS  
N-48 AND N-49 AT  
DARIEN, CONNECTICUT  
AUGUST 20, 1969

REPORT NUMBER: NTSB-RAR-70-3

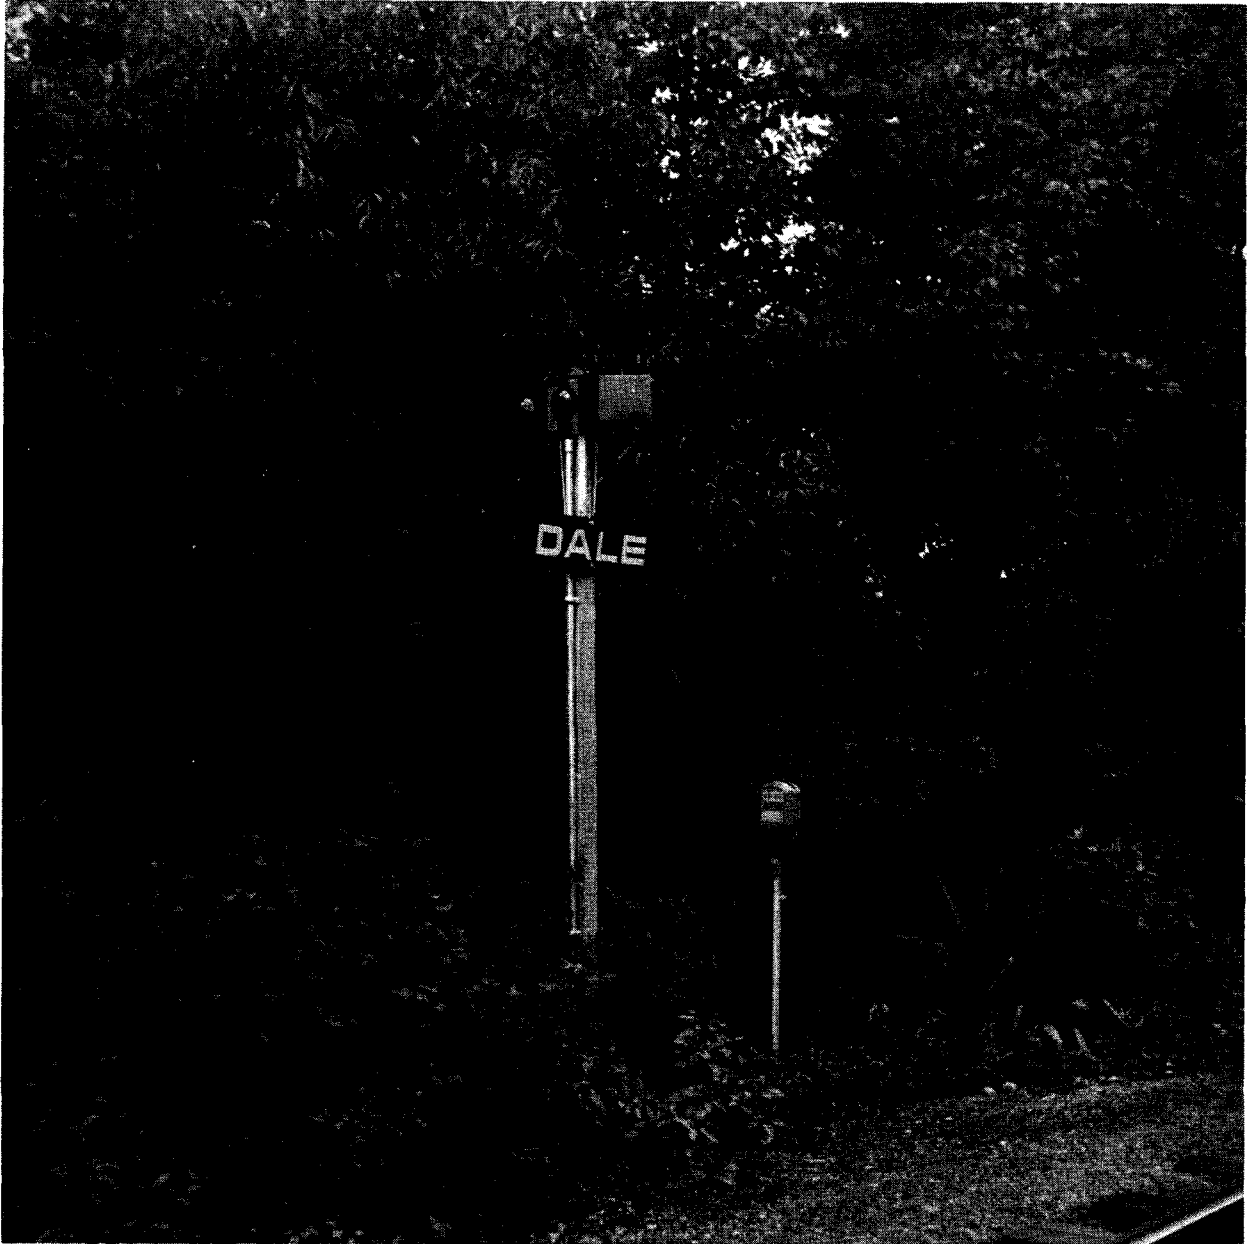
Figure No. 1

At Dale siding, there is a similar block-limit signal with "Dale" mounted below the lights. (See Figure 1, page 5.) This signal is located along the north side of the track, 299 feet east of the west switch of the siding. Dale block-limit station was opened by timetable instructions from 6:55 a.m. to 8:25 a.m. and from 6:10 p.m. to 7:25 p.m., daily except Saturday, Sunday, and holidays for regular meets between opposing trains. Dale block-limit station was opened as needed at other times by train order. Since the accident, rules regarding the time of the open block-limit station have been changed. When Dale block-limit station was opened, the New Canaan Branch was divided into two manual blocks, and a train was not permitted to pass the block-limit station without obtaining permission from the operator to occupy the block.

Dale block - limit station
