RAILROAD ACCIDENT REPORT

**PENN CENTRAL COMPANY
TRAIN SECOND 115 (SILVER STAR)
DERAILMENT AT
GLENN DALE, MARYLAND
JUNE 28, 1969
ADOPTED: JUNE 10, 1970**

Report Number: NTSB-RAR-70-1,

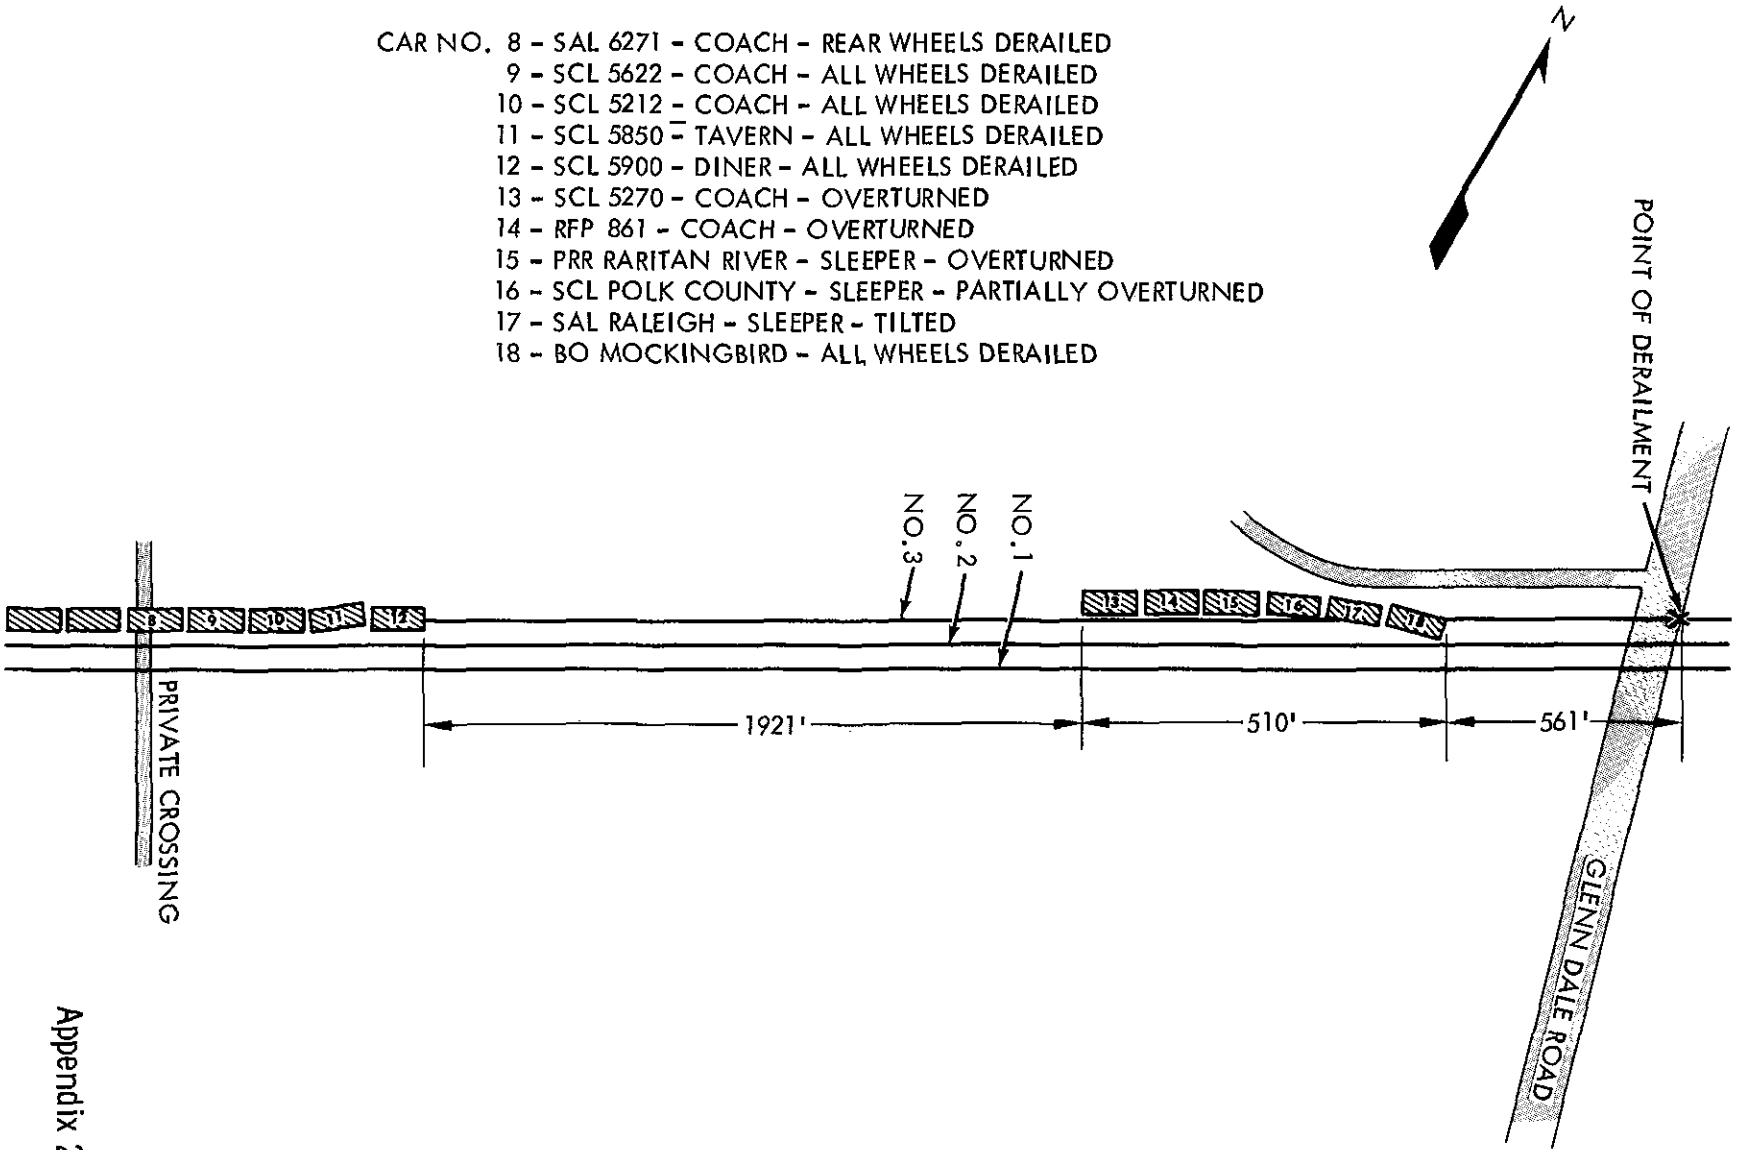
- CAR NO. 8 - SAL 6271 - COACH - REAR WHEELS DERAILED
- 9 - SCL 5622 - COACH - ALL WHEELS DERAILED
- 10 - SCL 5212 - COACH - ALL WHEELS DERAILED
- 11 - SCL 5850 - TAVERN - ALL WHEELS DERAILED
- 12 - SCL 5900 - DINER - ALL WHEELS DERAILED
- 13 - SCL 5270 - COACH - OVERTURNED
- 14 - RFP 861 - COACH - OVERTURNED
- 15 - PRR RARITAN RIVER - SLEEPER - OVERTURNED
- 16 - SCL POLK COUNTY - SLEEPER - PARTIALLY OVERTURNED
- 17 - SAL RALEIGH - SLEEPER - TILTED
- 18 - BO MOCKINGBIRD - ALL WHEELS DERAILED
