RAILROAD ACCIDENT INVESTIGATION

REPORT NO. 4145

PENN CENTRAL COMPANY

LANDISVILLE, PA.

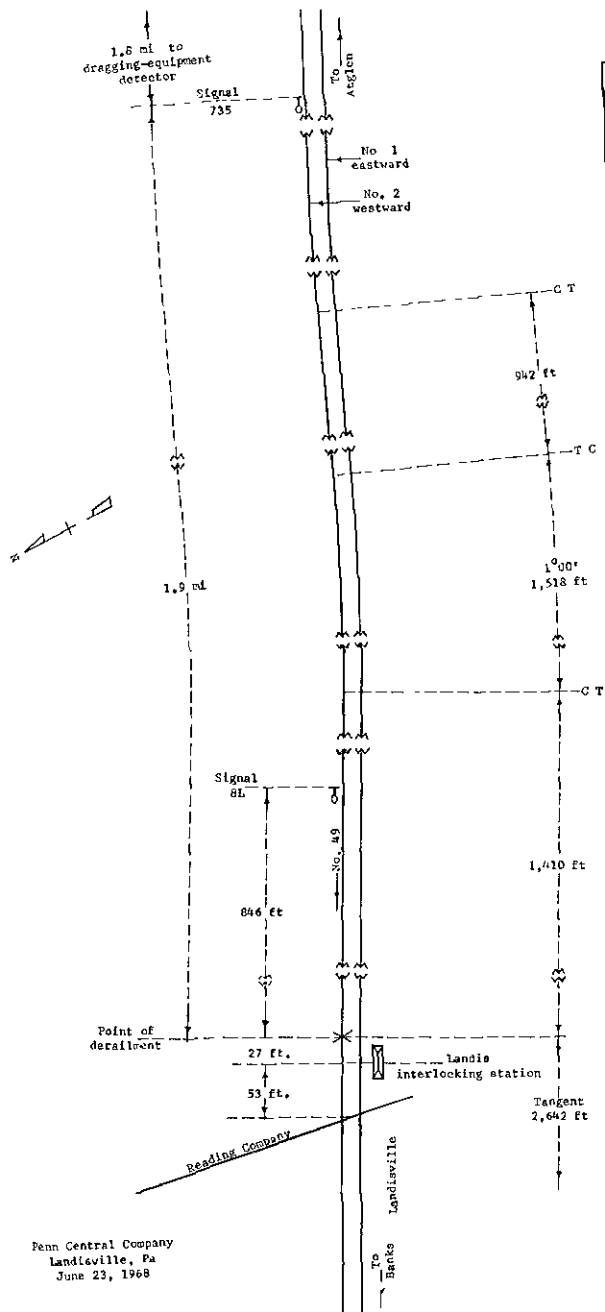
SKETCH "B"

In June 1967, Pullman Company employees reapplied the north generator bracket of Pullman car "Charles Lockhart" and secured it to the center sill of the car by welds. On June 23, 1968, the day of the accident, this car was dispatched from New York, N. Y., as the fifth car of No. 49. From all indications, the welds securing the north generator bracket of the car to the center sill had been partially or completely broken by this time.

center sill of the car because of the broken welds, permitting the generator to swing downward with the south bracket holding it to the car. The generator and/or its north bracket then struck rail anchors applied to the gage side of the north rail of track No. 2 in the vicinity of a point about 227 feet east of the Landis interlocking station. Immediately thereafter, while the train was moving westward at approximately 75 miles per hour, the generator swung downward sufficiently to contact the ties, between the rails. Impact forces from this contact caused the south generator bracket to break through its arm holes, permitting the generator to drop free to the track structure and bounce or roll under the train. After the rear truck of the fifth car passed over it, the generator evidently became wedged, successively, under the front and rear trucks of the sixth car. Wedging action then lifted the wheels of the trucks off the rails, causing the derailment to occur 27 feet east of the Landis interlocking station.

The accident was caused by the generator of a passenger car falling to the track structure under the train, resulting from breaks in the welds securing one of the generator brackets to the car \*

PULLMAN CAR "CHARLES LOCKHART"  
GENERATOR AND SUSPENSION BRACKET

It is recommended that the Penn Central Company and all other railroads operating passenger cars instruct their mechanical department employees to thoroughly examine generators applied to such cars, to determine whether the generators are properly secured
